Failure Analysis of Ceramic Clinical Cases Using Qualitative Fractography

Susanne S. Scherrer, PD, Dr Med Dent^a/Janet B. Quinn, BS, MS, PhD^b/George D. Quinn, BS^c/
J. Robert Kelly, DDS, MS, DMedSc^d

Purpose: To educate dental academic staff and clinicians on the application of descriptive (qualitative) fractography for analyses of clinical and laboratory failures of brittle materials such as glass and ceramic. **Materials and Methods:** The fracture surface topography of failed glass, glass fiber–reinforced composite, and ceramic restorations (Procera, Cerestore, In-Ceram, porcelain-fused-to-metal) was examined utilizing a scanning electron microscope. Replicas and original failed parts were scrutinized for classic fractographic features such as hackle, wake hackle, twist hackle, arrest lines, and mirrors. **Results:** Failed surfaces of the veneering porcelain of ceramic and porcelain-fused-to-metal crowns exhibited hackle, wake hackle, twist hackle, arrest lines, and compression curl, which were produced by the interaction of the advancing crack with the microstructure of the material. Fracture surfaces of glass and glass fiber–reinforced composite showed additional features,

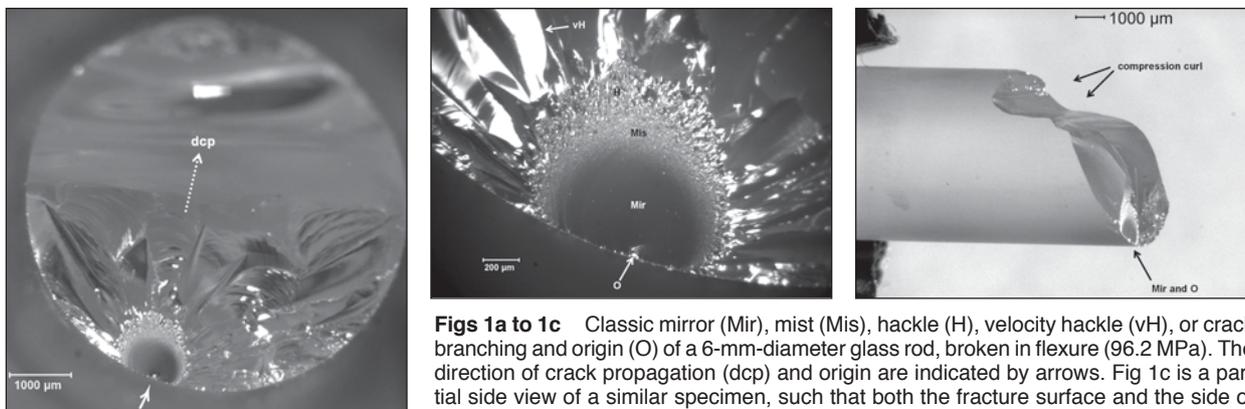
Figs 1a to 1c Classic mirror (Mir), mist (Mis), hackle (H), velocity hackle (vH), or crack branching and origin (O) of a 6-mm-diameter glass rod, broken in flexure (96.2 MPa). The direction of crack propagation (dcp) and origin are indicated by arrows. Fig 1c is a partial side view of a similar specimen, such that both the fracture surface and the side of the specimen are in view. The cantilever curl is readily evident. The origin is a small crack on the surface from grinding.

Hackle and velocity hackle are the most recognizable features on a fractured surface radiating from the mirror region and are thus often used to trace back to the fracture origin. The direction of crack propagation (dcp) runs from bottom to top (dotted arrow) in Fig 1.

Also in Fig 1a, there is a horizontal shadowed ridge at the upper quarter of the fractured rod. This is *compression curl* and indicates there was a flexural component to the failure stress. This feature is shown more clearly in Fig 1c, which is a partial side view of a similar specimen that shows both the fracture surface and the side of the specimen. The cantilever curl (ie, compression curl) is readily evident. The origin is a small crack on the surface from grinding. Compression curl is usually found near the exit side of the crack, and it curves off the plane of initial crack extension that is perpendicular to the tensile stresses on the lower half of the specimen.

Only modest magnifications ($10\times$ to $100\times$) are needed to show the fracture markings and even the origin in the bulk glass rod specimen in Fig 1. The fracture origin in this case was a small surface crack introduced during finish grinding of the outer surface of the rod. The origin can readily be detected, but a clear view of it and its size and morphology often requires higher magnification ($100\times$ to $1,000\times$) and good depth of field at the higher magnifications of an SEM. The fracture markings and origins for the following examples were photographed with an SEM. Normal fractographic analysis usually entails a combination of optical and scanning electron microscopy.

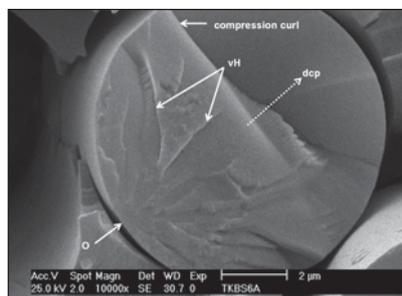
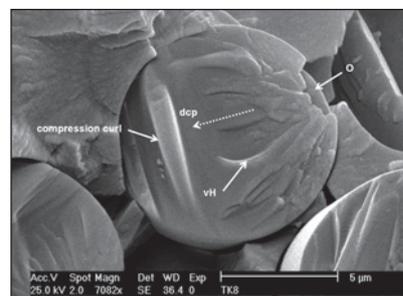
Figures 2a and 2b show the fracture surface resulting from a very small glass fiber ($\sim 9\ \mu\text{m}$ diameter) knit embedded in resin composite. The SEM is needed to discern the fracture marking in this small fiber. The bulk resin composite specimens had been tested in tension. *Velocity hackle* (vH) are discernible in both figures pointing back to the mirror region and origin (O) area (located on the surface edge). These features attest to high stress in the glass fiber. The direction of crack propagation (dcp) is indicated by the dotted arrow. The end of the fracture process is indicated by compression curl in the fiber, suggesting a flexural component as the crack breaks through the fibers. By tracing back the mirrors and compression curl in the individual fibers, the location of the failure origin of the whole component can be determined.

Figs 2a and 2b Velocity hackle (vH) pointing back to the origin (O) of a glass fiber embedded in composite resin. General direction of crack propagation (dcp) is indicated by the dotted arrows. Compression curl corresponds to the end of the fracture path.

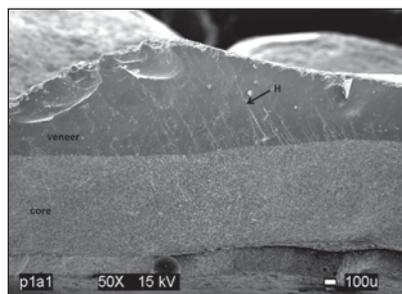
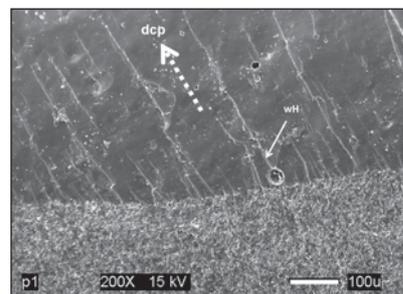
The images seen in Figs 3a and 3b are from a recovered fractured Procera crown that failed after 1 year of intraoral function. The rough alumina ceramic core (seen at the bottom of the figure) is covered by a glassy veneering porcelain in which many parallel running hackle lines are visible. Hackle is a good indicator of the direction of crack propagation, because it tends to point back toward the crack origin. Such clues are especially helpful when the origin is not visible. In this case, there were additional features that helped determine the direction of crack propagation (dcp). The question in the Fig 3 micrographs is whether the crack was running from the core toward the veneer or from the veneer toward the core. This question can be answered by noting the voids (pores) associated with the hackle (Fig 3b). When an advancing crack front encounters a pore or other discontinuity, the crack proceeds along either side of the void and eventually reforms a continuous crack front on the other side. As the crack advances along the sides of the pore, however, it continues on slightly different planes. This causes a surface irregularity that leaves a trail (wake) emanating from the bubble called *wake hackle*.^{1,3,4,16} The localized direction of crack propagation is therefore known and indicated by a dotted arrow in Fig 3b.

Figs 3a and 3b Through-thickness fracture of a Procera molar crown after 1 year. Parallel running hackle (H) is clearly visible on the porcelain veneer. The direction of crack propagation (dcp) is given by wake hackle (wH) extending from a discontinuity (a pore in this case) (Fig 3b). In this case, the fracture progressed through the core material first, then ran through the veneer.

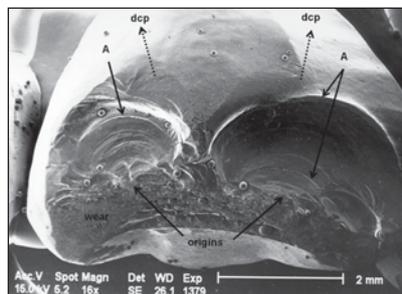
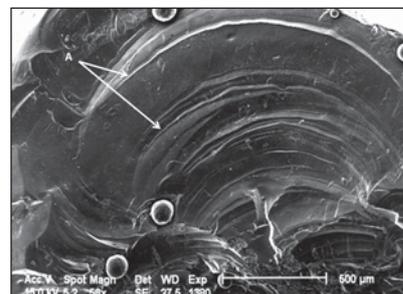
Fig 4a and 4b Replica of a Cerestore lateral incisor failure after 5 years. The veneering porcelain shows 2 parallel running chips starting from the incisal edge. Major wear is visible on the palatal incisal edge. Many arrest lines (A) on the chipped surface indicate the momentary crack halt before resuming again. The origins are located somewhere in the center of the chips, on the concave side of the first arrest lines near the incisal edge, resulting from contact loading. The general direction of crack propagation (dcp) is indicated for each chip.

Another characteristic feature indicating the direction of crack propagation is an *arrest line* (also called *rib mark*). This is a well-defined line produced when the crack comes to a halt, before resuming its propagation, often in a slightly different direction. Figure 4 shows a replica of a maxillary lateral incisor Cerestore crown from which the veneering porcelain chipped off after 5 years of intraoral function. A large wear surface over the entire palatal-incisal edge indicates chewing or bruxing activity from friction with the opposing mandibular incisors. The 2 parallel shell-shaped chips likely occurred from contact loading of the mandibular teeth with the abraded incisal porcelain edge of the crown. The 2 crack events left clear semicircular *arrest lines* with similar spacing. Arrest lines give the shape of the crack front and are useful in locating the failure origin that would normally be on the concave side of an arrest line. The exact location of the failure origin(s) (indicated by arrows) corresponds to a contact area at

the intersection of the wear region and the incisal edge at the center of the semicircular arrest lines. The direction of crack propagation (dcp) is indicated by the dotted arrow, which runs from the incisal edge toward the cervical region.

The fracture surface analyses of a chipped veneering porcelain of a Cerestore incisor crown (case 4, Fig 4) and an In-Ceram premolar crown (case 5, Fig 5) showed, for both cases, evidence of surface wear near the starting area of the crack. An excess of wear (bruxing function of the patient) on the Cerestore crown remained clinically unnoticed and resulted in thinning of the incisal edge, which in turn became more prone to surface chip fractures. Early detection of such bruxing activity could have prevented the failure, with an overnight acrylic resin mouthguard provided for the patient to protect the ceramic crowns. Premature contact on the In-Ceram premolar crown resulted in contact damage from the opposing dentition, and either the porcelain or the patient's opposing dentition should have been adjusted to prevent this. A similar conclusion is drawn from the porcelain failure of the PFM crown (case 7, Fig 7). Because this failure occurred in a very short time (3 months), no wear was visible, but the 2 impact indents seen under SEM are evidence for an excess of occlusal (palatal) porcelain thickness. The crown was supported by an implant; thus, no periodontal ligament was present to absorb the impact shock. Again, a careful initial occlusal adjustment would have prevented this early failure.

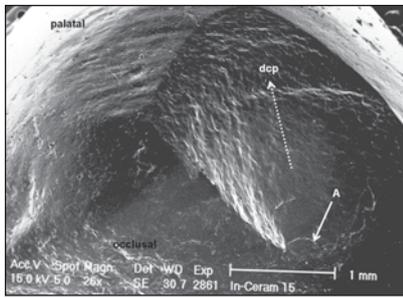
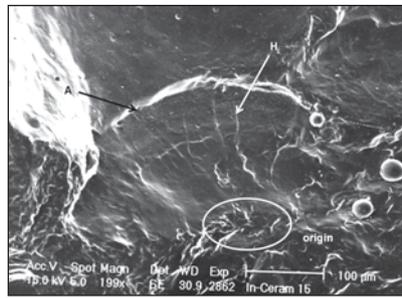
Another fracture surface replica of a veneering porcelain is shown in Fig 5. The fracture of this maxillary In-Ceram premolar occurred after 9 months of intraoral function. The occlusal-palatal view shows contact wear (rough surface) from the antagonist tooth. A clearly defined semicircular arrest line (A) is visible above the wear contact region (Fig 5b). Some hackle (H) is recognizable on the concave side of the arrest line pointing back to the origin (O), a contact area located within the circled region (Fig 5b). This crown failed from contact loading. The general direction of crack propagation (dcp) is indicated by the dotted arrow.

Figs 5a and 5b Replica of an In-Ceram premolar veneering fracture. The porcelain chip is located on the palatal cusp. An arrest line (A) is visible on the occlusal side of the chip. Hackle (H) can be seen on the concave side of the arrest line (circle) and worn porcelain surface. The general direction of crack propagation (dcp) is known thanks to the arrest line and hackle.

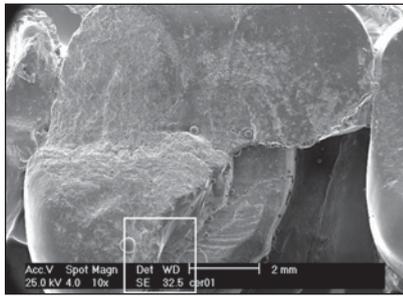
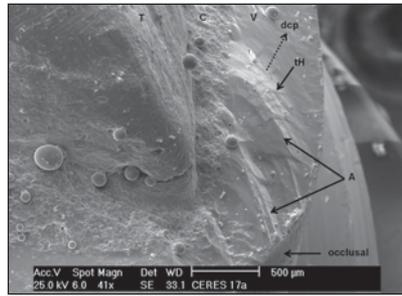
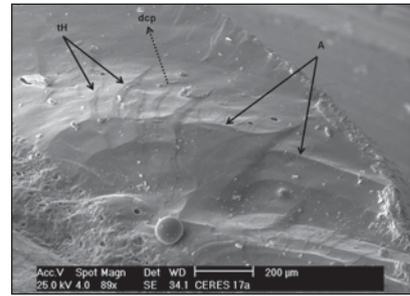
Figs 6a to 6c Replica of a failed Cerestore upper molar after 18 years showing a heavily worn occlusal surface (Fig 6a). The 41× magnified views (Figs 6b and 6c) of the occlusal palatal angle of the crown (rectangle in Fig 6a) show several arrest lines (steps) (A). The direction of crack propagation (dcp) is indicated by the concavity of the arrest lines. Twist hackle (tH) is shown in Figs 6b and 6c.

Figure 6 shows a replica of a fractured Cerestore molar crown after 18 years of intraoral function. At the occlusal palatal crown angle (Figs 6b and 6c), on the porcelain veneer, arrest lines (A) are recognized, indicating that the crack propagated in steps. This suggests successive loads were applied. Also visible is *twist hackle*, which occurs when the principal tension axis undergoes a lateral rotation (twist). The hackle that separates portions of the crack surface briefly twists in a direction normal to the new tension axis before resuming in parallel but non-coplanar crack propagation. In this case, the fracture started from the occlusal contact area.

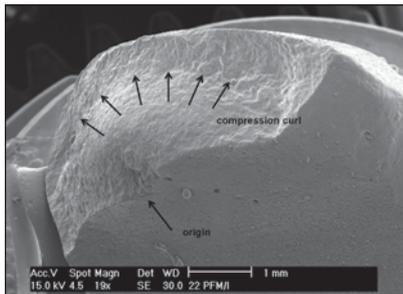
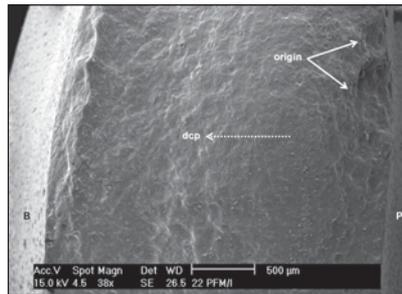
Figs 7a and 7b Replica of an incisal angle fracture of the veneering porcelain of a PFM crown. Arrows indicate a zone called compression curl—a curved lip indicating the end of the fracture process. The origin (O) is therefore located on the opposite side of the compression curl. The higher magnification (in b) shows 2 semicircular indents (impact by mandibular incisors) located on the palatal side and corresponding to the origin of the failure event.

Figure 7 was obtained from a replica of a maxillary incisal porcelain veneer fracture of a PFM crown that failed after 3 months of intraoral function. At a low magnification (Fig 7a), compression curl on the buccal side of the crown is evident (arrows). As previously mentioned, compression curl (also known as cantilever curl) is indicative of flexural stress. A crack starts and grows perpendicular to the tensile surface of a specimen or component loaded in bending. As the crack grows, it approaches the compression side of the specimen, slows, and veers away (maintaining a perpendicular relationship to the tensile stress field), leaving a curved lip just before total fracture. Compression curl

is common in failures of rectangular bars used for bend strength tests, where it is often used to quickly determine the side opposite the one that contains the initiating flaw.¹⁶ Based on the presence of the compression curl, the end of the fracture is located on the buccal side of the crown, therefore the palatal (opposite) side was searched for a starting flaw (origin). By rotating the specimen and tilting the SEM, the fracture origin area could be located in the form of 2 adjacent damage sites, resulting from contact impact of the mandibular lower incisors. Excessive occlusal contacts generated by the mandibular incisors during mastication were responsible for the early failure of the structure.
