Scanning Electron Microscopy Observations of Failures of Implant Overdenture Bars: A Case Series Report

ABSTRACT

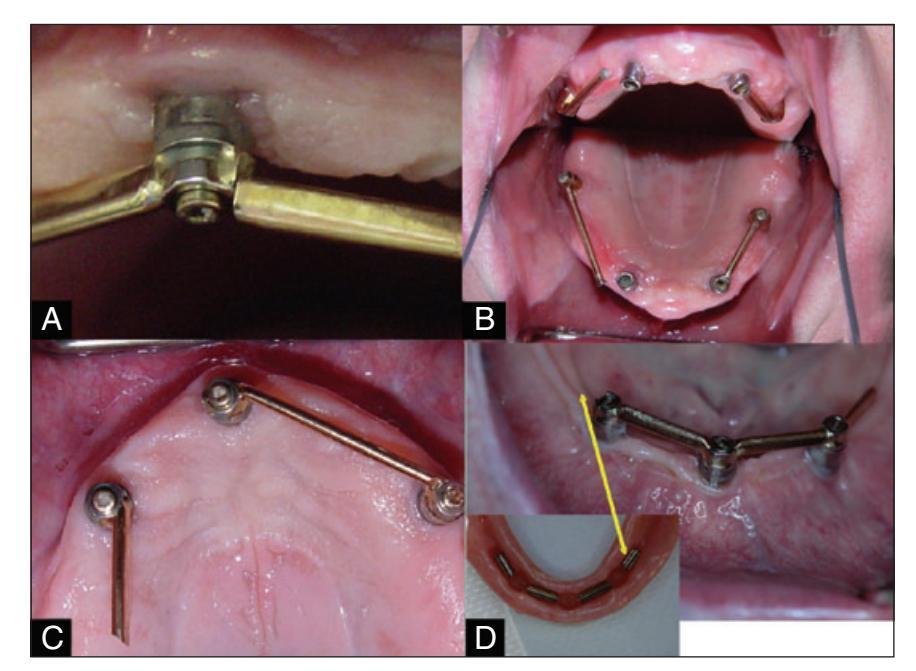
Figure 1 Clinical presentation of some patients of failed bar group. *A*, Failure occurred after 12 months; *B*, 24 months; *C*, 12 months. *D*, Fractured distal cantilever extension. Failure occurred after 24 months.

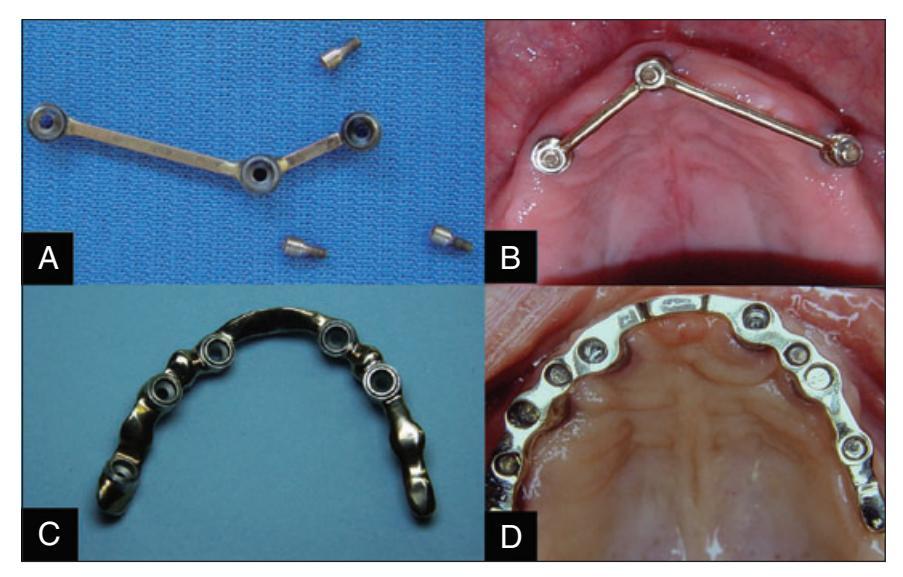
Figure 2 Clinical presentation of some patients of intact bar group. *A*, Shows underside of maxillary overdenture bar attachment system using U-shaped gold bars soldered to nonoxidizing gold cylinders; *B*, Intraoral view; *C*, Shows underside of maxillary overdenture bar attachment system using cast milled gold bars incorporating cast-on nonoxidizing gold cylinders; and *D*, Intra-oral view.

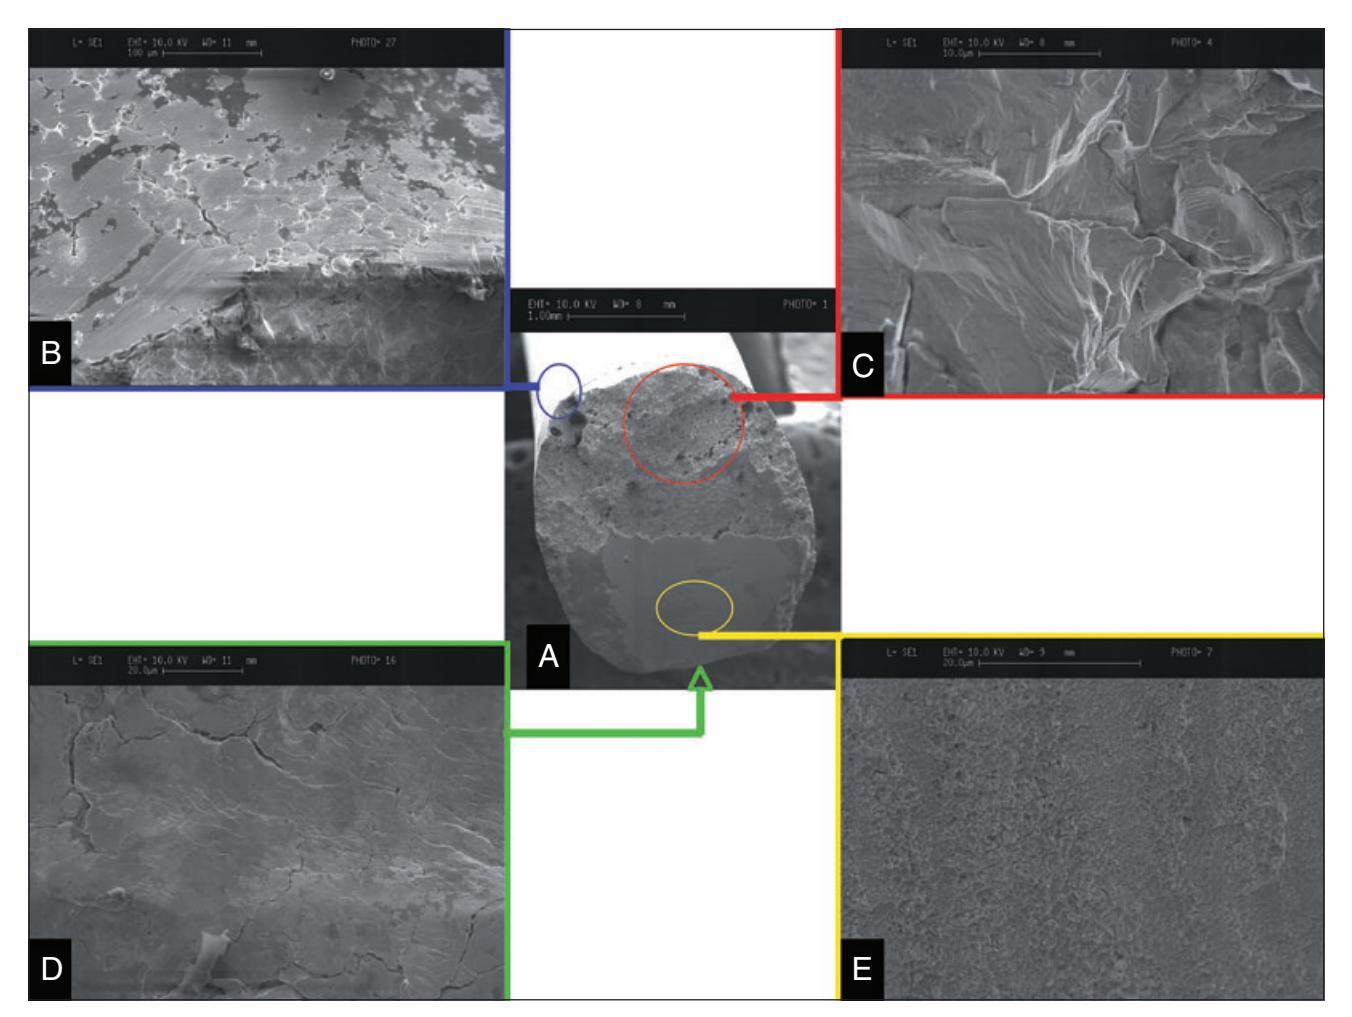
For failure 1, corrosion was observed through the solder on the superior and lateral sides, with evidence of porosity defects in the solder. In the lower half of the overdenture bar, a smooth fracture at the solder-cylinder interface had occurred (Figure 3A). The point of initiation appeared to be from the defects (porosity) in the solder (see Figure 3B). Across the top third of the failure surface, the area in tension and torque, there was evidence of cleavage type cracks with branching in different directions. There was also evidence of grain distortion that indicates a ductile overload (see Figure 3C), and of buckling and creep on the underside of the solder joint in the zone of compression (see Figure 3D). There was evidence of brittle overload shown by the intergranular fracture that had taken place within the surface layer of the cylinder (cylinder/cylinder break) across the lower third of the cylinder where the solder had been jointed to the cylinder. No distortion was evident (see Figure 3E).

Figure 3 *A*, Overview of fracture surface of the cantilever bar (failure 1, Table 1). The upper portion shows that the crack had extended through the solder, whereas in the lower half, a smooth fracture at the solder-cylinder interface has occurred. *B*, Higher magnification of the surface features from which the crack appeared to initiate. These show regions of porosity along with corrosion of the grain boundary phase of the solder. *C*, Higher magnification of the crack extension through the solder appears to show fatigue striations running across the face of the break surface and cleavage type cracks branching in different directions. There is also the appearance of grain distortion. *D*, Creep and buckling of the solder in the zone of compression at the base of the solder joint. *E*, Fracture surface of the smooth lower portion of the failure showing fine grained intergranular fracture within the outer surface of the gold cylinder and not through the solder. This was evidenced by the color of the surface being gray, the same as the cylinder surface and not yellow as in the solder-solder fracture surfaces.

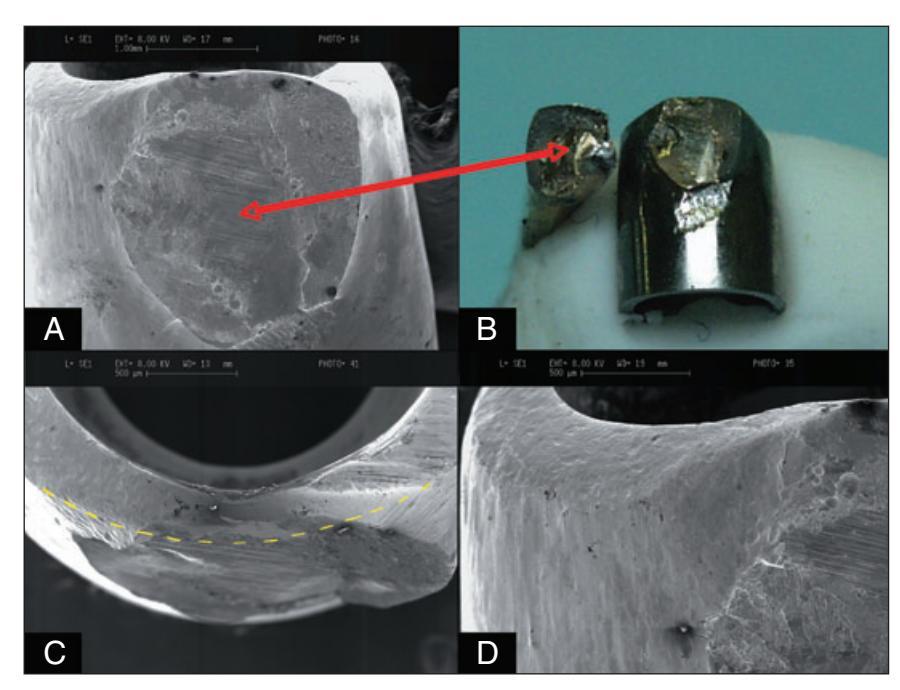
For failure 3, the center third of the joint, extending from below the top area of the joint down to the base, was devoid of solder, having large porosity defects, and even showed the bur marks from the manufacturing phase on the cylinder surface and shiny gold colored solder on the adjacent surface (Figure 4, A and B). Fatigue striations were present on the solder in the left top quarter of the joint, and buckling-induced deformation was present at the base of the solder in the zone of compression. There was intergranular brittle fracture extending within the cylinder where the crack has moved from the solder into the cylinder (see Figure 4C). Corrosion was observed on the superior and lateral sides of the solder and on the top and side surfaces of the nonoxidizing gold cylinder (see Figure 4D).

Figure 4 *A* and *B*, An overview of the center third of the joint where no solder flowed over the nonoxidizing gold cylinder surface during the manufacturing process. *C*, A top view of the nonoxidizing gold cylinder showing where the crack has extended into the cylinder. Missing area indicated by the dotted lines. *D*, Shows pitted top edge surface of nonoxidizing gold cylinder resulting from corrosion.

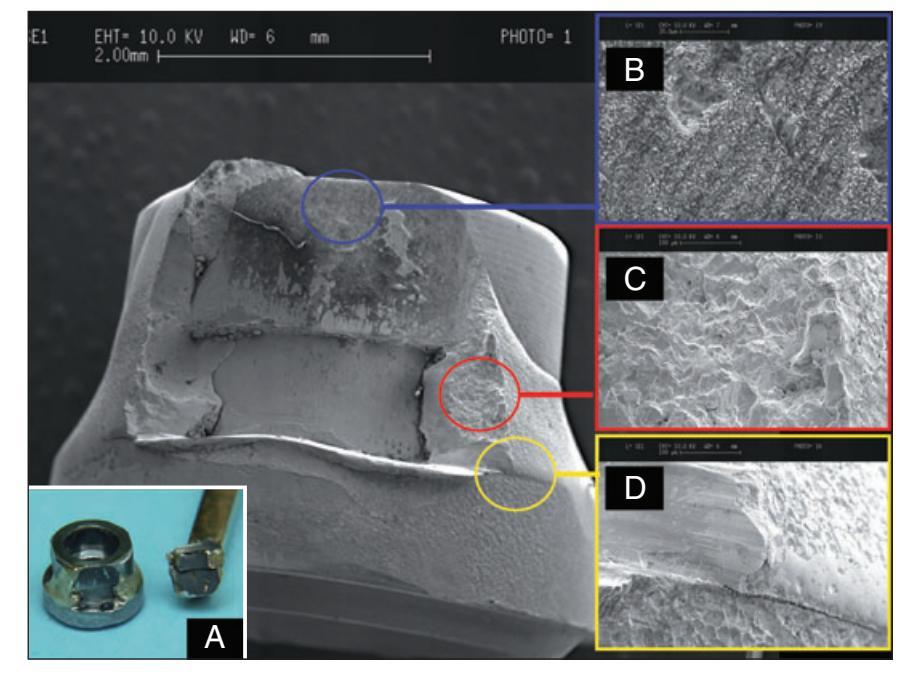
For failure 4, corrosion was also present on the lateral and superior sides of the solder and on the lower portion of the cylinder. Early stages of corrosion and cracking were detected at the opposite ends of the bar in the solder and nonoxidizing gold cylinder. The central area of the fracture occurred through the cylinder, with evidence of a brittle gray-colored intergranular fracture within the cylinder at the solder-cylinder interface (Figure 5, A and B). There were corrosion fatigue and transgranular fatigue striations on the top third of the solder, near the top of the cylinder. The middle area of the solder break surface showed cleavage type cracks, with branching in different directions (see Figure 5C). The lower portion of the solder shows evidence of buckling, as well as cracking, where it joined the gold cylinder (see Figure 5D).

Figure 5 An overview of the fracture surface that has predominantly occurred through the cylinder at the solder-cylinder interface. This is evidenced by the gray-colored fine grained intergranular fracture that occurs with brittle overload (A and B). The fracture surface through the solder highlighted in (C) shows evidence of cleavage-type cracks with branching in different directions. The lower portion of the solder highlighted by (D) shows buckling and cracking where the solder joins the gold cylinder. Note the corrosion on the cylinder and solder outer surface.

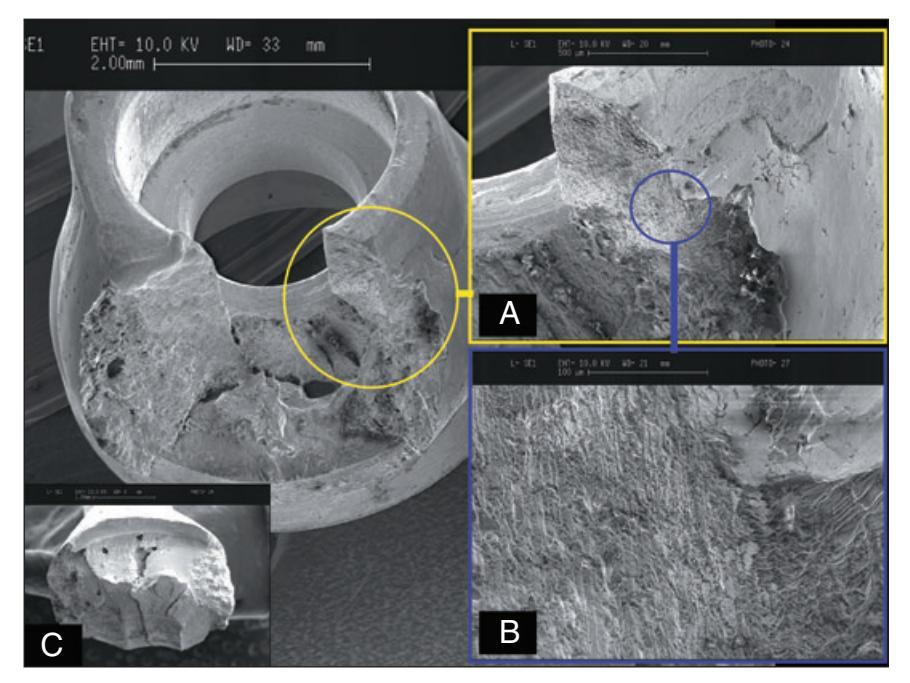
For failure 6, in addition to the usual corrosion and porosity defects, transgranular fatigue striations (Figure 6, A and B) were observed on the right-hand side of the fracture surfaces, which may indicate the initial zone of failure. The crack plane passed through

the solder and into the cylinder, resulting in the wall of the cylinder breaking out and remaining attached to the solder and bar (see Figure 6C). There was creep and buckling around the solder/cylinder junction on the sides of the cylinder. There appeared to be irregular transgranular fracture branching in different directions, indicating ductile overload. Intergranular fracture indicating brittle overload was apparent on the floor of the failed cylinder and the remainder of the failed cylinder wall. There was corrosion and early stages of progressive failure modes on the other intact abutment solder joints or abutment gold cylinders at the distal cantilever extension.

Figure 6 Fracture that has resulted in the cylinder wall breaking out and remaining attached to the solder and bar that was a distal extension cantilever of the overdenture bar. *A* and *B*, Shows an area of transgranular fatigue striations that may indicate the zone in which the crack initiated. *C*, Shows the inner cylinder wall still attached to the solder and bar.

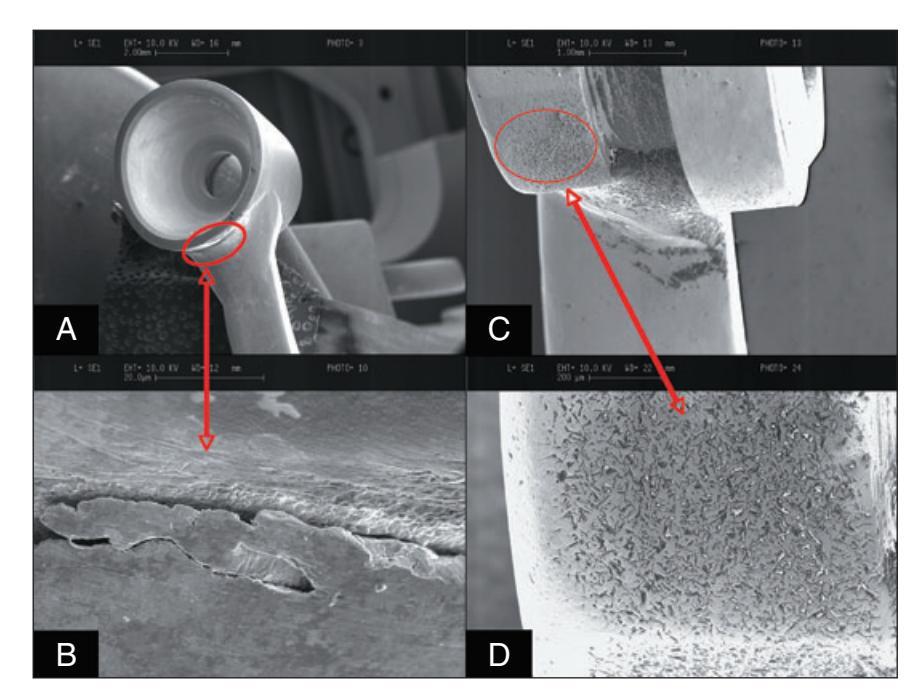
by mechanical stresses. In another patient in the IB group when examined at the 2-year recall, extensive corrosion was seen to be taking place on the side of the nonoxidizing gold cylinder adjacent to the solder joint (see Figure 7, C and D). Evidence of stress corrosion cracking along with buckling and creep was seen on the underside of the cast gold milled bar adjacent to the junction of the cast-on nonoxidizing gold cylinder for

Figure 7 A and B, Shows the start of a crack system on the mucosa side of the solder joint at the solder/cylinder junction. C and D, Shows corrosion on the side of the cylinder adjacent to the solder joint, which also was showing signs of corrosion.

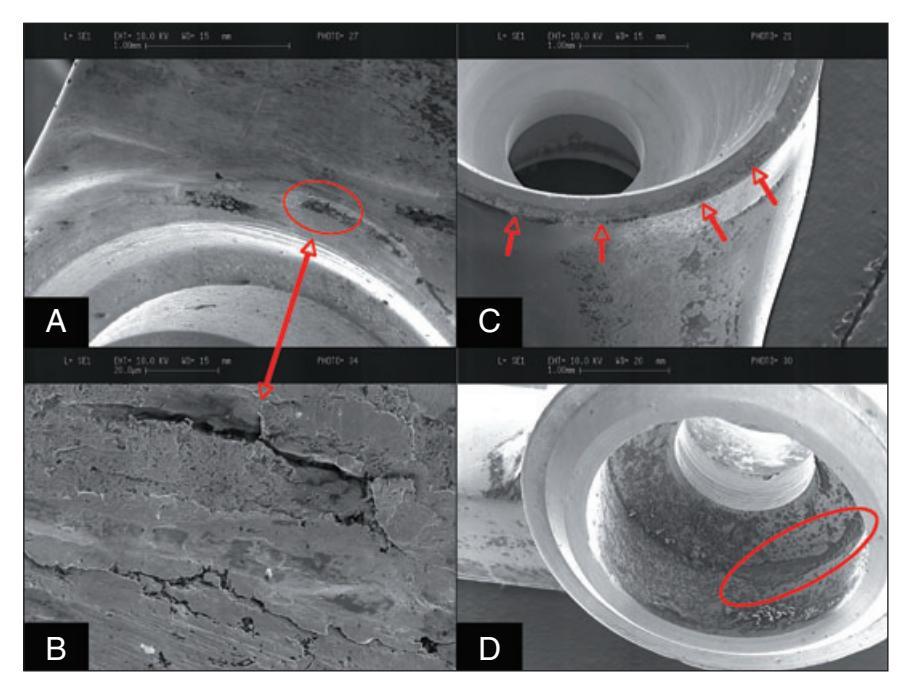
Figure 8 *A* and *B*, Shows stress corrosion cracking along with buckling and creep on the mucosa side of the cast gold milled bar adjacent to the junction of the cast-on nonoxidizing gold cylinder (taken at 5 years). *C*, Crevice corrosion on the edge of the fitting surface of the nonoxidizing gold cylinder where it seats onto the abutment or implant. The mucosa side of the solder is also showing evidence of corrosion. *D*, Extensive internal crevice corrosion.

another patient when examined at the 5-year recall (Figure 8, A and B). Similar evidence was detected on the underside (in contact with the mucosa) of the cast gold milled bar around the other four cast-on nonoxidizing gold cylinders. There was no evidence of progressive failure modes on the top side of the bar that was in contact with the denture and had easy access for cleaning. Figure 8C showed crevice corrosion on the edge of the fitting surface of the nonoxidizing gold cylinder where it connected onto the abutment or implant head when examined at the 2-year recall. The underside of the solder also showed evidence of corrosion. There was extensive internal crevice corrosion undermining the internal structure of the cylinder (see Figure 8D), as well as evidence of crevice corrosion on the outer edge of the fitting surface.
