Failure Modes and Fracture Origins of Porcelain Veneers on Bilayer Dental Crowns

Yihong Liu, PhD, DDS^a/Guanghua Liu, PhD^b/Yong Wang, PhD^c/ James Zhijian Shen, PhD^d/Hailan Feng, PhD, DDS^e

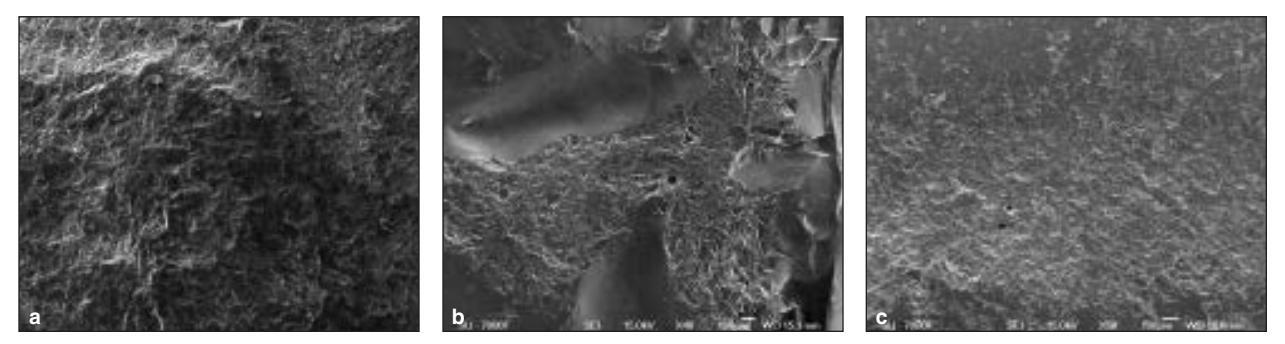
Fig 1 Porcelain wear scars on the (a) occlusal surface of an Ni-Cr coping crown (mandibular molar), (b) occlusal surface of a zirconia crown (maxillary molar), and (c) lingual surface of a galvano-ceramic crown (maxillary incisor).

Several typical damage features were found in the porcelain. Wear scars were found on the surfaces of porcelain in all restorations, presenting as microcracks, roughness, and mass loss (Fig 1). Hertzian cone cracks and multiorigin cracks were characteristic features visible on the occlusal surfaces of molar crowns and on the lingual surfaces of incisor crowns (Fig 2).

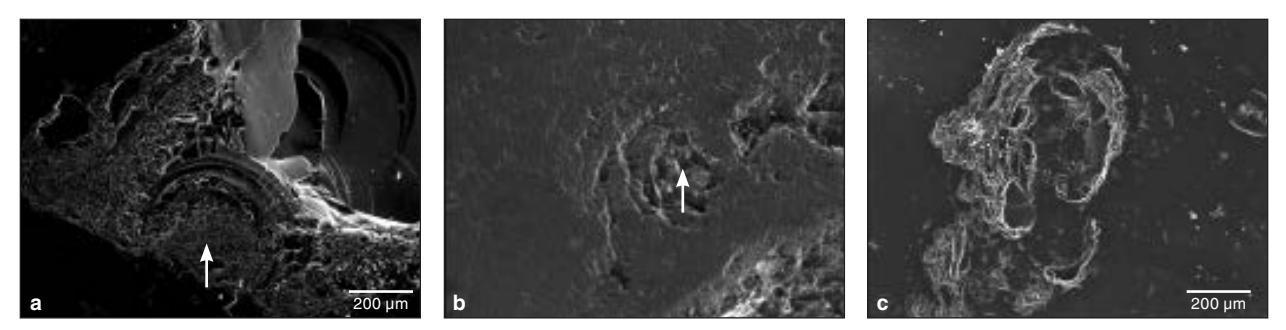
Fig 2 Hertzian cone cracks observed in the porcelain: (a) typical Hertzian cone cracks observed on the occlusal surface of a maxillary molar zirconia crown and (b) the lingual surface of a maxillary incisor galvano-ceramic crown. The origins of the Hertzian cone cracks are marked by arrows. (c) The multiorigin cracks presented on the occlusal surface of a maxillary molar zirconia crown.

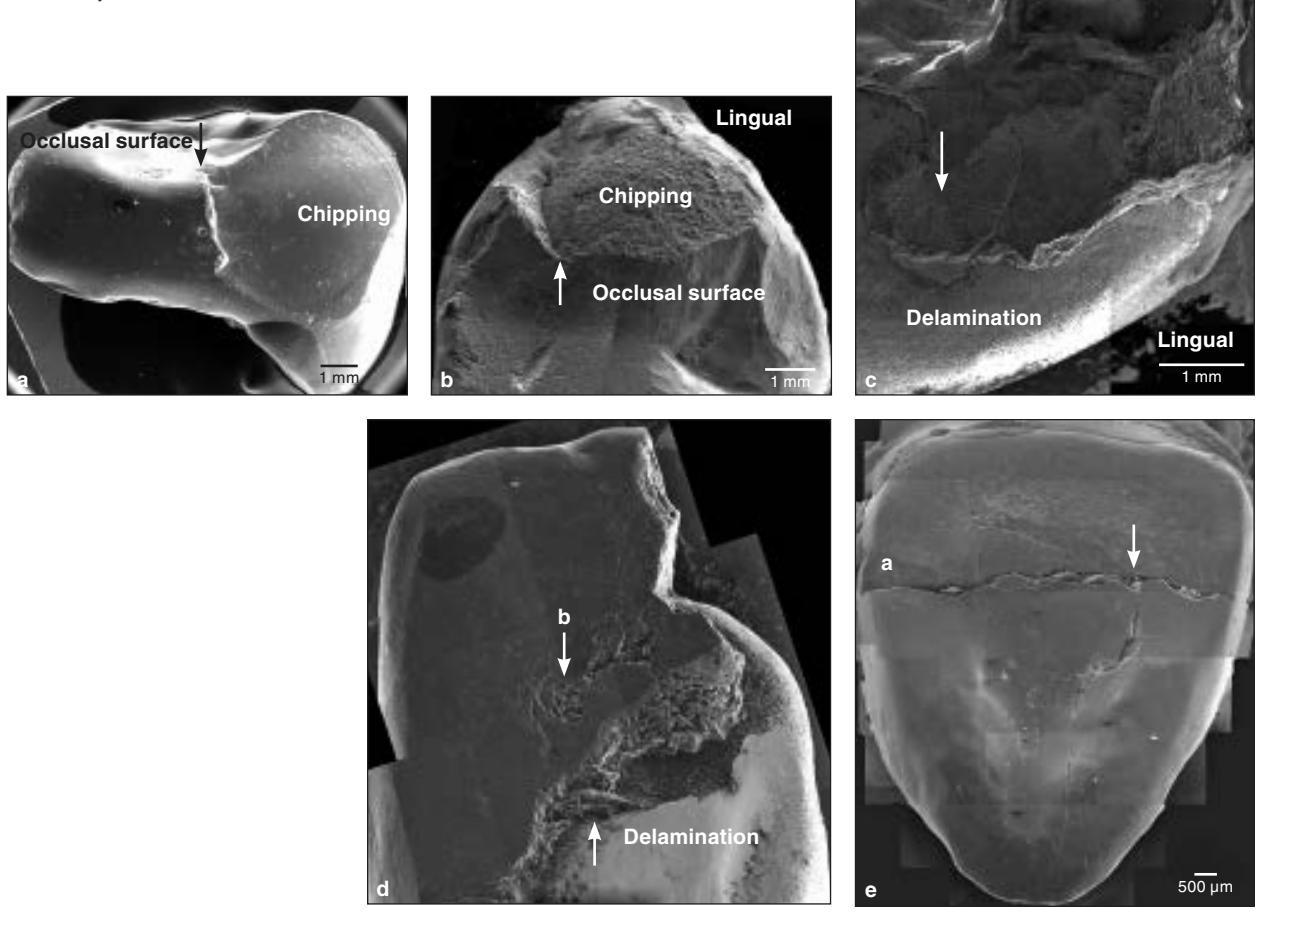
Fig 3 Fractography overviews by low magnification SEM micrographs of the failed bilayer ceramic crowns. **(a)** The porcelain chipping damage was observed on the occlusal surface of a maxillary molar zirconia crown. Arrow indicates the fracture origin of a Hertzian cone crack. **(b)** The lingual part of a maxillary premolar noble alloy porcelain-fused-to-metal crown was illustrated by merging 15 individual SEM images. Arrow indicates the origin of a Hertzian cone crack. **(c)** The distal part of the mandibular molar Ni-Cr alloy porcelain-fused-to-metal crown was shown by merging 20 SEM images. The fracture origin was marked with an arrow. **(d)** The lingual side of a maxillary incisor galvano-ceramic crown was illustrated by merging 13 SEM images. The fracture origin was marked by arrow "a," and a Hertzian cone crack was marked by arrow "b." **(e)** The lingual side of a maxillary incisor galvano-ceramic crown was illustrated by merging 30 SEM images. The porcelain chipping was marked by "a," and porcelain fracture was marked by an arrow.

and zirconia. Figure 3a shows the fractured surface of a maxillary molar zirconia crown after porcelain chipping off. The fracture was initiated by Hertzian cone crack at the distal marginal ridge on the occlusal surface. As seen in Fig 3b, Hertzian cone crack yielded the porcelain chipping on the occlusal surface of a premolar noble metal alloy crown.

Porcelain delaminations originating at the occlusal contact were observed on noble metal alloy porcelain-fused-to-metal and zirconia crowns. As shown in Fig 3c, the porcelain delaminations originated from multiorigin cracks on the occlusal surface of a mandibular molar Ni-Cr coping crown. In contrast, the porcelain delaminations on the galvano crowns originated from the porcelain-core interface. The clear arrest lines on the facture surface of a maxillary incisor galvano crown indicated that the porcelain fracture originated from the porcelain-core interface (Fig 3d). High magnification observation revealed that the microcracks were only detected at the porcelain-core interface (Fig 4a). The same fracture origin and crack path were also found in another incisor galvano crown (Fig 3e). The arrest lines occurred on the concave side toward the core-porcelain interface (Fig 4b). Additionally, wake hackles were observed on the side away from the inner core (Fig 4c).

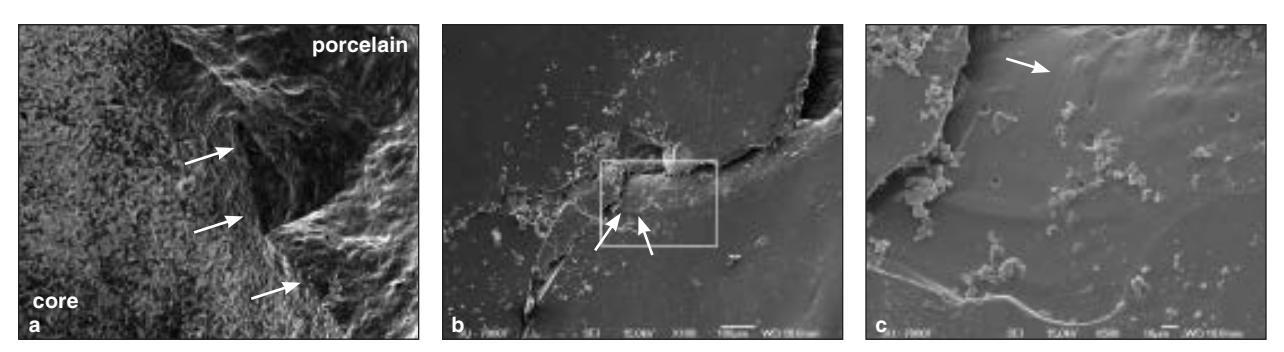
Fig 4 Fracture surfaces of galvano-ceramic crowns revealing interface fracture origins. (a) The critical cracks at the porcelain-core interface are marked by arrows in a maxillary incisor crown. (b) The arrest lines occurred on the concave side toward the coreporcelain interface in the fracture area of a maxillary incisor crown. (c) The wake hackles *(arrow)* were observed on the side away from the inner core.

These features indicated that the porcelain fracture might have initiated at the core-porcelain interface.

Microcracks at the porcelain-core interface were observed only in the galvano crowns. The formation of microcracks was initiated by the momentarily high tensile stress due to plastic deformation of galvano-gold copings, which relate to poor rigidity and strength, but add only 0.3 to 0.4 mm of thickness.
