# Influence of the fabrication process on the in vitro performance of fixed dental prostheses with zirconia substructures

**Abstract** Chipping of the applied veneering ceramic is reported to be a main clinical failure type of computer-aided design/computer-aided manufacturing- or manually copy-milled zirconia restorations. The aim of this in vitro study was to investigate whether different substructure designs and veneering processes done by different dental technicians do significantly influence chipping in zirconia-based all-ceramic fixed dental prostheses during simulated oral service. Five groups ( $n=8$  per group) of three-unit zirconia substructures were fabricated in three different laboratories using copy-milling technique. Three series were veneered with identical porcelain (groups 1–3) and one with a second different porcelain (group 4). The fifth group was milled to final contour design without veneering. Dimensions of the connector areas were determined. All fixed partial dentures (FPDs) were adhesively boned on human teeth and thermally cycled and mechanically loaded ( $1.2 \times 10^6 \times 50$  N;  $6,000 \times 5^\circ\text{C}/55^\circ\text{C}$ ) using human ant

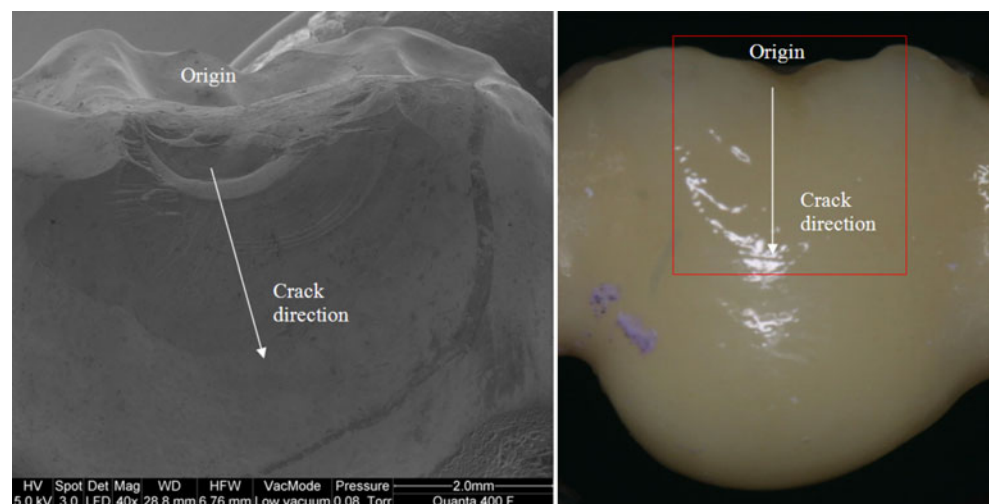
**Fig. 1** Group 1: picture of the chipping area and SEM image (magnification)

of the porcelain were found. Exemplary SEM micrographs are provided as detailed figures (Figs. 1–5).

As cracks and chipping occurred in most of the tested groups, it seems to stay as a problem in zirconia-based FPDs. Failure reasons are supposed to be occlusal overload, stress corrosion, fatigue or improper structure design [25]. Antagonists cause occlusal wear (see Figs. 1, 2, 3, 4, 5) by means of chewing impact and clenching and roughening of the porcelain surface. These flaws or superficial ruptures cause crack initiation, and flaws can propagate through the veneering without being stopped or deflected. As described earlier for crowns [22], a worst case scenario may be produced if the FPDs are fabricated in a simple shape-reduced design without occlusal support for the veneering porcelain. The high strength of zirconia and the individual copy-milling process even allow for the fabrication of a small substructure thickness, reduced connector areas or thin crown copings. Therefore, the high number of chippings may be influenced by a low support by the substructure and high thickness of the veneering. This would conform to the crack initiation in two and three layer systems [15–17] and the description of cone cracking and radial cracking of the veneering. It is also in accordance with the failure type, where no interfacial failures between substructure and veneering were found, but solely chipping in the veneering.

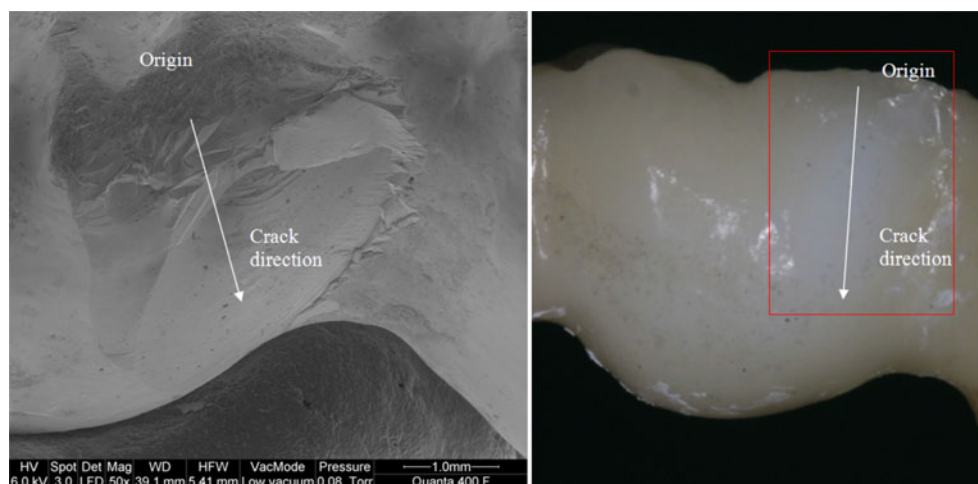
**Fig. 2** Group 2: picture of the chipping area and SEM image (magnification)

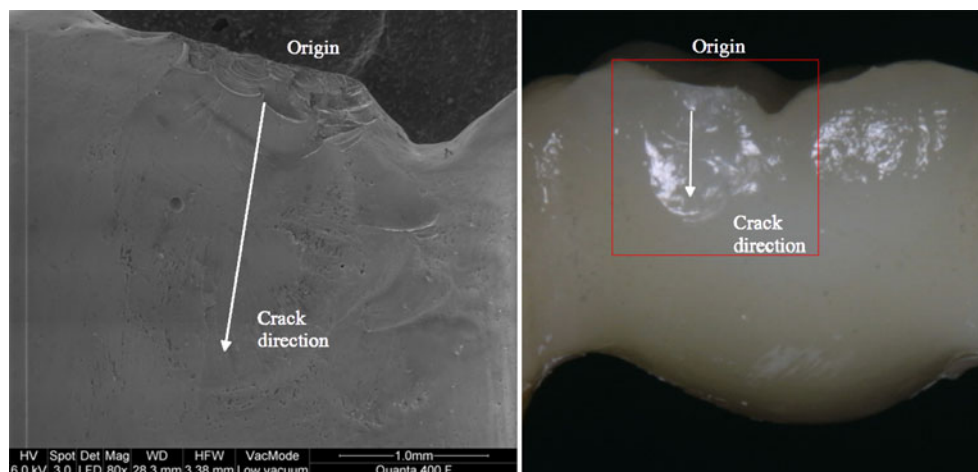
**Fig. 3** Group 2: picture of the chipping area and SEM image (magnification)

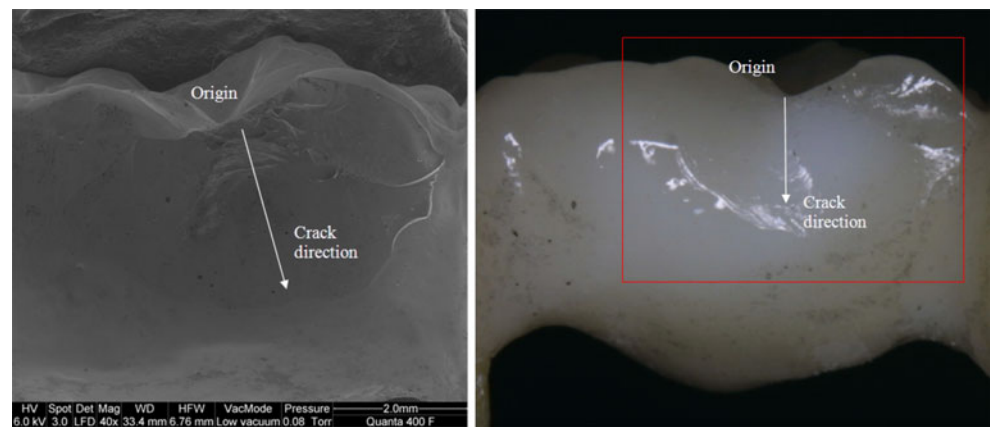
**Fig. 4** Group 2: picture of the chipping area and SEM image (magnification)

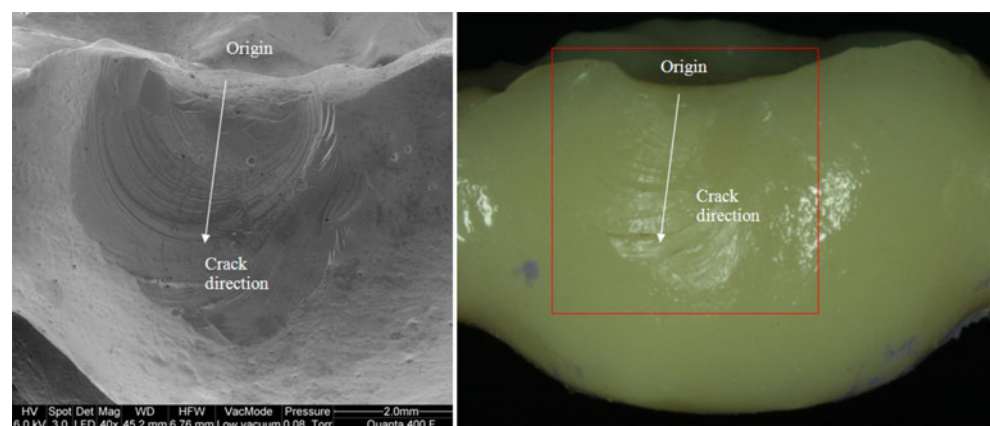
**Fig. 5** Group 3: picture of the chipping area and SEM image (magnification)
