Detection of artificial demineralization bordering different types of laminate veneers using visual inspection and storage phosphor radiography

Objective The objective of this study is to compare the diagnostic accuracy of visual inspection (VI) and storage phosphor plate (SPP) radiography for the detection of artificial demineralization bordering different laminate veneers.

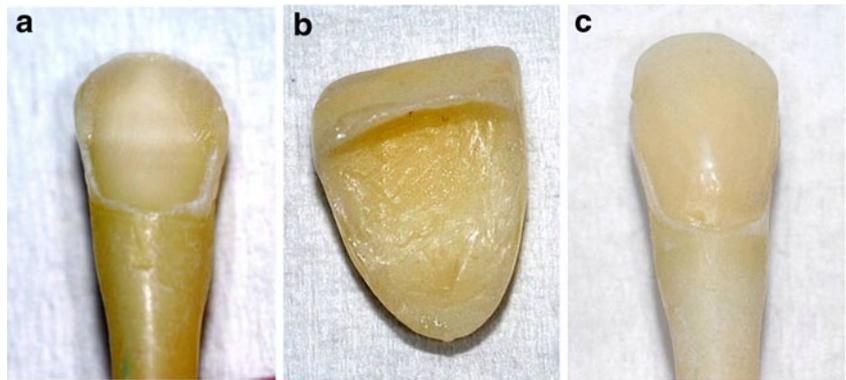
Fig. 1 **a** Canine tooth prepared for laminate veneer restorations. **b** Laminate veneer restoration. **c** Image showing the ceramic specimen luted to canine tooth surface

The roots of the teeth were mounted in a plastic holder filled with auto polymerizing acrylic resin (Palapress, Heraeus Kulzer, Wehrheim, Germany). Laminate veneer preparations were made using Modular Veneer Preparation Set (Intensiv SA, Lugano, Switzerland) using an air turbine followed by a red handpiece. Cervical marking was performed with the bur no: 200S (Intensiv SA). A 0.3-mm limited depth cutting was made with the bur no: S4 (Intensiv SA). Labial and incisal reductions were made with the bur no: 101 (Intensiv SA) and all of the chamfers were finished with the bur no: 4310S (Intensiv SA) (Fig. 1a). Impressions were made with a polyvinyl siloxane elastomeric material (Pentsoft Duo-Mix, 3M ESPE, Germany). Laminate veneers were fabricated from a lithium disilicate all-ceramic (A) (IPS E.Max, IvoclarVivadent, Schaan, Liechtenstein) ($n=10$) and hybrid ceramic (H) (Estenia, Kuraray, Osaka, Japan) ($n=10$) materials (Fig. 1b).

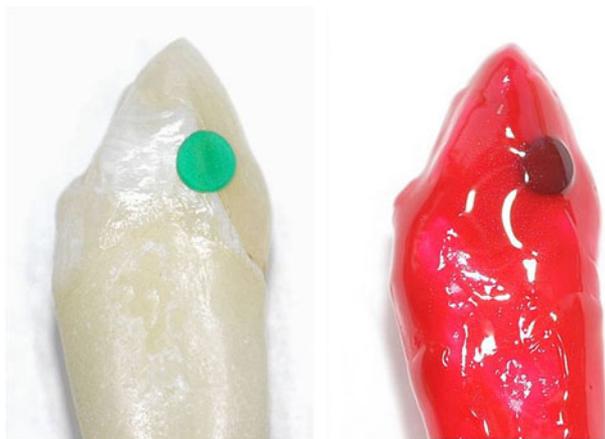
Fig. 2 Test tooth showing the area of acid application (*green area covered with latex*) and test tooth covered with nail varnish on proximal surface

Veneered teeth were covered with acid-resistant varnish (Sally Hansen, New Jersey, USA) except for a circular window about 1.4 mm in diameter on the distal proximal surfaces at enamel-restoration junction (Fig. 2). Mesial halves of each tooth was spared to act as control groups, while their distal halves served as experimental groups.

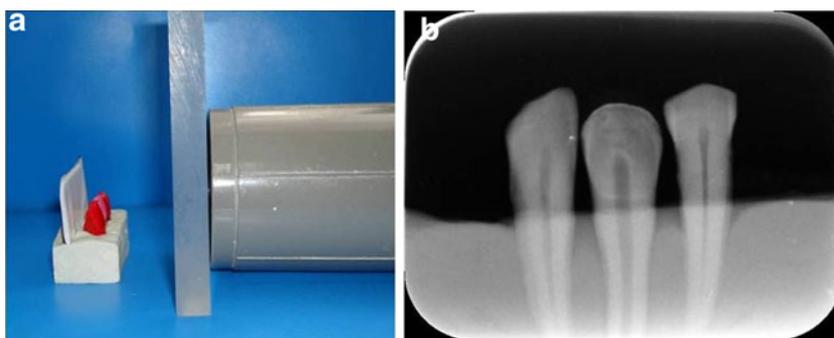
Fig. 3 **a** Picture demonstrating the test teeth in contact with non-test teeth on two sides mounted in silicon blocks and the projection geometry during radiographic exposures. **b** Storage phosphor plate image obtained with the set-up in **a**

The teeth were mounted in blocks of silicone with one test tooth and two non-test teeth in each block. The non-test teeth at either end created natural contact points. Standardized exposures of all specimens were done at the last day of 80 h of demineralization period (Fig. 3). All teeth were

radiographed with Digora Optime storage phosphor plate (SPP) system (Soredex Corp., Finland). SPPs were exposed for 0.25 s. with a dental X-ray unit operating at 60 kVp, 7 mA, and 1.5 mm Al equivalent filtration at a focus-receptor distance of 25 cm. A 20-mm thick soft tissue equivalent material was placed close to the blocks and facing the X-ray tube. After the plates were scanned the resulting images were displayed in random order using the Digora for Windows software.

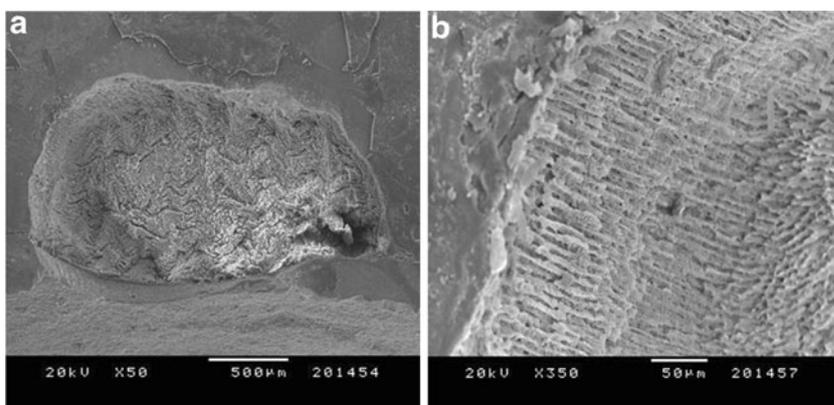
Fig. 4 **a** Scanning electron microscopy image representing the demineralization areas (magnification $\times 50$). **b** The $\times 350$ magnification of the border of demineralization seen in **a**

Two samples from each group of veneered teeth were sectioned and examined using scanning electron microscopy (SEM) (JSM-5200, JEOL, Japan) to visualize enamel surfaces after acid exposure to observe the nature and extent of the artificially created lesions (Fig. 4a, b). In our previous study, scanning electron microscopic and stereomicroscopic observations demonstrated that 80 h of demineralization produced enamel defects confined only to the superficial layers of enamel tissue (with an average depth of approximately 18 μm) [12]. Further SEM observations in the present study were done to confirm the previous findings, i.e., the defects created by acid application were subsurface enamel demineralizations.

Scanning electron microscopic evaluation revealed lesions from superficial to deeper layers of enamel. The mean of the largest diameter of demineralization (artificial lesion) that was measured in different samples was approximately 2.22 mm while the mean measured for the narrowest diameter was approximately 1.02 mm. The depth of demineralization was recorded by measuring the dentinal wall around the lesion cavity and ranged between 0.35 and 0.81 μm (Fig. 4a: H and b: A).
