Case Report

Combined technique with polyethylene fibers and composite resins in restoration of traumatized anterior teeth

Vitale MC, Caprioglio C, Martignone A, Marchesi U, Botticelli AR. Combined technique with polyethylene fibers and composite resins in restoration of traumatized anterior teeth. *Dent Traumatol* 2004; 20: 172–177. © Blackwell Munksgaard, 2004.

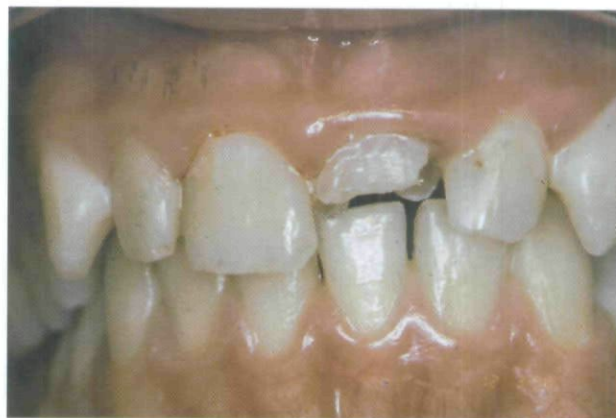
A.B., a 13-year-old patient, presented a complex crown fracture of the upper left maxillary incisor with pulp involvement. After radiographic examination, a decision was made to start an endodontic treatment (Fig. 1).

Fig. 1. First examination: complex crown fracture of upper left central incisor (ULCI).

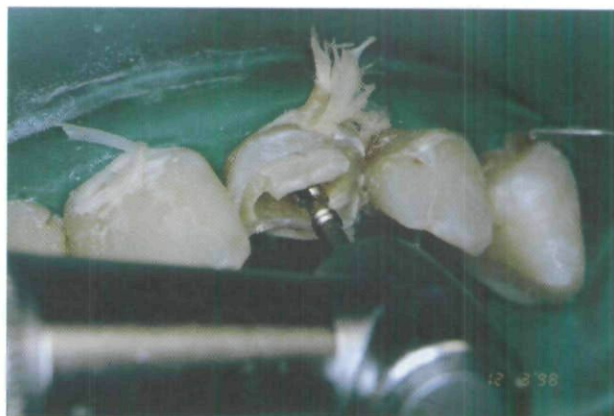
Fig. 2. After a traditional endodontic treatment, a slot is created in the root canal in order to lay the fibers.

Two weeks later, it was decided to restore the dental morphology by a central support stump created using polyethylene fibers and composite resins. The dental element was isolated by a rubber dam, and a slot was created into the root canal in order to lay polyethylene fibers. (Fig. 2)

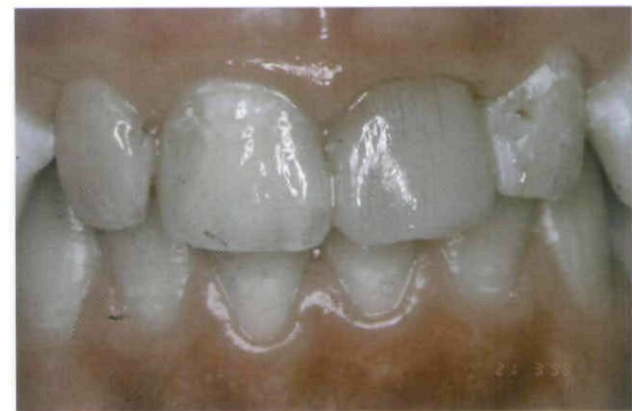
Fig. 8. Final result: ULCI is completely restored by composite materials.

in the slot of the root canal in association with composite material (Spectrum T.P.H., Light-Cure Composite, Dentsply De Trey GmbH, Konstanz, Germany). (Figs. 3–6). A central support stump was created (Fig. 7). Finally, the dental restoration was completed using the composite's incremental technique (Fig. 8).

According to the esthetic requirements of the anterior sector, the dental morphology was perfectly restored together with a complete functional recovery. Clinical and X-ray control examinations (3, 6, 12, and 24 months later) confirmed the efficacy of the combined technique with polyethylene fibers and composite materials.

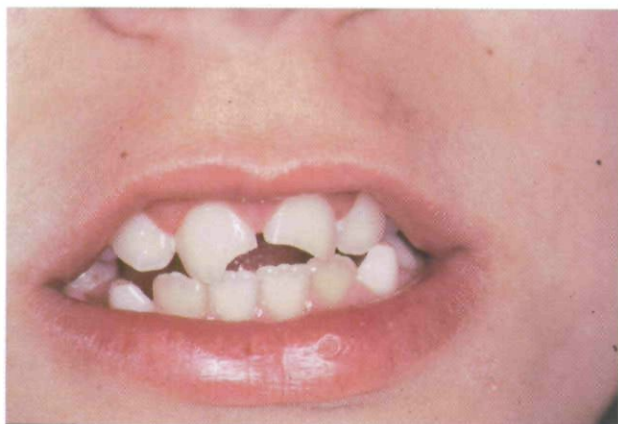
Fig. 9. First examination: crown fracture of both upper right central incisor (URCI) and upper left central incisor (ULCI).

C.N, a 9-year-old patient, showed a crown fracture of both maxillary central incisors (Fig. 9). The vitality test was positive, and the crown fragment of the left incisor was available (Fig. 10). We restored the right incisor using the acid-etch composite resin technique. On the contrary, the dental morphology of the left

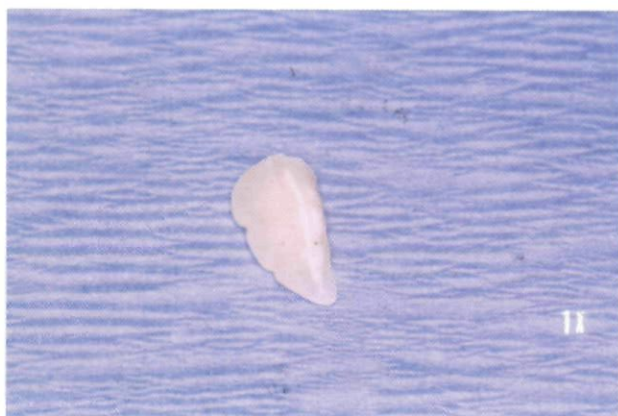
Fig. 10. Crown fragment of ULCI.

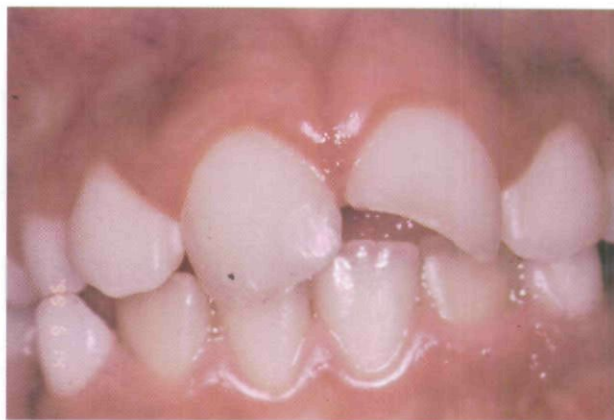
Fig. 12. Failure of ULCI restoration by sticking the crown fragment.

Two months later, the crown fragment broke off (Fig. 12), and we decided to restore it using the combined technique with polyethylene fibers and composite resins. The anterior sector was isolated by a rubber dam (Hygenic Dental Dam, Coltène, Mahwah, NJ, USA), and the enamel surface was etched by orthophosphoric acid (Conditioner 36, Dentsply De Trey GmbH, Konstanz, Germany) (Fig. 13).

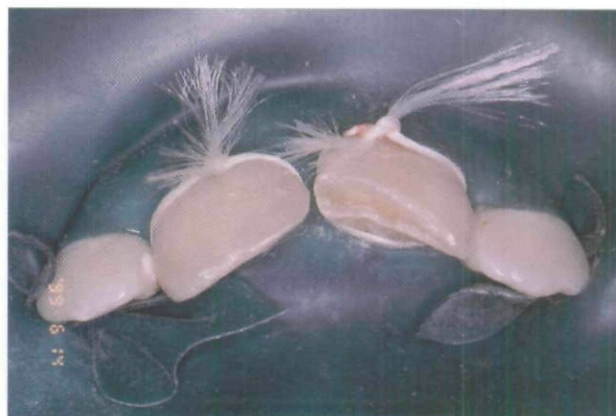
Fig. 13. Isolation of the anterior sector by a rubber dam.

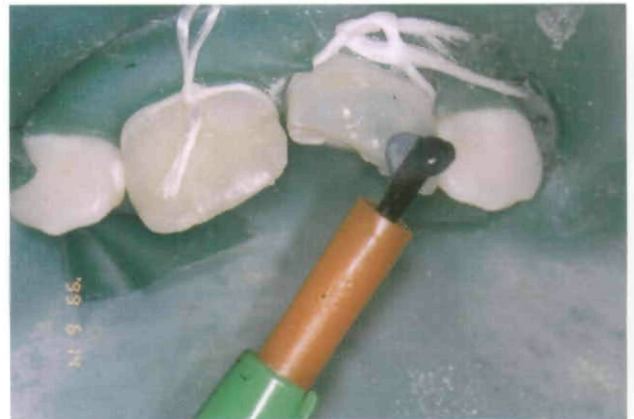
Fig. 17. ULCI enamel surface is etched by orthophosphoric acid.

Both the dental element and the polyethylene fibers were conditioned by the bonding agent (Scotchbond

1, 3M Dental Products, St. Paul, MN, USA) (Figs 16 and 17).

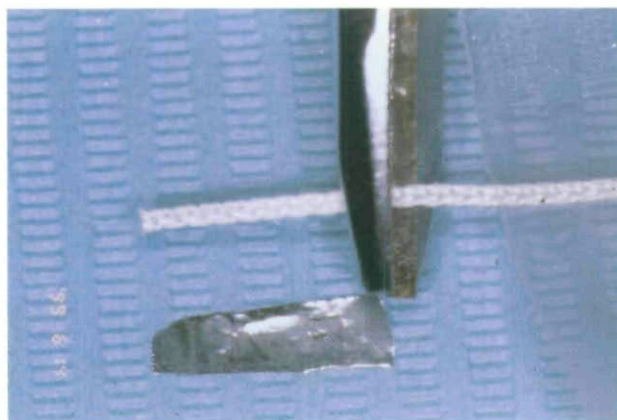
Fig. 15. Cutting of a Ribbond® fiber by using special nippers.

Having evaluated the required length, polyethylene fibers (Ribbon Reinforcement Ribbon, Ribbon, Scottle, WA, USA) were cut by special nippers (Figs. 14 and 15).

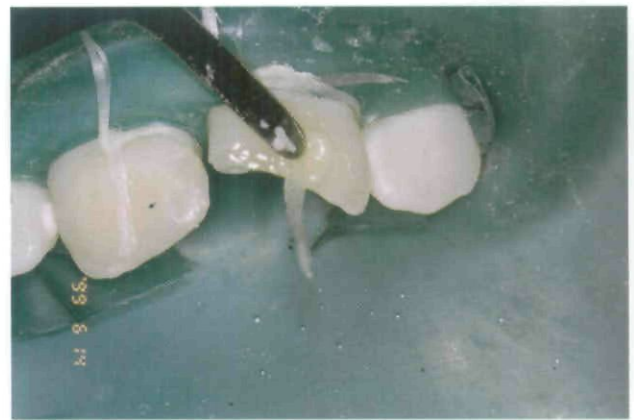
Fig. 18. Laying of Ribbond® fibers.

Polyethylene fibers were laid correctly, and restoration was completed by stratifying composite resin (Spectrum T.P.H., Light-Cure Composite, Dentsply De Trey GmbH, Konstanz, Germany) (Figs. 18–21).

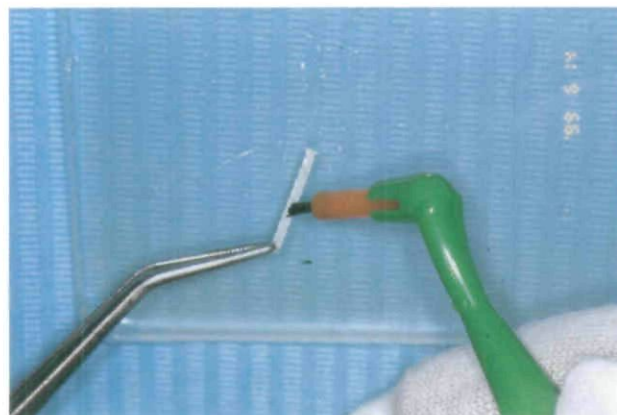
Fig. 16. A Ribbond® fiber is conditioning by the bonding agent.

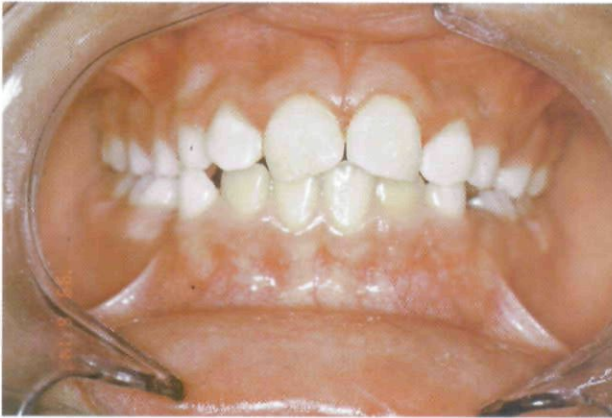
Fig. 20. Final results.

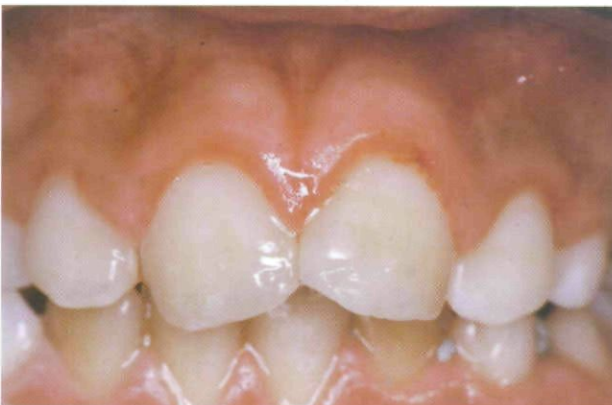
Fig. 21. Control examination after 18 months.

During control examinations, the efficiency of the combined technique of polyethylene fibers and composite resins was confirmed; in fact, there were no restoration fractures or dimensional changes.
