# Trauma to an osseointegrated anterior dental implant: a case report

Allen EM, Allen PF. Trauma to an osseointegrated anterior dental implant; a case report. *Dent Traumatol* 2006; 22: 44–47.  
© Blackwell Munksgaard, 2006.

**Abstract** – Single tooth implant systems have been shown to offer a safe and highly predictable option for the replacement of anterior teeth. There is however, a paucity of evidence on the result of trauma to single tooth implant systems, particularly in the vulnerable anterior maxillary area. This article presents a report on the outcome of a traumatic incident to an osseointegrated single tooth implant.

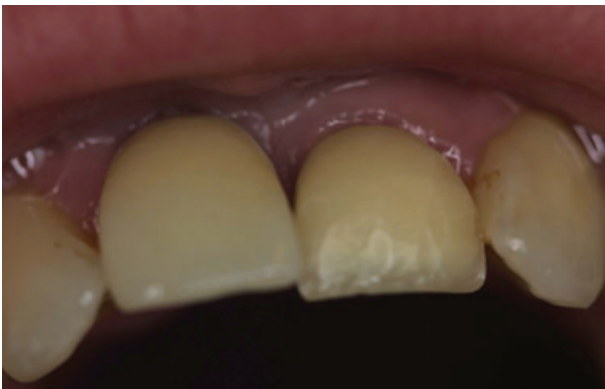
The porcelain on the left central incisor porcelain fused to metal (PFM) crown was fractured. It was quite firm and did not display mobility but was seen to be displaced in a disto-palatal direction (Fig. 1). Further examination revealed that this displacement was causing a premature, occlusal contact on the tooth, which was preventing full closure of the posterior dentition (Fig. 2). It was considered that displacement of the tooth was the result of alveolar fracture secondary to blunt trauma, or distortion and 'bending' of the abutment screw again secondary to blunt trauma. The left lateral incisor was tender to percussion and exhibited grade 1 mobility. It recorded a negative response with ethyl chloride and electronic pulp testing.

*Fig. 1.* Clinical appearance of UL1 on presentation.

Immediate treatment for symptomatic relief was provided. Selective grinding on the labio-incisal aspect of the left central incisor relieved the premature occlusal contact, which allowed normal closure into occlusal contact of the posterior teeth. The patient was given an appointment to return for further investigation.

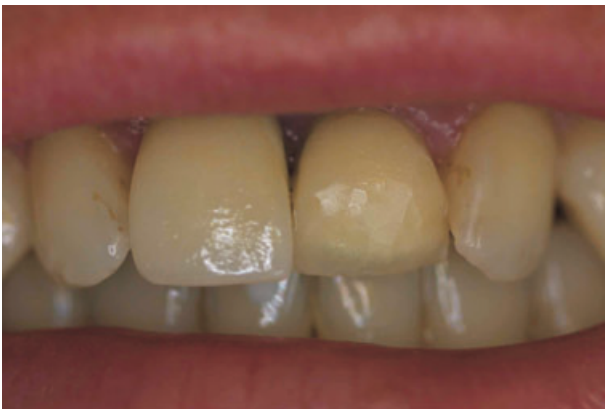
*Fig. 2.* Clinical appearance of UL1 on presentation.

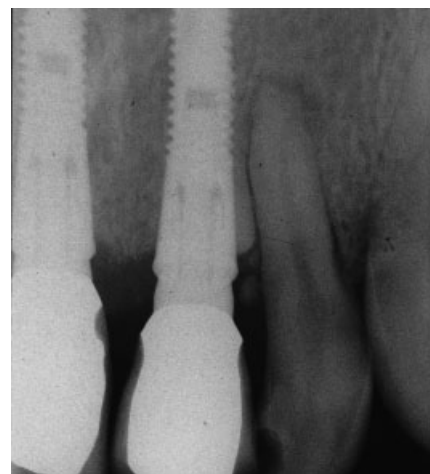
Radiographic examination was performed using an upper, anterior occlusal view supplemented with intra-oral, peri-apical radiographs (Fig. 3). Radiographic examination of the left incisor was inconclusive, neither alveolar fracture nor screw distortion being confirmed by radiograph. The decision was made to remove the crown on the implant and to investigate further. No evidence of root-fracture on the left lateral incisor was found but widening of the periodontal ligament was noted around it.

*Fig. 3.* Intra-oral radiograph of 21 and 22. Note widening of the apical periodontal ligament on 22 and fractured bone fragments evident between 21 and 22.

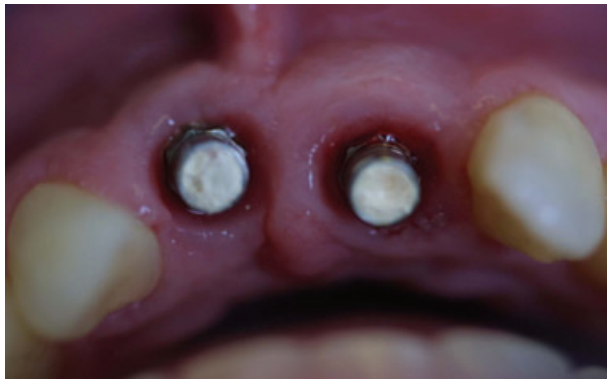
On the return visit, the PFM crown on the left central incisor was removed with ease. Examination revealed that the abutment fixation screw (Astra-Tech™, Stonehouse, UK) had not loosened or distorted and that complete osseointegration of the implant was maintained. There was no pain or evidence of loosening of the implant. The position of the left central incisor implant within the bone was seen to be at a different orientation and plane to that of the right central incisor (Fig. 4).

It appeared that blunt trauma to the implant abutment had resulted in bodily movement of the implant within the cancellous bone, possibly in combination with fracture of the labial cortical plate. The implant had maintained its osseointegration indicating that the implant–bone interface had maintained its integrity, with bony healing occurring around this interface in the new position adopted by the implant post-trauma.

Fig. 4. Position of implants 11 and 21 within the alveolus.

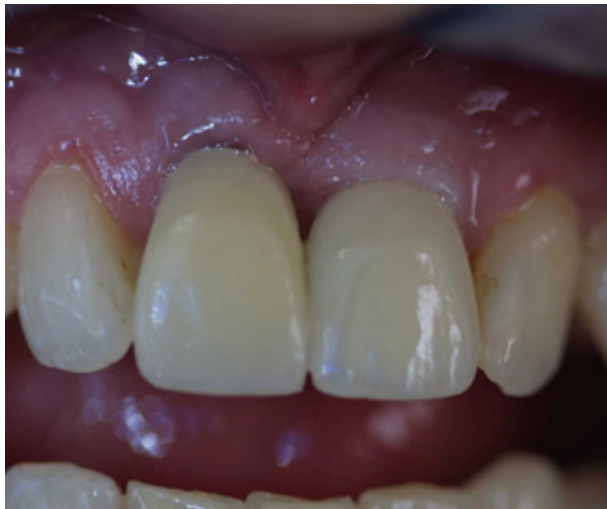
Fig. 5. Clinical appearance of replacement implant-retained PFM crown on 21.

A 'pick-up' impression was made using an AstraTech impression coping. An impression of the lower dentition, together with an occlusal registration, details of shade and characterizations, were sent to the laboratory with instructions to make a new PFM crown on the implant abutment of the left central incisor.

On delivery of the PFM crown, the fit, appearance and occlusion was checked. When this was deemed to be satisfactory and the patient was happy, the crown was cemented in with zinc-phosphate cement (Fig. 5).
