Rehabilitation of an extracted anterior tooth space using fiber-reinforced composite and the natural tooth

CASE REPORT

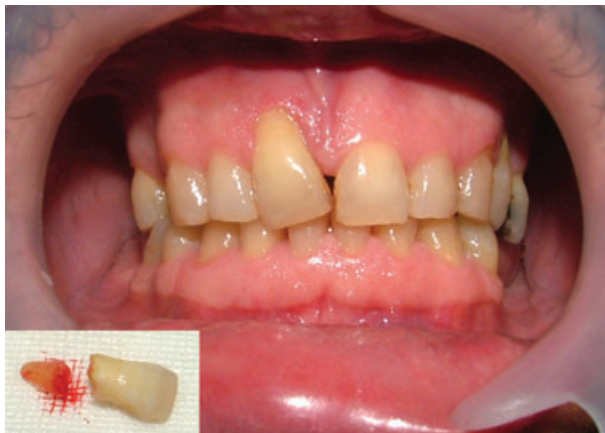
Fig. 1. Clinical view of the patient and the extracted tooth.

A 45-year-old male patient was referred to our clinic for a fractured right upper central tooth. After oral and radiographic examinations, the decision was made to extract the central tooth (Fig. 1). Because of time constraints and patient expectations, the patient wanted to use the tooth in the restoration of its own extracted area. The patient was informed about possible discoloration and failure of the tooth. After extraction, the tooth was freed of debris and kept in sterile saline solution while bleeding was being controlled. Following pulp removal, the pulp chamber was sealed with a micro-filled hybrid composite (Gradia Direct Anterior, GC Corp., Tokyo, Japan, shade A3) and formed into a convex pontic shape using composite resin. Because of the need for mechanical support, a groove was made in the mid-palatal section of the extracted tooth (Fig. 2). The mesial and distal contours of the extracted tooth were enlarged with composite resin and adapted to the edentulous

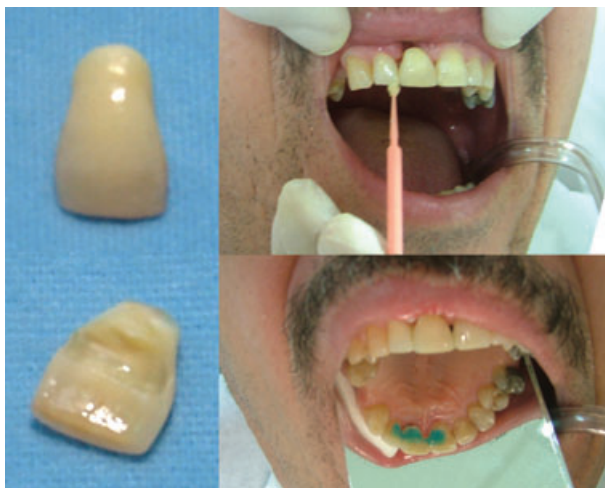
Fig. 2. The prepared tooth, etching and bonding process.

with water and air-dried after etching. The bonding agent (Adper™ Single Bond 2; 3M ESPE) was applied and light-cured according to the manufacturer's instructions using a light-emitting device (Mini LED; Satelec Acteon Group, Merignac, France; Fig. 2). A thin layer of flowable composite resin (Stick® Flow; StickTech Ltd.) was applied to the palatal grooves and the proximal surfaces of the adjacent teeth.

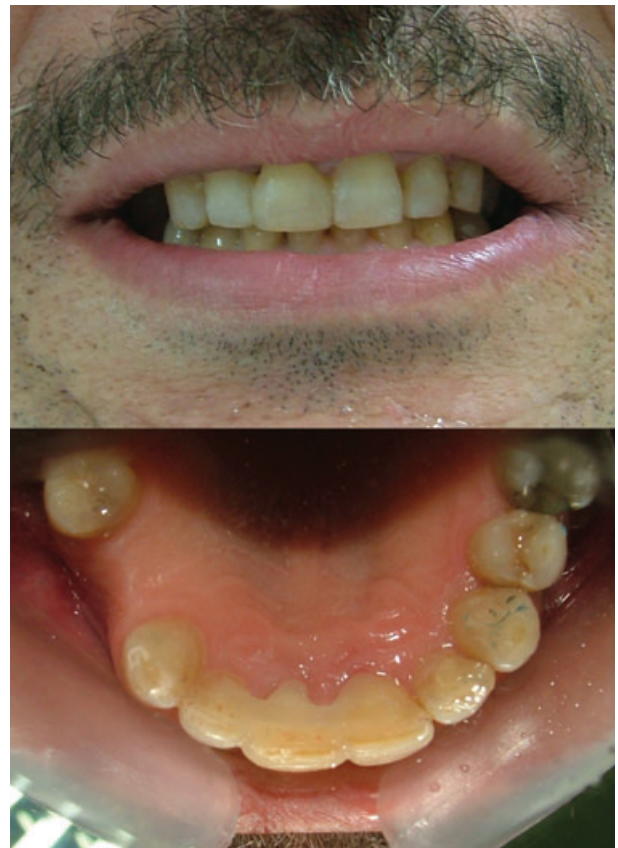
Fig. 3. Palatal and final view of the first restoration.

The occlusion was evaluated with articulating paper, and premature contacts were eliminated. The restoration was polished (Sof-Lex™; 3M ESPE). The extracted tooth was replaced in its space with the aid of glass fiber, composite resin, and grooves. The apical part of the tooth was shaped after the bleeding was controlled (Fig. 3).

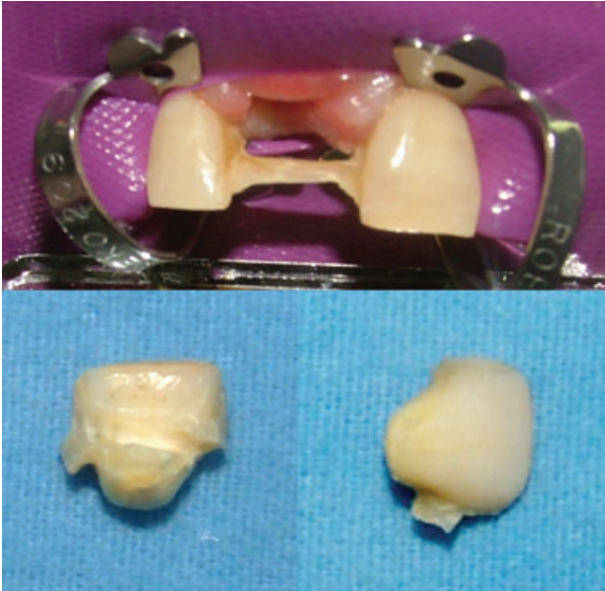
The patient returned with a separated pontic at the end of the first month postprocedure (Fig. 4). Although the tooth that was used as a pontic was kept in water for a couple of hours, discoloration of the dehydrated tooth was noticed. The tooth was again kept in saline solution until a treatment decision was reached. After a brief examination, the conclusion was made that adhesion of

Fig. 4. The detached tooth and the fiber frame.

the fiber frame with the abutment teeth and the fiber frame itself were not the problem, although a debonding problem occurred between the extracted tooth and the fiber frame. While trying to replace the tooth for a second attempt at rebonding restoration, insufficient adaptation of the fiber and the groove was noted. To strengthen the restoration, the decision was made to thicken and adapt the fiber frame to the groove of the separated tooth. During this adaptation process, the groove was prepared again and the fiber frame was thickened with the aid of flow resin and fiber pieces. Before rebonding, the apical end of the pontic tooth was shaped with composite resin to compensate for bone resorption. The etching and bonding processes were repeated for the newly formed pontic tooth and fiber frame. The final steps included adjustment of occlusion and esthetic contouring of the restoration and polishing the restoration. The patient was informed about the importance of proper hygiene and was followed up periodically. He was satisfied with the results after 12 months and did not complain of any color problem (Fig. 5).

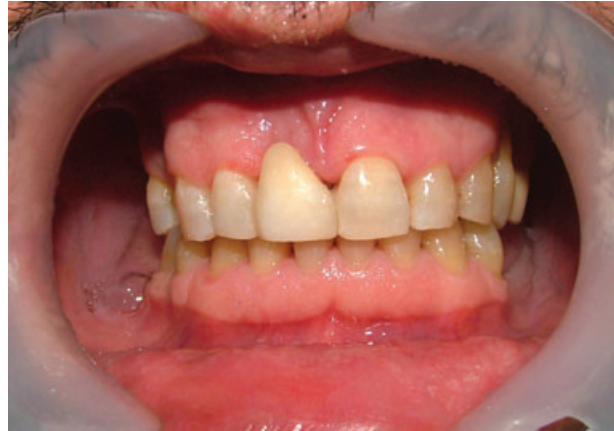
Fig. 5. View of the final restoration after 12 months.
