Trauma to an implant-supported crown that was saved by the fixation screw: a case report

CASE REPORT

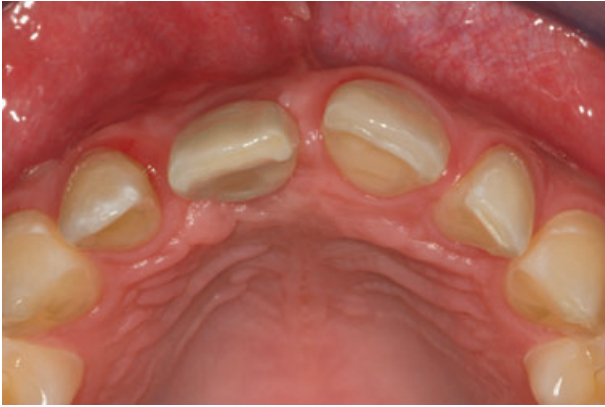
Seven months later (14 months after implant placement), the patient consulted our department following an accident 2 days previously in a swimming pool in which his knee stroke his anterior dentition. He had no pain and only complained about a disrupted occlusion because of displacement of the implant crown. There were no extra-oral injuries. An intra-oral inspection showed that the implant crown was displaced to the palatal, causing a premature contact (Fig. 1). The

Fig. 1. Implant-supported crown, region 11; palatal displaced after trauma.

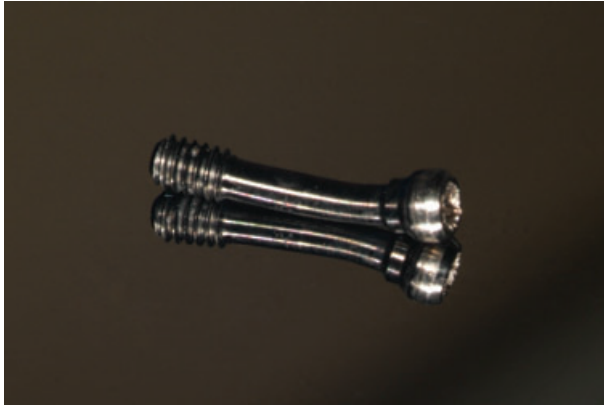
This report describes a case of trauma to an anterior implant-supported crown. It appeared that only the fixation screw had sustained damage. Apparently, a major part of the impact energy was absorbed by the

Fig. 4. Bent fixation screw.

deflection of the fixation screw, thereby saving the crown, implant and alveolar bone. Thanks to this protective mechanism, only a small prosthetic retreatment could restore the implant-supported crown. More complicated prosthetic retreatments or surgical retreatments in particular should be prevented as much as

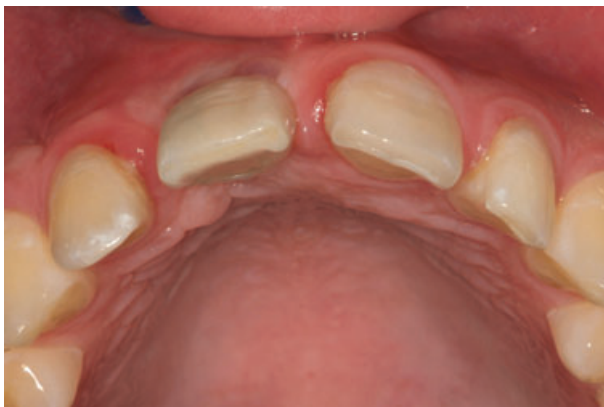
Fig. 6. Clinical view after replacement of the crown with a new fixation screw.

For radiographic examination, a maxillary anterior occlusal radiograph was taken together with a peri-apical radiograph. No abnormalities were detected on the occlusal radiograph. The peri-apical radiograph was closely compared with a peri-apical radiograph that was taken before the accident, just after placement of the crown. Distally, the implant-abutment interface showed a small triangular gap (Figs 2 and 3). It was suggested that the displacement of the implant crown was caused by deformation of the fixation screw. However, it was not certain that, besides this, the alveolar process surrounding the implant had been fractured, causing a displacement of the implant itself. As the aesthetics were still acceptable for the patient, an expectative policy was pursued. It was possible to leave the implant crown free from occlusion contacts by grinding the porcelain of the palatal aspect of the implant crown. The patient was instructed to follow a soft diet and to avoid force on the implant crown as much as possible. Follow-up visits 1 and 3 months later showed status quo. On the last visit, the one-piece screw-retained implant crown was removed. A torque wrench was necessary to loosen the fixation screw that was clearly bent (Fig. 4). A careful visual inspection of the implant platform and implant crown revealed that both were undamaged. For further investigation of the implant crown, it was installed on the original soft tissue cast with the aid of a laboratory fixation screw. It was found that there was a good fit with the implant analogue and that the implant crown was properly located in harmony with the adjacent dentition (Fig. 5). The palatal aspect of the implant crown that was grinded earlier was restored in the dental laboratory by fusing a new layer of porcelain. The implant crown was replaced on the implant and fixed with a new fixation screw. The implant-abutment interface was approved radiographically and finally the fixation screw was torqued. The screw hole was filled with a cotton pellet and composite resin (Fig. 6).
