Fracture resistance of microhybrid composite, nano composite and fibre-reinforced composite used for incisal edge restoration

Chandrashekhar M. Badakar¹,
Kukkalli Kamalaksharappa
Shashibhushan², N. Sathyajith
Naik², Ulavala Venkata Subba
Reddy²

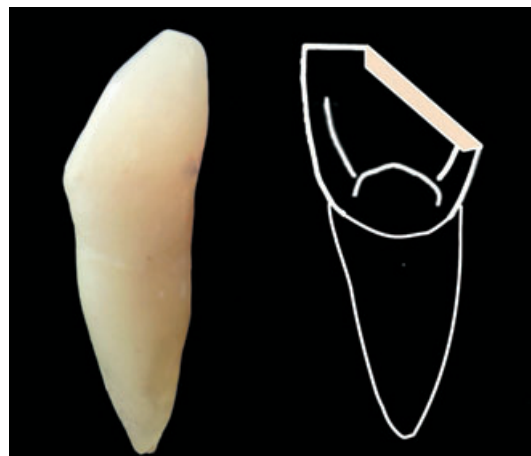
Fig. 1. Obliquely cut incisal edge.

The samples in the group A were unprepared and used as control. In the other three experimental groups, the incisal edge was cut obliquely, extending incisally from the mesial or distal surface with a diamond disc mounted on a slow speed micromotor hand piece (Ultimate 500K; NSK, Kanuma, Japan) directed perpendicular to the labial surface of teeth (Fig. 1). Teeth showing any visible pulp exposures and cracks were excluded from the study.

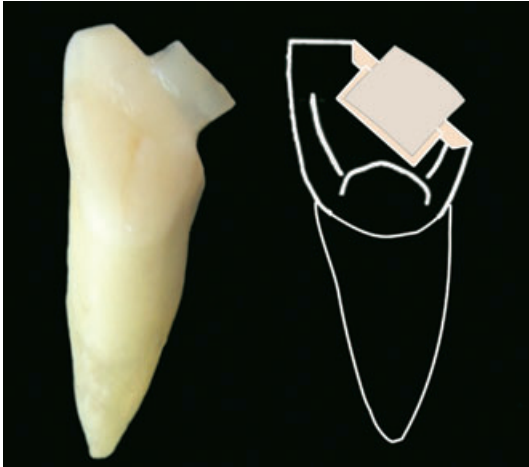
Fig. 3. After etching and bonding, the flowable composite was placed in the prepared cavity, a piece of polyethylene fibre, that was dipped in bonding agent and blotted to remove excess solution was placed in the cavity with clean instrument, and covered entirely with flowable composite and then light cured.

For group D, a palatal cavity of 0.5 mm depth and 5 mm width was prepared within the enamel (Fig. 2) with fine diamond bur using a water coolant. Same etching and adhesive bonding systems were used as in group B and C. Flowable composite (Esthet X flow; Dentsply/Caulk) was placed in the palatal cavity. Before curing it, a required size of polyethylene fibre (Ribbond THM; Ribbond Inc.) was placed in the cavity as close to enamel as possible, carrying it above the fractured edge (Fig. 3). The fibre was entirely covered with a thin layer of flowable composite and then light cured for 20 s as per the manufacturer's instructions. The remaining portion of the lost tooth structure was freehand built with microhybrid composite (Esthet X; Dentsply/Caulk) and polymerized, incrementally (Fig. 4).
