Fracture resistance of composite resin restorations and porcelain veneers in relation to residual tooth structure in fractured incisors

Guido Batalocco^{1,2}, Heeje Lee², Carlo Ercoli², Changyong Feng³, Hans Malmstrom⁴

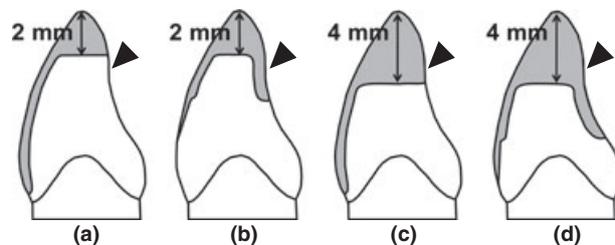
Fig. 1. Schematic drawing of four experimental settings. (a) porcelain veneer for 2-mm fracture; (b) composite resin restoration for 2-mm fracture; (c) porcelain veneer for 4-mm fracture; (d) composite resin restoration for 4-mm fracture. Arrowhead represents position and direction of cyclic loading (135° to axis of tooth).

Thirty-two human-extracted maxillary central and 28 maxillary lateral incisors without caries and/or restorations were collected. Each individual tooth was mounted in an acrylic block (Acraweld Repair Resin; Henry Schein Inc, Melville, NY, USA) up to a level of 3 mm below the cemento-enamel junction, therefore leaving the coronal aspect of the tooth protruding from the block surface. The long axis of the tooth was oriented at 45° to the horizontal surface of the block, so that, during cyclic loading testing, the load would be applied in 135° to the long axis of the tooth (Fig. 1). Two matrices for each tooth were made covering the entire crown: matrix A was

From the mechanical point of view, 4-mm fracture was a less favorable situation than that of 2-mm fracture in that the occlusal force was applied directly on the restoration (Fig. 1). For this reason, there might have been higher risk of adhesive failure in the composite resin restoration/4-mm fracture group. However, on the other hand, the bond strength of the veneer appeared to be adequate and predictable for long-term clinical success

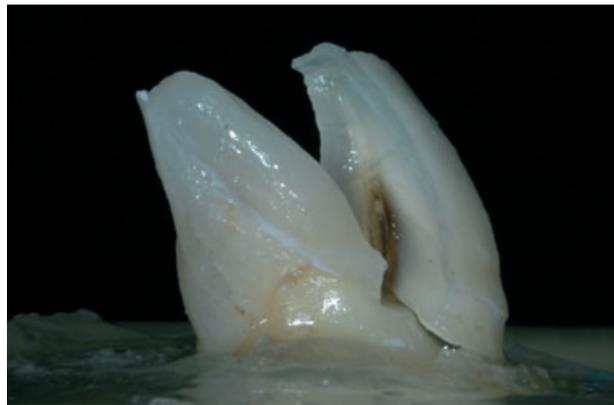
Fig. 2. Restoration and crown fracture from porcelain veneer/2-mm fracture group (central incisor).

During the cyclic loading, in the porcelain veneer/2-mm fracture group, two specimens failed (both adhesive/cohesive failures) (Figs 2 and 3). For the composite resin restoration/2-mm fracture group, two specimens failed

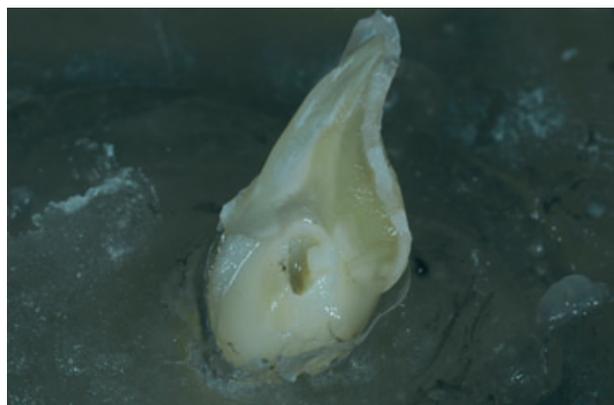
Fig. 3. Crown fracture from porcelain veneer/2-mm fracture group (lateral incisor).

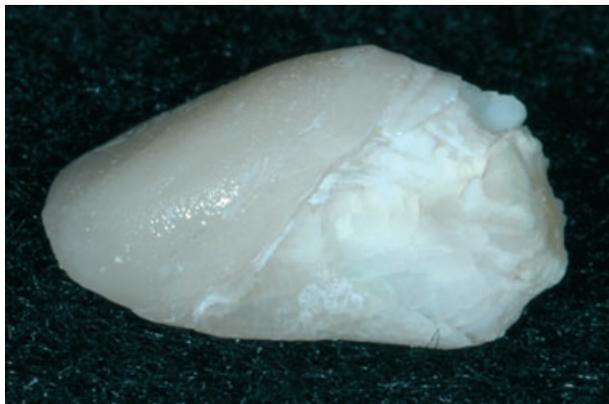
Fig. 4. Root fracture from porcelain veneer/4-mm fracture group (lateral incisor).

during the cyclic loading and one of them was a root fracture (the other one was adhesive/cohesive failure). For the porcelain veneer/4-mm fracture group, one root fracture (Fig. 4) occurred during the cyclic loading. For the composite resin restoration/4-mm fracture group, three specimens failed during the cyclic loading and they were two restoration fractures (both adhesive failures) (Fig. 5) and one root fracture (Table 2).

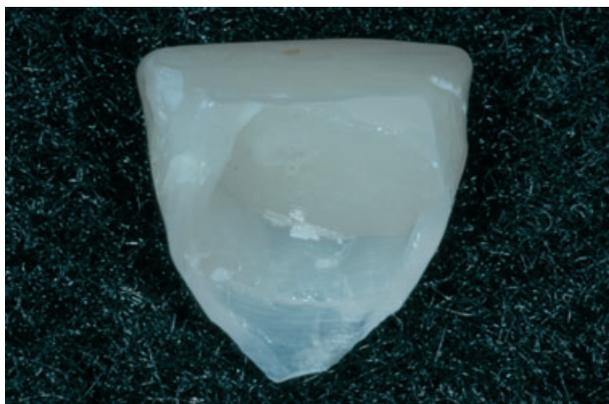
Fig. 5. Restoration fracture (adhesive failure) from composite resin restoration/4-mm fracture group. Tooth was left intact (central incisor).

In the porcelain veneer group, three specimens failed and veneer fracture occurred in only one specimen. The veneer broke with the crown, and the other two failures were a crown fracture and a root fracture without the breakage of the veneers. The composite resin restoration/2-mm fracture group showed similar results that the fractures occurred on either restoration with the crown or the root without composite resin failure. However, the composite resin restoration/4-mm group showed a different result that two specimens failed at the material-tooth interface where the bonding was achieved (adhesive failure). There was one more failure in the composite group and it was a root fracture. In a summary, only the composite resin restoration/4-mm group showed complete debonding of the restoration.
