Effect of Veneering Method on the Fracture and Bond Strength of Bilayered Zirconia Restorations

Moustafa N. Aboushelib, DDS, PhD^a/Marcel de Kler^a/Jef M. van der Zel, PhD^b/Albert J. Feilzer, DDS, PhD^b

This study evaluated the fracture strength and microtensile bond strength of a new computer-aided design (CAD) veneering method for zirconia frameworks. A new CAD/computer-assisted manufacture system was used to fabricate a resin replica of the esthetic ceramic required to veneer a zirconia framework. The replicas were processed using press-on technology. Identical manually layered zirconia specimens served as a control ($n = 18$; $\alpha = .05$). Statistical analysis revealed that the fracture strength (442.8 ± 25 N) and microtensile bond strength (26.6 ± 2 MPa) of CAD-veneered zirconia were significantly higher ($P < .001$) compared to the control (346 ± 24 N and 15.1 ± 1 MPa, respectively). CAD veneering is a reliable method for veneering zirconia frameworks. *Int J Prosthodont* 2008;21:237–240.

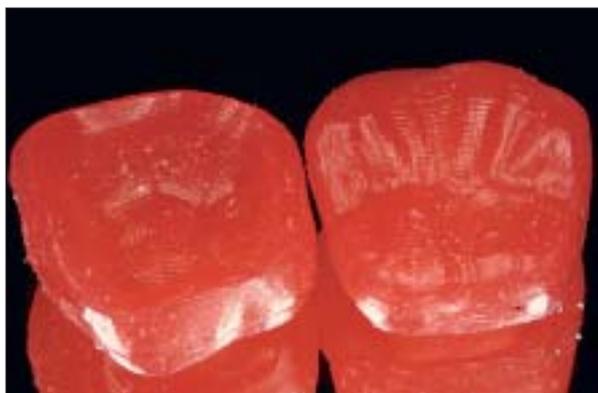
Fig 1 Milled carving block demonstrating the outer and inner surfaces of the resin veneer replica.

The resin veneer replica (Fig 1) was seated on the zirconia framework and processed according to the press-on technique (IPS e.max Zirpress, Ivoclar Vivadent).¹ The specimens were attached to the plastic muffle of a disposable paper ring using 2-mm wax sprues. The ring was filled with a vacuum-mixed investment material (IPS pressVest, Ivoclar Vivadent), and after a setting time of 45 minutes, the ring was placed in a preheated burnout furnace (850°C) for 60 minutes. A ceramic pellet of the required shade (A3.5) was inserted in the muffle, followed by an alumina plunger. The ring was then transferred to a computer-controlled press furnace (EP500, Ivoclar Vivadent), which pressed the molten ceramic pellet under vacuum. The remaining zirconia frameworks were manually layered (IPS e.max Ceram, Ivoclar Vivadent) and used as a control group ($n = 18$).

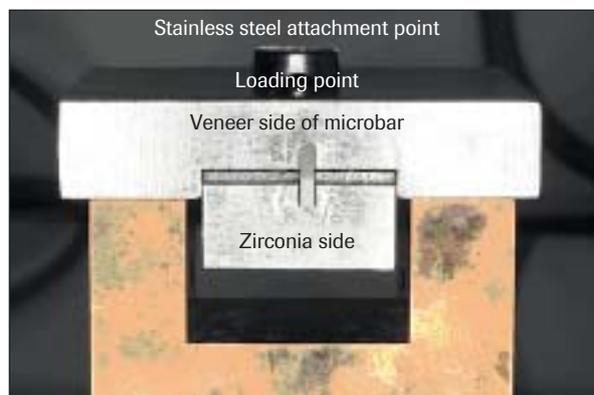
Fig 2 Zirconia veneer microbar attached to the attachment unit using a light-polymerized adhesive resin. As the 2 plates of the attachment unit are separated, the interface is subjected to tensile stresses.

were individually glued to the attachment using a light-polymerized adhesive resin (Clearfil SE, Kuraray). The zirconia veneer bond strength was measured by delivering axial load perpendicular to the bonded area, which tended to separate the 2 plates of the attachment unit, thus subjecting the zirconia veneer interface to tensile stresses (Fig 2).⁴
