# Zirconia-Composite Bonding After Plasma of Argon Treatment

**Purpose:** To compare the shear bond strength (SBS) values of resin cement to zirconia treated with a new activating method. **Materials and Methods:** Forty-five zirconia specimens were divided into three groups: no treatment (group 1), plasma of argon cleaning for 375 seconds (group 2), and plasma of argon cleaning for 750 seconds (group 3). Composite cylinders were bonded with a self-adhesive cement. After 40 days of water storage, specimens were subjected to the SBS test. Data were analyzed with one-way analysis of variance and the Neuman-Keuls multiple comparison test. **Results:** Test groups obtained SBS values significantly higher (101% for group 2 and 81% for group 3) than controls. **Conclusion:** Plasma of argon appeared to improve bonding between zirconia and resin cement. *Int J Prosthodont* 2014;27:267–269.  
doi: 10.11607/ijp.3686

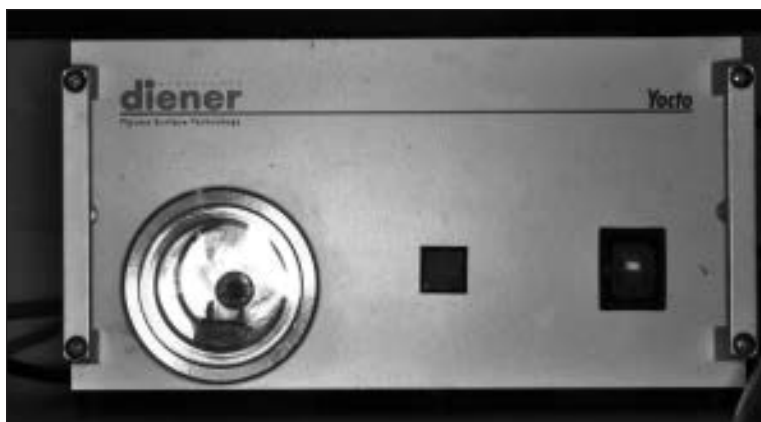
**Fig 1** Yoko reactor working at 75 W and pressure of 10 MPa.

Plasma treatment was performed using a plasma reactor (Yocto, Diener Electronic) with argon at 75 W of power and 10 MPa of pressure (Fig 1).
