Achieving Optimal Esthetics in a Patient with Severe Trauma: Using a Multidisciplinary Approach and an All-Ceramic Fixed Partial Denture

JOSÉ-LUIS RUIZ, DDS*

(*J Esthet Restor Dent* 17:285–292, 2005)

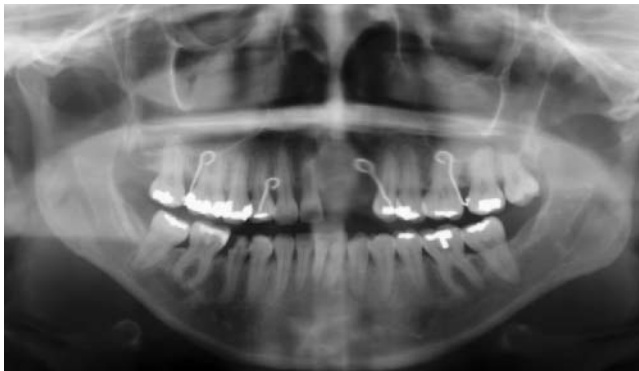
Figure 1. Panoramic radiograph showing that the right maxillary canine and lateral and central incisors and left maxillary central incisor are missing.

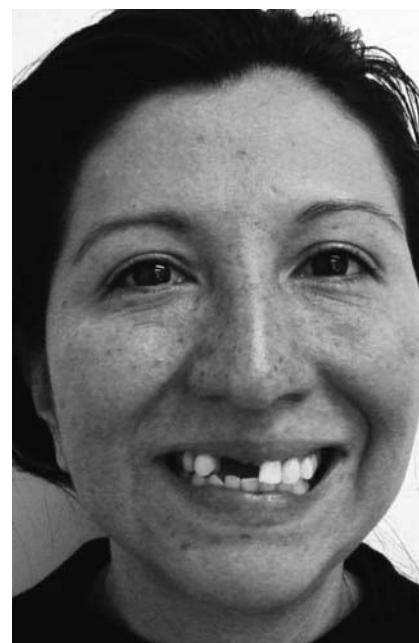
Figure 2. Portrait before treatment, showing midline discrepancy.

that caused severe facial injuries and the loss of the right maxillary canine and lateral and central incisors as well as the left maxillary central incisor. She also reported having started dental treatment 3 years earlier to replace her anterior teeth. That treatment plan included orthodontics and subsequent implant treatment. After completing the orthodontic phase of the treatment, the patient became disillusioned because she was unhappy with her smile and stated that her entire smile had become “crooked” and that the midline was “very off to the left” (Figure 2).

The intraoral evaluation yielded the following findings: the right maxillary canine and lateral and central incisors, and the left maxillary central incisor were missing; there was a severe ridge defect in the area; and both hard and soft tissues had been lost owing to the traumatic injury. The previous orthodontist had attempted to move the entire dentition forward to close the edentulous space as much as possible. At the end of the treatment, only two pontics were needed because the right bicuspid had replaced canine and the left lateral had replaced the left central incisor. However, the patient was left with a severe occlusal cant (the right side was much higher than the left) and a posterior crossbite and anterior open bite. The left lateral incisor

had been moved to the left central position but remained 3 mm from the midline; as a consequence, the temporary removable partial that was fabricated by the previous dentist had a severe midline discrepancy. The patient was aware and unhappy about these problems.

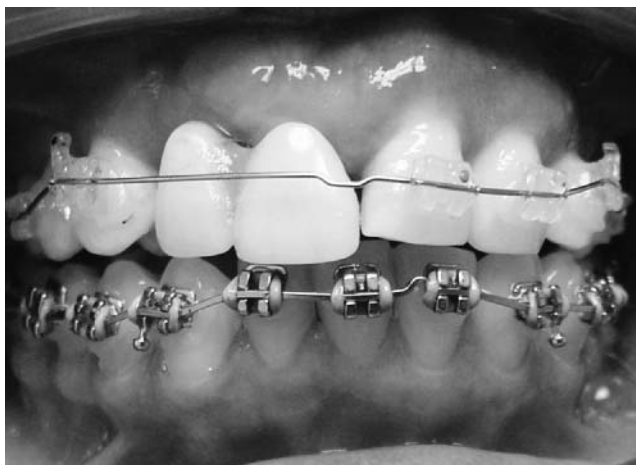
Figure 4. Orthodontics were performed to correct the midline discrepancy and occlusal cant.

The first phase of the treatment was limited to orthodontics (Figure 4). At the end of the first year of treatment, the patient was happy to see that the occlusal cant had almost disappeared and the midline was much closer to the middle.

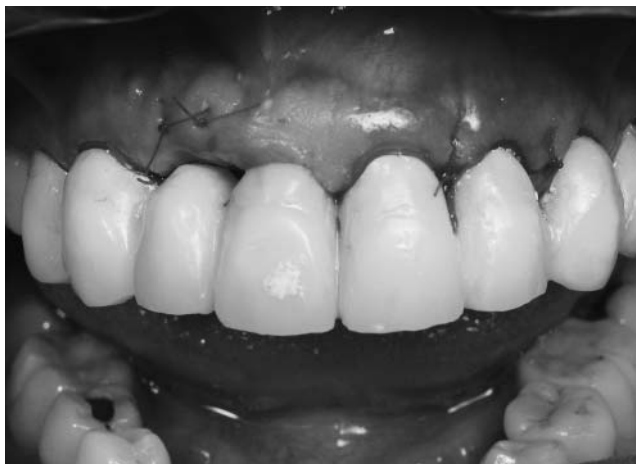
Figure 6. Provisionals act as the guide for ridge augmentation.

The third phase of the treatment involved sending the patient to a periodontist for the ridge-augmentation surgery.⁷⁻⁹ The provisionals served as the surgical guide for how much tissue needed

to be augmented (Figure 6) and also revealed that to achieve ideal symmetry, some crown-lengthening surgery was necessary. This underscores the importance of good communication among members of the esthetic dental team (specialists, technicians, and restorative dentist) and how proper records and provisionals are needed to properly plan, communicate, and achieve the ultimate result.^{1,10}

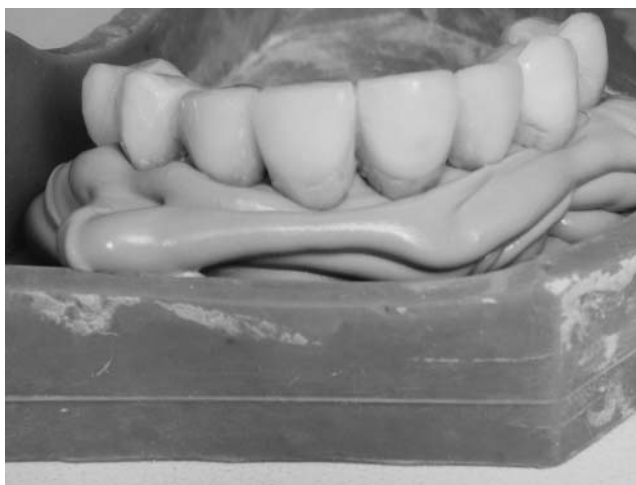
Figure 7. Fabrication of the ovate pontic matrix.

After approximately 8 weeks of healing, the patient was referred back from the periodontist for final impressions. At this appointment, the preparations were refined and the impression was taken using Impregum Penta Soft Impression Material (3M ESPE) because it is the most hydrophilic material and best reproduces the developed ovate site. An additional impression of the provisional was taken with Position Penta Quick Preliminary Impression Material (3M ESPE) (Figure 7), reproducing the custom-developed pontics and half of the internal portion of the abutment. (This becomes the matrix that the laboratory uses to reproduce the carefully developed pontic sites.)

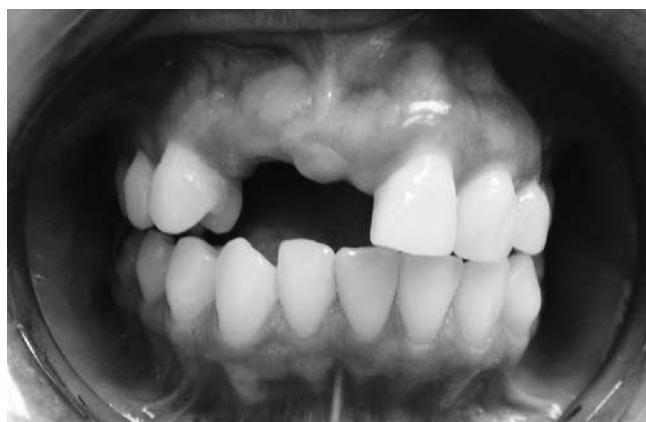
Figure 9. Preoperative retracted close-up.

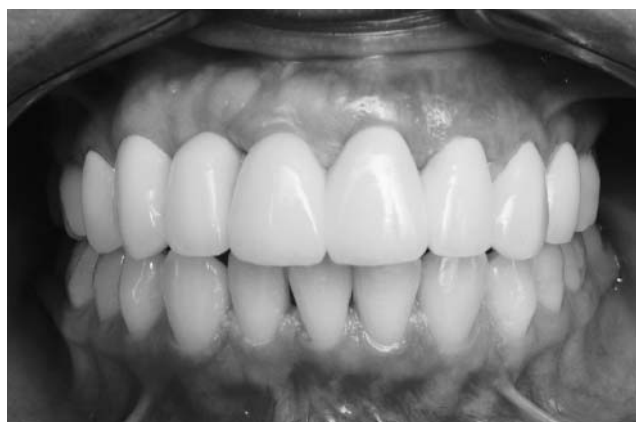
Figure 10. Retracted close-up, 2 weeks postoperatively.

using resin cements. In this case, the bridge and other crowns were cemented with RelyX Luting Cement (3M ESPE) because of its

long clinical history and easy clean up. The patient was extremely satisfied with the results, as shown in the final photograph, taken 2 weeks
