Multiple Cuspal-Coverage Direct Composite Restorations: Functional and Esthetic Guidelines

This paper is intended to introduce specific esthetic and functional guidelines for the placement of cusp-capping restorations using resin-bonded composite.

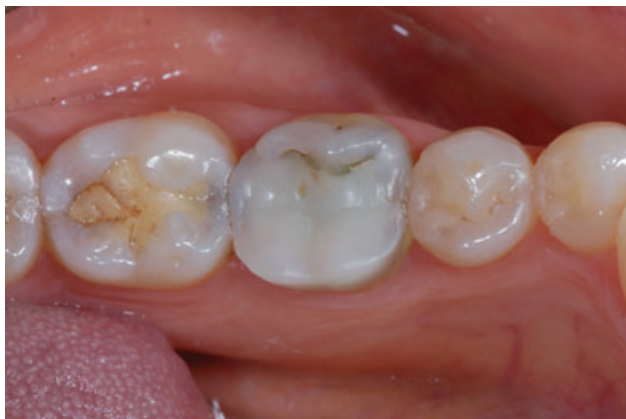
Figure 1. Preoperative view of teeth #18 (incongruous restoration and decay) and 19 (incongruous cusp-replacing restoration).

A 46-year-old female patient presented with an incongruous restoration in a lower molar tooth, replacing both the lingual cusps and marginal ridges (#19). The tooth was restored with a composite resin 2 years earlier. Caries on the mesial surface of tooth #18 was also detected (Figure 1). Preoperative occlusal analysis showed the concentration of the occlusal load on the residual facial wall of tooth #19 and an absence of an upper molar palatal centric stop. Because of the unbalanced occlusion, a fracture of the remaining wall can occur under mastication (Figure 2).

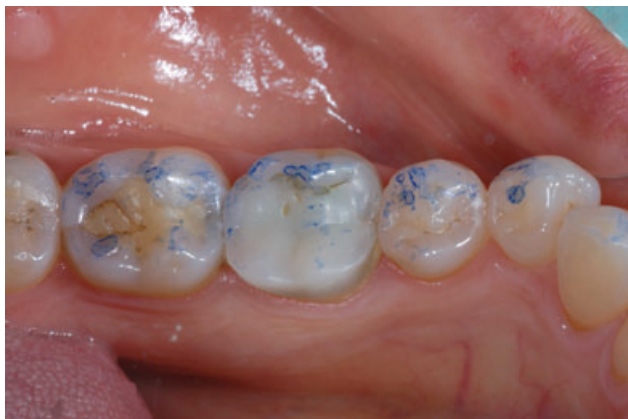
Figure 2. Before starting anesthesia, occlusion was checked and centric stops were recorded.

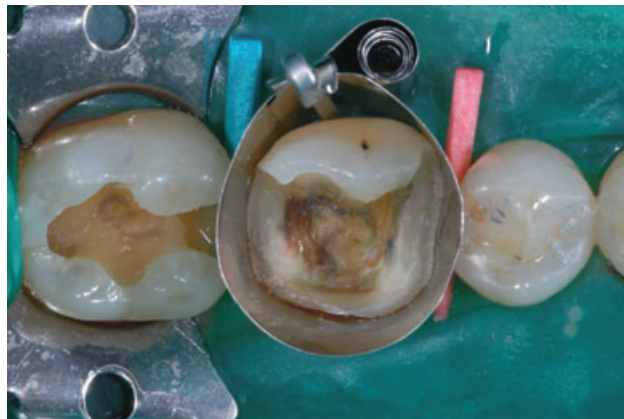
Figure 3. Cavity preparation was completed and a circular matrix was placed.

A rubber dam was placed and the cavity was prepared in a very conservative manner, just removing the decay and/or the existing restoration with a #245 bur (Shofu Dental Corporation, San Marcos, CA, USA), rounding sharp angles with #2 and #4 burs (Shofu Dental Corporation) on both teeth #18 and 19. A caries indicator (Sable Seek, Ultradent Products, South Jordan, UT, USA) was applied onto dentin and stained nonmineralized dental tissue removed with an excavator. No bevels were placed either in the occlusal or gingival margins. A circular matrix (Automatrix-Dentsply/Caulk, Mildford, DE, USA) was placed around tooth #19 and tightened. Interproximal matrix adaptation was secured using wooden wedges (Figure 3). The cavity was disinfected with a 2% chlorhexidine antibacterial solution (Consepsis,

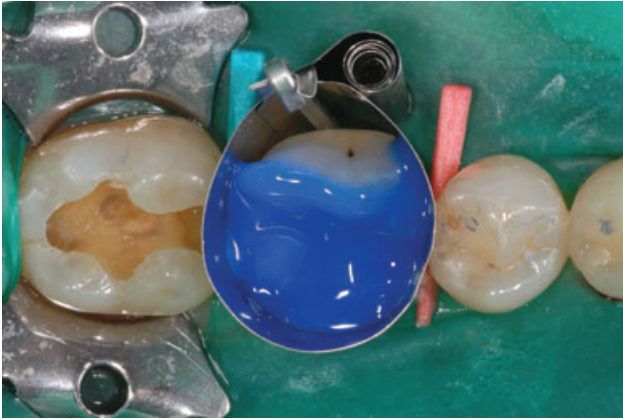
Figure 4. Etching was performed using 35% phosphoric acid.

Ultradent Products). The tooth was etched for 15 seconds using a 35% phosphoric acid (UltraEtch, Ultradent Products) (Figure 4). The etchant was removed and the cavity was rinsed with water spray for 30 seconds, being careful to maintain a moist surface. A fifth generation 40% filled ethanol-based adhesive system (PQ1, Ultradent Products) was placed in the preparation, gently air thinned until the milky appearance disappeared, and light cured for 20 seconds using a Quartz Tungsten Halogen curing light (VIP, Bisco, Inc., Schaumburg, IL, USA) (Figure 5).

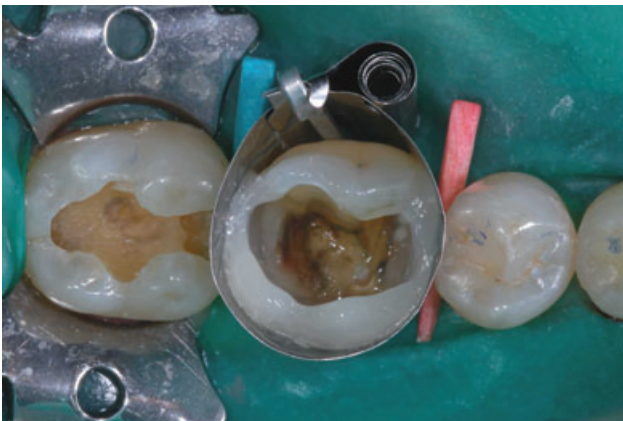
Figure 6. The peripheral enamel skeleton was built up first using pearl smoke wedge-shaped increments.

smoke (PS) shade were used to reconstruct the enamel portion of the proximal surface first and then the enamel external shell of each lingual cusp (Figure 6). At this point, the stratification of dentin was started, placing a 1- to 1.5-mm even layer of A 3.5 flowable composite (PermaFlo, Ultradent Products) on deeper dentin (Figure 7), which was followed by the application of dentin wedge-shaped increments strategically placed to a single surface, decreasing the C-factor ratio (Figure 8).^{13,14} For the same reason, single increments of PS enamel shade were applied to one cusp at a time (Figure 9); each cusp was cured separately, achieving the final primary and secondary occlusal morphology (Figure 10). In order to avoid microcrack formation of the remaining wall and reduce stress from polymerization shrinkage,

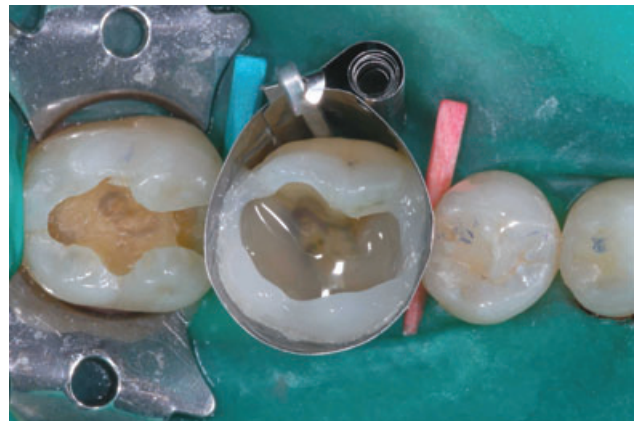
Figure 7. Dentin stratification was started, placing a 1-mm layer of A 3.5 flowable composite resin.

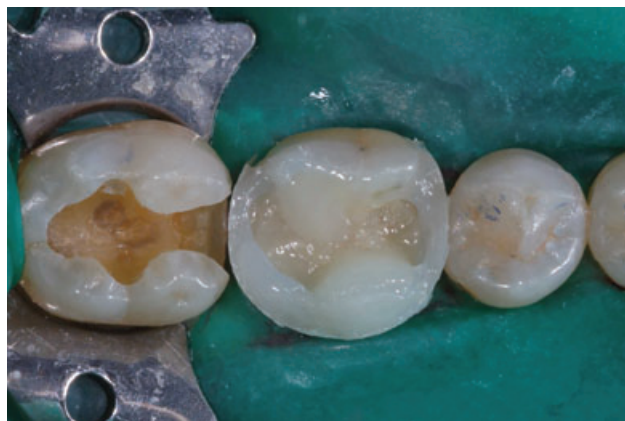
Figure 9. Restoration was completed with the application of pearl smoke shade to each cusp in order to develop cuspal ridges and supplemental morphology.

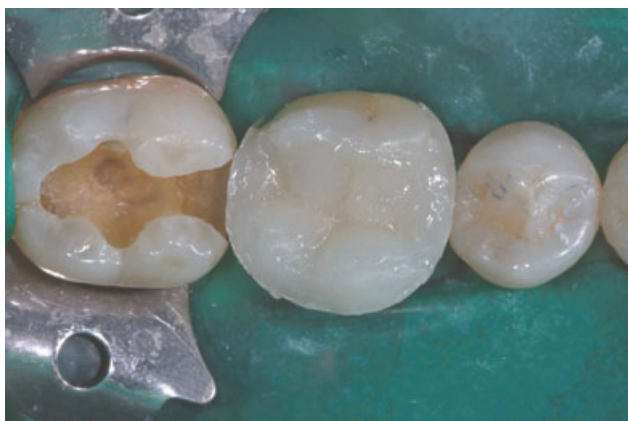
Figure 10. Restoration was completed with the application of pearl smoke shade to each cusp in order to develop cuspal ridges and supplemental morphology.

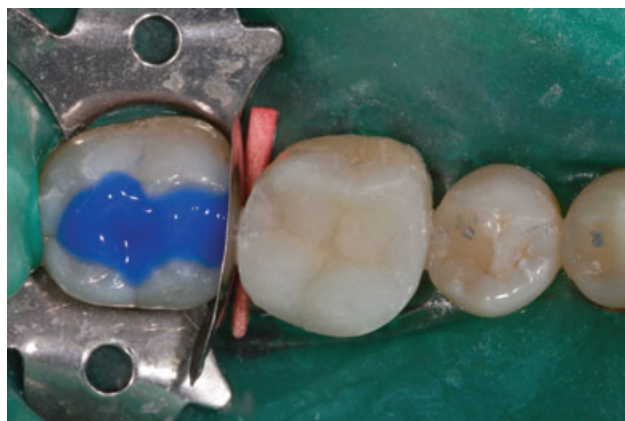
Figure 11. A sectional matrix was secured in place using a wooden wedge; etching of the cavity on tooth #18 was performed using 35% phosphoric acid.

Ultradent Products) was inserted on tooth #18; the same restorative steps described for tooth #19 were repeated for tooth #18 (Figures 11–14).

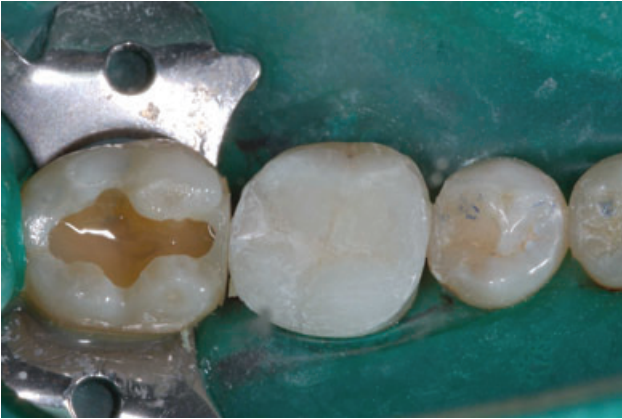
Figure 12. Once hybridization was completed, the mesial proximal surface was built up and flowable composite was applied to deep dentin.

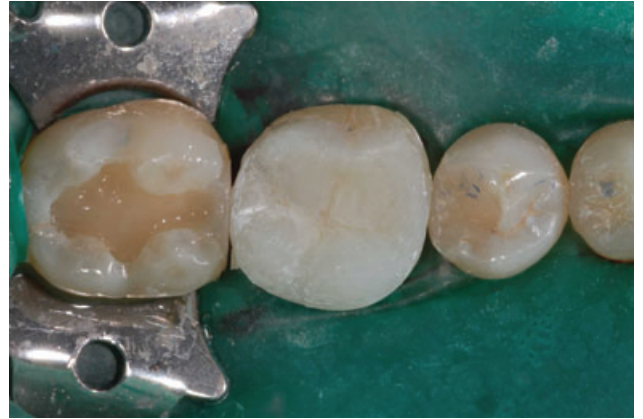
Figure 13. Dentin stratification was completed by using wedge-shaped increments of dentin shades.

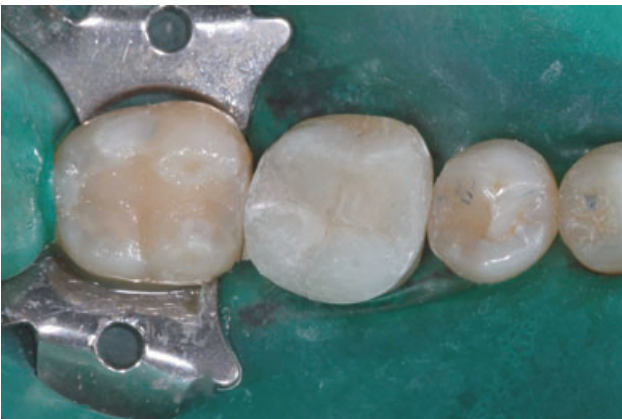
Figure 14. Restoration was completed with the application of pearl smoke shade to the final contour of the occlusal surface.

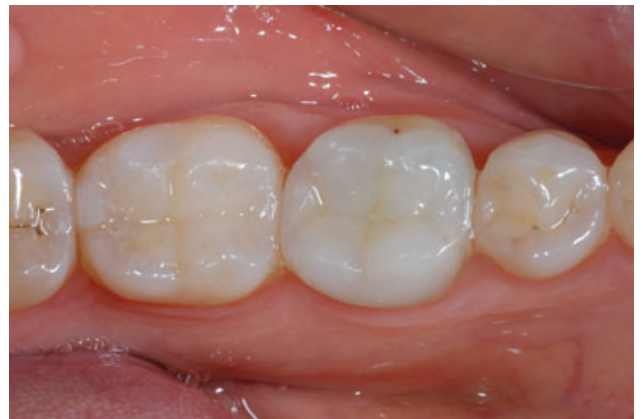
Figure 15. Result at the 2-week recall.

polishing was performed with impregnated silicon rubber cups and points, and final polishing was performed with diamond and silicon carbide impregnated cups, points, and brushes (Finale Polishing System, Ultradent Products). Figure 15 illustrates the final result at the 2-week recall; occlusion was verified avoiding excessive load on the weak facial cusp

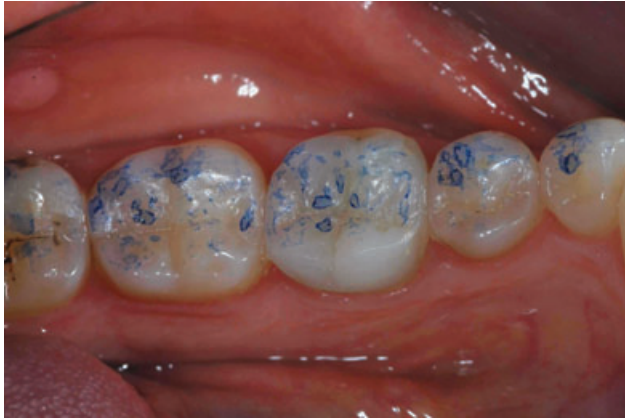
Figure 16. Postoperative occlusal view of the final restorations after occlusion checking.

and achieving prevalence of an axial load (Figure 16). Interestingly, the occlusion, relative to both pre-op and post-op contact points were of the same intensity on both the canine and premolar, although a modification of the occlusal scheme was performed on molar teeth.
