CLINICAL REPORT

Rehabilitation of a Spark Erosion Prosthesis: A Clinical Report

When complex prostheses are fabricated, it is expected that at some point maintenance will be necessary. This clinical report documents a 10-year-old maxillary spark erosion prosthesis that had been repaired many times, was discolored, and exhibited significant signs of wear. The metal superstructure was intact; therefore, only the acrylic resin base and teeth needed to be replaced. To reduce both cost and time without the prosthesis for the patient, the rehabilitation was completed within 24 hours.

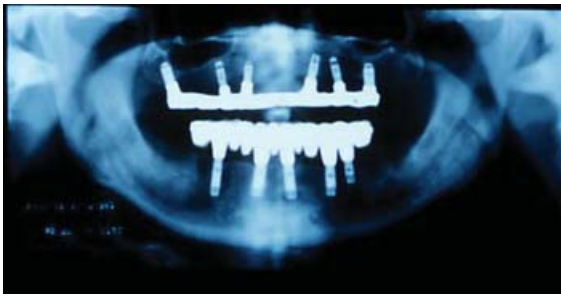
Figure 1. 1990 Panorex with implant fixtures placed and restored.

remaining teeth were extracted and replaced with implants of various sizes. Six implants were placed in the maxilla and five in the mandible. The maxilla was restored with a spark-eroded palateless removable prosthesis, and the mandible was restored with a screw-retained ceramometal fixed partial denture (Fig 1). The patient presented to the clinic every 6 months for hygiene recall appointments.

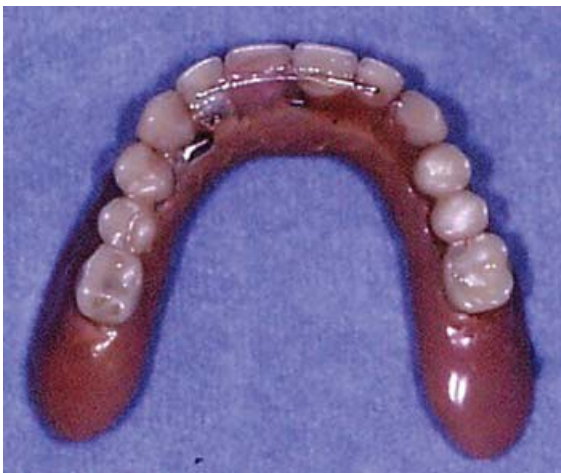
Over a period of 10 years, the removable maxillary prosthesis had been repaired numerous times, showed signs of wear, and had evidence of discoloration (Fig 2). Two rehabilitative options were presented to the patient. One was a 24-hour process to be completed at a laboratory within the university. The other option was to remove the infrastructure, place healing abutments, and use an outside laboratory to rehabilitate the prosthesis. The second option would have taken weeks to

Figure 2. Cameo surface of prosthesis before rehabilitation.

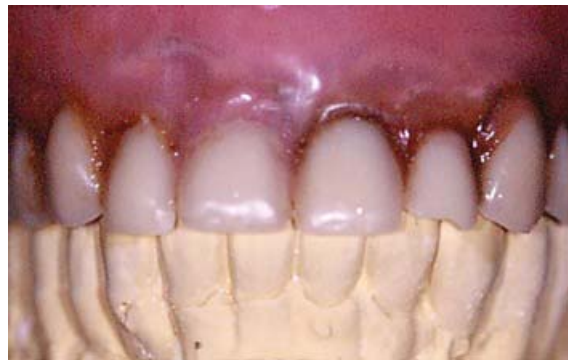
Figure 4. Prosthesis mounted against mandibular cast before rehabilitation.

Several days before the rehabilitation appointment, a cast of the maxillary substructure was made with lab putty (Coltène Whaledent, Cuyahoga Falls, OH), and a stone base (Whip Mix, Louisville, KY) was added for mounting on an articulator (Fig 3). A face-bow transfer record using the existing prosthesis was obtained. An opposing cast was made and mounted on a Hanau H2X articulator (Waterpik Technologies, Inc., Pittsburgh, PA) (Fig 4) using an interocclusal

record. The occlusal vertical dimension (OVD) was assessed using the physiologic rest position, and, although there was a decrease of 4 mm registered, the OVD was not altered because the closest speaking space was 1 mm, and the patient was very comfortable at this OVD.

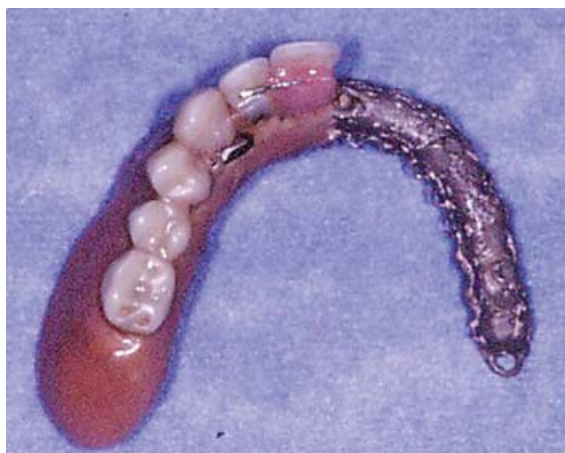
Figure 5. Superstructure with one-half of acrylic and teeth removed.

The patient presented to the Postgraduate Prosthodontic Clinic in the morning; after disinfection, the spark erosion removable prosthesis was taken to the laboratory to remove one-half of the existing acrylic base and teeth exposing the metal superstructure (Fig 5). New teeth were set in Type III extra-hard baseplate wax (Dentsply International, Inc., York, PA) and tried in the patient's mouth to verify both esthetics and phonetics. After verification, the process was repeated on the other half of the metal superstructure. Again, it was tried in the patient's mouth to verify esthetics and phonetics. Once the patient approved of the tooth position, size, shade, and shape, the patient was dismissed and asked to return the next morning.

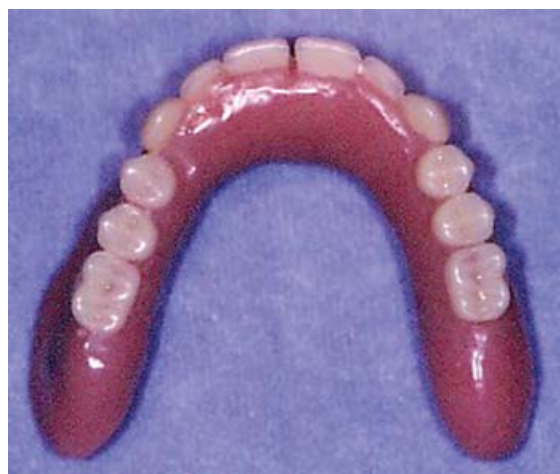
Figure 6. New cameo surface of prosthesis after rehabilitation.

The prosthesis was disinfected and taken to the laboratory for final processing. The wax up was sealed down to the putty cast with additional wax and then flaked like a conventional complete denture. Once the boil out was completed, the metal superstructure was sealed to the putty cast with cyanoacrylate (Elmer's Products, Inc., Columbus, OH). This was done to prevent acrylic resin from reaching the internal surface of the superstructure where various attachments are located.

a doughy stage. The trial packs were eliminated, and only a final pack at 3000 psi was performed. The flask was placed in a clamp and then into a processing tank at 165°F for 10 hours. The following morning, the prosthesis was deflashed, finished, and polished (Fig 6). The patient returned for insertion at which time home-care instructions were given (Figs 7 and 8).

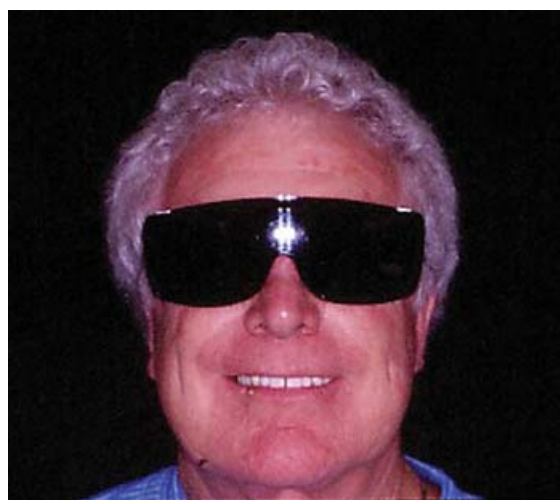
Figure 7. Frontal smile after rehabilitation.

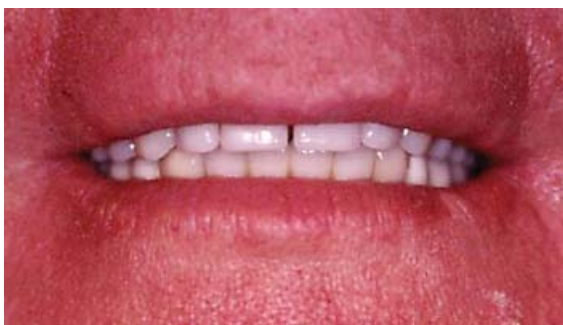
Figure 8. Close up of smile after rehabilitation.
