Mandibular Fracture in Conjunction with Bicortical Penetration, Using Wide-Diameter Endosseous Dental Implants

Won-suk Oh, DDS, MS,¹ Eleni D. Roumanas, DDS,² & John Beumer III, DDS, MS²

This clinical report was presented at the biennial session of the ICP in Fukuoka, Japan, September 2007.

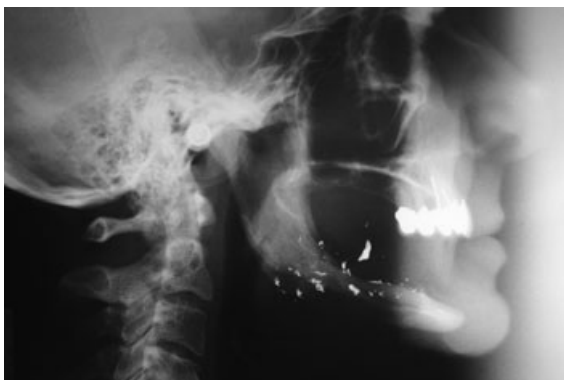
Figure 1 Preoperative cephalometric radiographic image exhibiting natural dentition in maxilla, atrophic edentulous mandible, and opaque particles from gunshot wound in posterior mandible.

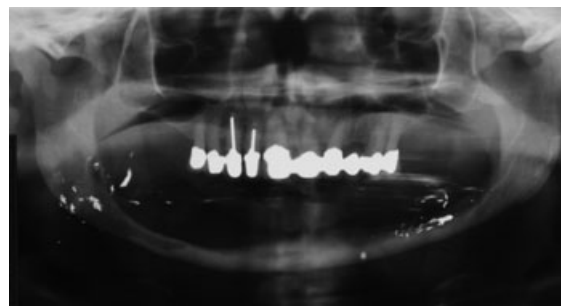
Figure 2 Preoperative panoramic radiographic image exhibiting advanced atrophy of the mandible (7 mm height of anterior mandible).

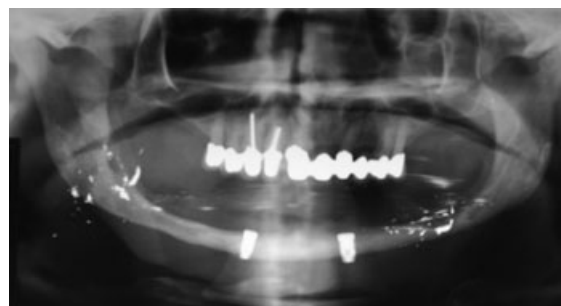
Figure 3 Postoperative, panoramic radiographic image exhibiting two screw-type endosseous wide-diameter implants in each canine area, penetrating inferior border of mandible.

Wide-diameter implants (5.0-mm diameter) were selected to increase the contact surface area of the implant with the bone. Under local anesthesia, a crestal incision was made and a mucoperiosteal flap was reflected between the mental foramen. Gentle surgical technique was used to create implant osteotomy sites under copious irrigation during drilling. Two short (8.5-mm length) two-stage endosseous screw-type implants (Osseotite, 3i, Palm Beach Gardens, FL) were placed in the right and left mandibular canine sites where the implants engaged and penetrated the inferior border of the mandible (Fig 3). The implants were submerged and allowed to heal undisturbed. The patient did not wear his denture for 1 week postoperatively. Following this period, the intaglio surface of the existing denture was aggressively relieved and relined with a resilient tissue conditioning material (Visco-gel), which was replaced every other week. The patient was instructed to maintain a soft

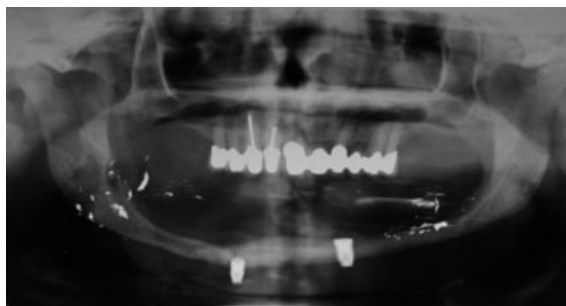
Figure 4 Panoramic radiographic image exhibiting displacement of right implant, along with fracture of mandible at implant site and radiolucency around left implant.

Three months following surgery, the patient presented with pain and swelling in the right submandibular area. Intraoral examination revealed hyperplastic granulation tissue and purulent exudate from the periimplant area in the right mandible. A panoramic radiograph showed evidence of a right mandibular fracture, displacement of the right implant into the submandibular soft tissue space, and signs of infection around the left implant (Fig 4). Review of the medical history did not reveal any contributory findings, and the patient did not report a history of external trauma to the region. The patient was placed on Clindamycin (Cleocin, Pfizer Inc, New York, NY), 300 mg orally, four times daily for 7 days and advised to remain on a pureed, soft diet.

An open reduction was planned to remove both implants and reduce the mandibular fracture. Under local anesthesia and IV sedation, the left implant was identified and removed without complications. The right implant site was noted to have a mandibular fracture with the implant displaced in the submandibular area. The implant was removed, and the fracture site was debrided of all reactive granulation tissue. The bony fragments were approximated and stabilized with a 1.7-mm 4-hole Ti bone fixation plate (Arthrex Inc, Naples, FL) and 6-mm bone screws (Arthrex Inc). A 2.0-mm-wide and 12-mm-

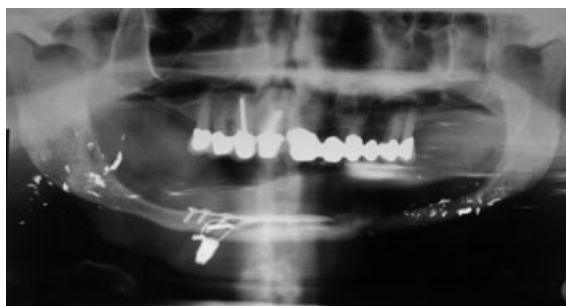
Figure 5 Panoramic radiographic image exhibiting fixation of mandible with titanium plate and displaced right implant in submandibular soft tissue.

long lag screw (Arthrex Inc) was also placed (Fig 5). Following reduction, the fracture was noted to have good stability, the region was irrigated copiously, and the intraoral incision was closed in a watertight manner. The patient was instructed not to use the denture for 6 weeks and placed on Clindamycin, 300 mg four times daily for 7 days.

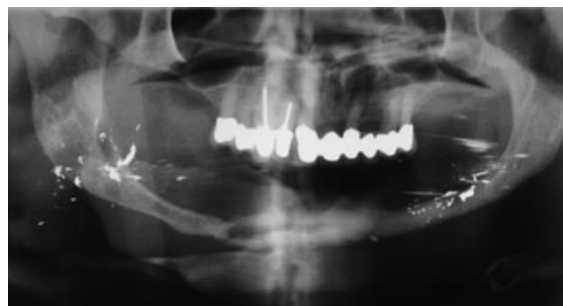
Figure 6 Panoramic radiographic image exhibiting reunion of fractured mandible and removal of hardware.

The patient's postoperative course was uneventful, and he was discharged from the hospital two days later. He was recalled biweekly, until an improvement in symptoms was noted with no evidence of extraoral swelling or lymphadenopathy. At the 6-week follow-up appointment, a follow-up panoramic radiograph was made, showing evidence of good bony alignment, bony callus formation, and healing around the fracture site. The patient did not report discomfort or other adverse symptoms. The existing denture was relined with a tissue conditioner (Visco-gel), and the patient continued on a soft diet regimen. Approximately 4 months later, the hardware was removed, and following complete healing of the soft tissues, a new mandibular conventional CD was fabricated (Fig 6).
