Retrieval of a Fractured Zirconia Implant Abutment Using a Modified Crown and Bridge Remover: A Clinical Report

This clinical report describes a novel method to retrieve the internal connection of a fractured zirconia abutment through modification of a crown and bridge remover. Furthermore, the strengths and limitations of using a zirconia implant abutment will be highlighted.

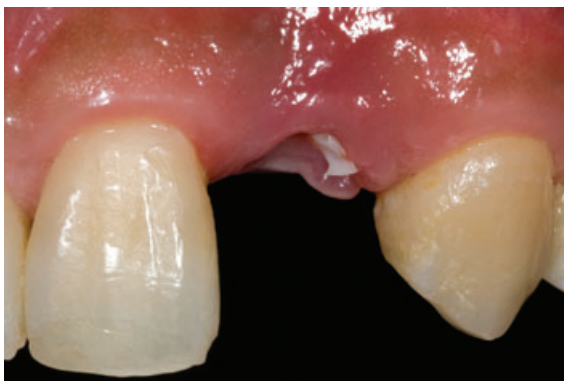
Figure 1 Facial view of the fractured ceramic abutment.

After removing the interim prosthesis and the fractured fragments of the zirconia abutment with cotton pliers (Figs 1–3), it was noted that the base portion of the abutment remained tightly lodged inside the internal connection of the implant. A periapical radiograph was taken to identify the remaining ceramic implant abutment (Procera[®] Zirconia Oxide, Nobel Biocare USA) (Fig 4) fragments. Due to the presence of soft tissue inflammation and active bleeding, visual access to the implant site was significantly compromised. Despite numerous attempts with an ultrasonic device, explorer, and periodontal curettes, the removal of the lodged fractured abutment fragment was not successful.

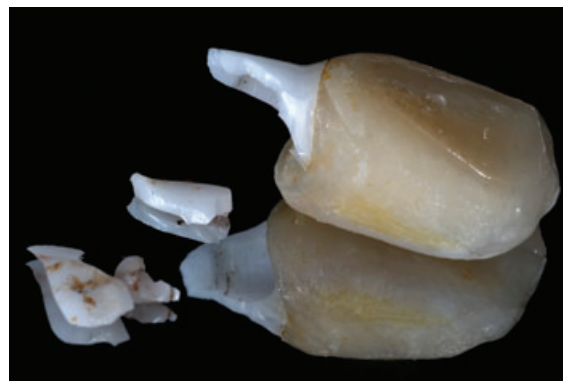
Figure 3 Interim prosthesis and ceramic abutment fragments.

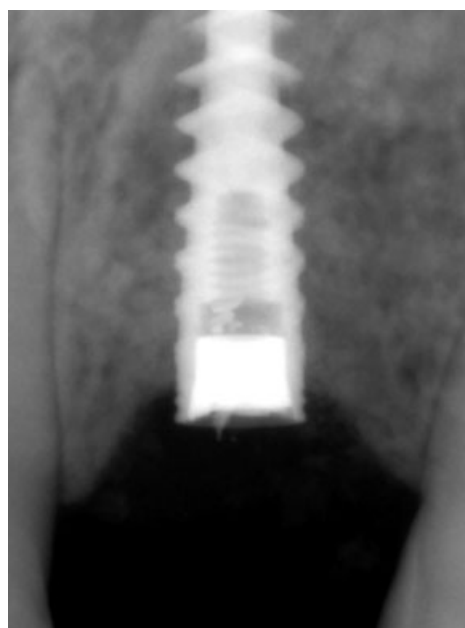
Figure 4 Periapical radiograph displaying the fractured ceramic abutment.

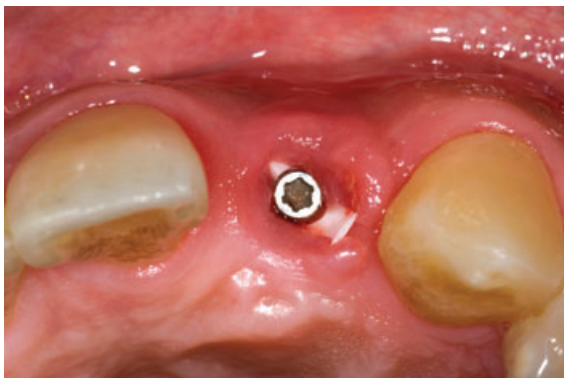
Figure 2 Occlusal view of the fractured ceramic abutment with abutment screw in place.

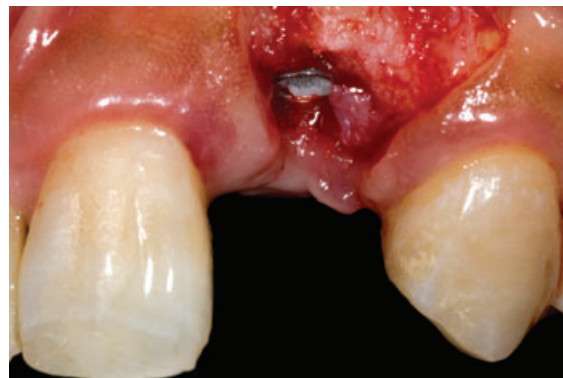
Figure 5 Full thickness flap reflection to completely expose the implant platform and remaining ceramic abutment structure.

Local anesthesia was then administered, and a full thickness flap was reflected to expose the coronal aspect of the implant for direct visualization of the fractured base portion of the abutment (Fig 5). In addition to repeating the aforementioned methods, various diamond and carbide burs with a high-speed handpiece were used but without significant progress. The tip of a crown and bridge remover (CRP1, Pulpdent, Watertown, MA) was then modified with a heatless stone (767A, Brasseler USA, Savannah, GA) to form a small sickle-shaped instrument (Fig 6). The modified tip was then inserted into the intaglio portion of the implant and was used with a back-action motion as it engaged the base of the abutment (Fig 7). The fractured portion of the zirconia abutment was successfully and completely removed without damage to the implant as verified by the periapical radiograph (Fig 8).

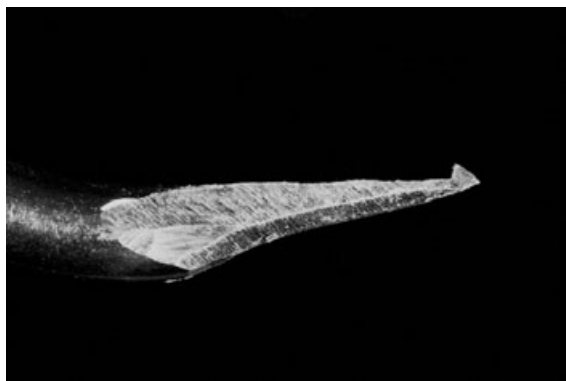
Figure 6 Crown and bridge remover modified to create a sickle-shaped instrument.
