# Full-Mouth Rehabilitation of a Patient with Gastroesophageal Reflux Disease: A Clinical Report

This report focuses on a patient with a long history of GERD, and a presentation of tooth wear on the maxillary and the mandibular anterior teeth, along with heavily restored dentition and a failing five-unit fixed dental prosthesis (FDP).

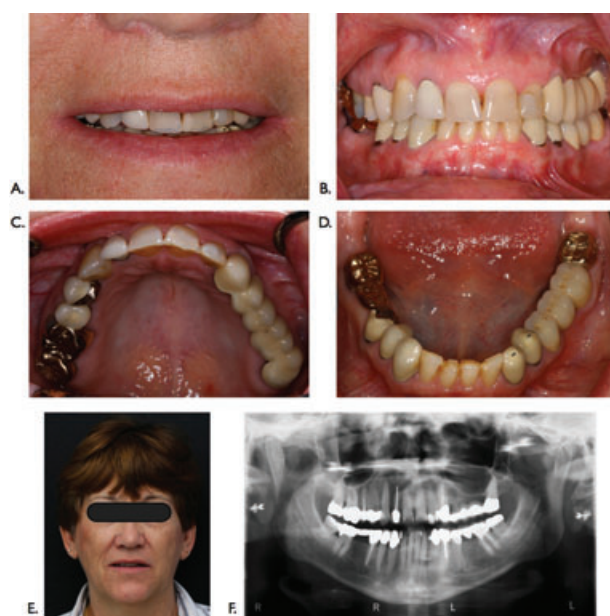
**Figure 1** Preoperative images and panoramic radiograph. (A) Close-up frontal view showing thin maxillary incisors. Intraoral images: (B) Frontal view at maximum-intercuspal position (MIP); (C) Maxillary occlusal; and (D) Mandibular occlusal views. (E) Preoperative smile image. (F) Preoperative panoramic radiograph.

Over the past 35 years, the patient had extensive dental treatment, including root canal treatment (RCT), fillings, crowns, and FDPs. The upper-left FDP had been loose for more than 6 months. Clinical exam revealed that a five-unit FDP on teeth #11 to 15 was loose. After removal of the FDP, abutment tooth #11 was noted to have deep caries below the gingival level and was determined nonrestorable. The patient also presented with moderately worn dentition and restorations. Defective composite restorations were present on most of the anterior teeth. Multiple fixed restorations were in place, including porcelain-fused-to-metal (PFM) crowns on teeth #4, 5, 7, 21, 22, 27, and 28, full-gold crowns on teeth #2 and #17, a 7/8 gold crown on tooth #3, a PFM-FDP on teeth #18 to 20, and a gold FDP with mesial retainer facial porcelain veneer on

#29 to 31. Secondary caries was noticed on teeth #2, 6, 8, 9, 10, 11, 17, 18, 20, and 29. The patient had an Angle's Class I canine relationship and an Angle's Class III molar relationship. The mandibular midline was coincident with the facial midline, whereas the maxillary midline was 2 mm to the left. The occlusal vertical dimension (OVD) was deemed reduced after evaluation of esthetics and phonetics. The patient's centric occlusion and maximal intercuspal position (MIP) were coincident. Radiographic findings revealed generalized mild to moderate bone loss (Fig 1). Using the American College of Prosthodontists' Prosthodontic Diagnostic Index (PDI) for partial edentulism, the patient was classified as Class IV.<sup>6</sup>

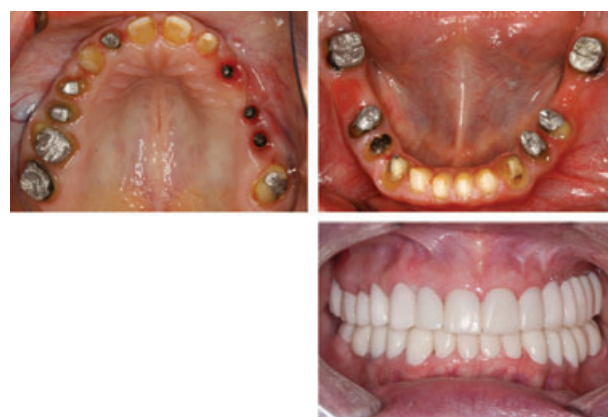
**Figure 4** Tooth preparations and interim prostheses.

During the healing of bone grafting and implant surgery, all defective restorations on teeth #6 to 10 and #23 to 26 were removed, and secondary caries excavated. The cavities were restored with composite resin. All existing crowns and FDPs were sectioned and removed. All abutment teeth were thoroughly examined, and secondary caries excavated. Tooth #17 had lost extensive tooth structure and was extracted due to nonpredictable RCT. Teeth #2 and 20 had lost extensive tooth structure, and were recommended to have selective RCT and dowel-core buildup before new crowns were fabricated. Teeth #3, 4, 18, 20, 21, and 31 did not have enough remaining coronal tooth structure for adequate ferrule effect. Therefore, crown-lengthening surgery was recommended. Teeth #3, 5, 15, 18, and 31 lost some tooth structure, but were determined to be restorable and have a favorable prognosis. They were restored with amalgam, with pins placed on teeth #3 and 31 to assist core retention. A cast dowel-core of tooth #21 became loose and was removed. Teeth #2, 4, 7, 20, 21, and 29 were recommended to have RCT. Dowel spaces were prepared on #2, 4, 7, 20, and 21 using a ParaPost XP System (Coltene Whaledent Inc, Cuyahoga Falls, OH). Prefabricated stainless steel ParaPosts was bonded with resin cement (MaxCem Resin Cement, Kerr Corporation, Orange, CA), and the teeth were then restored with amalgam. Tooth #29 had adequate tooth structure after RCT and was restored with amalgam. The preparations were refined. Provisional crowns and FDPs were fabricated using autopolymerized acrylic resin.
