Dental Traumatology 2013; 29: 479-482; doi: 10.1111/j.1600-9657.2012.01154.x

Crown reattachment with complicated chisel-type fracture using fiber-reinforced post CASE REPORT

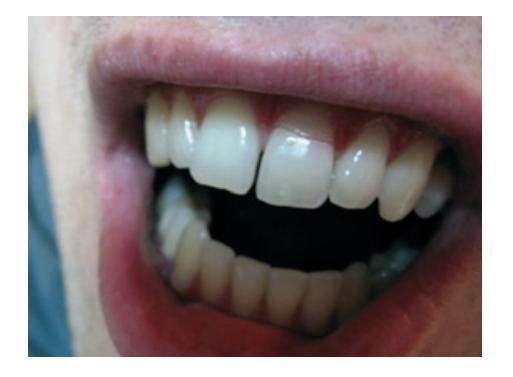
A 24-year-old male patient came to The Department of Restorative Dentistry and Endodontics at the Dental Clinic in Vojvodina with dental injury of the maxillary left central incisor. The patient reported a sport injury that had occurred the night before during a football match (Fig. 1).

Fig. 1. Image of fractured tooth taken immediately after trauma with mobile phone camera.

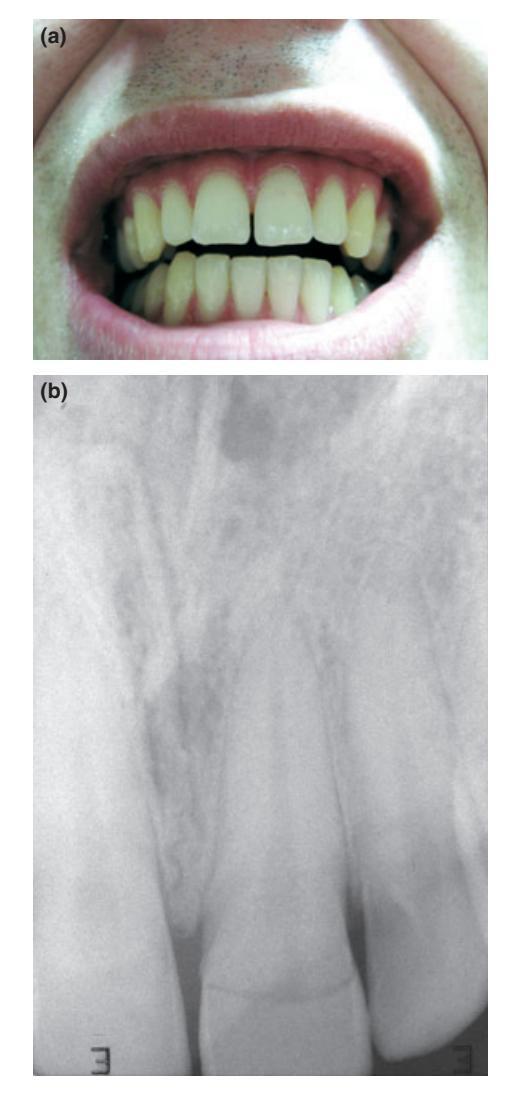
Clinical and radiographic examination revealed a complicated oblique crown fracture that extended subgingivally on the mesiopalatal area with a single fragment, attached only by periodontal ligament fibers as well as widely open pulp chamber (Fig. 2a,b).

Fig. 2. (a) Preoperative view of fractured tooth. (b) Radiograph of fractured tooth.

Upon examination, the treatment options were presented to the patient, including (i) no treatment, (ii) post-and-core and crown, (iii) crown buildup restoration with a resin-based composite, and (iv) reposition of the tooth fragment. After some deliberation about the advantages, disadvantages, prognosis, and cost/benefit of every treatment option, the patient opted to have the tooth fragment repositioned. Provisional repositioning of the crown was performed using a composite resin splint and after that endodontic treatment was performed (Fig. 3).

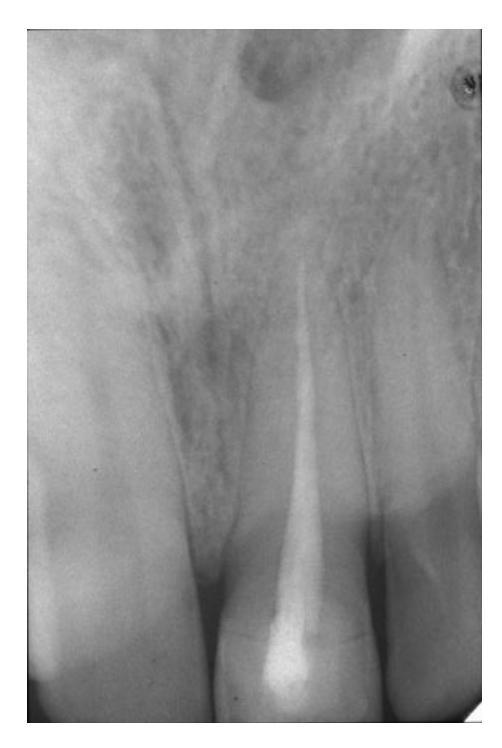
Fig. 3. Radiographic aspect of endodontic treatment.

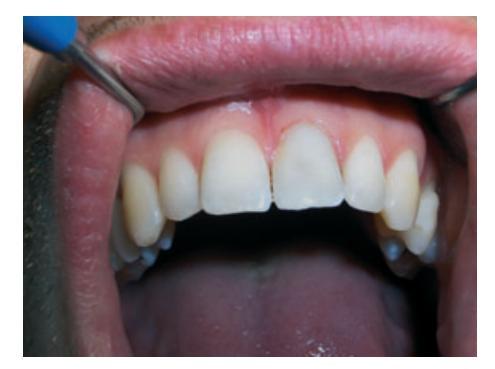
Fig. 4. Intraoral view of the patient after the treatmant.

Preparation for a composite resin veneer was performed in the gingival third of tooth's vestibular surface because the fracture line remained visible and was esthetically unacceptable. The cervical tooth zone was roughened with a diamond bur, and a slight finish line was created just below the gingival margin. The preparation was kept strictly in enamel. A contoured anatomical matrix was placed and wedged loosely. The matrix extended slightly into the sulcus and provided the smoothest possible surface to finish the composite resin. After the tooth was etched with 36% phosphoric acid (DeTrey[®] Conditioner 36 Conditioning&Etching Gel/Dentsply/De Trey, Konstanz, Germany), it was rinsed thoroughly, and a dentin bonding agent (Prime&Bond[®] NT/Dentsply/De Trey, Konstanz, Germany) was applied and air thinned, and then polymerized using an LED curing unit (Prime&Bond® NT/Dentsply/De Trey) for 10 s. Composite resin (Esthet.X[®]) Dentsply/De Trey, Konstanz, Germany) was placed, adequate contoured, and polymerized. A No. 3 10blade SafeEnd series carbide finishing bur (SS White Burs, Inc., Lakewood, NJ, USA) that has a noncutting tip designed to trim and to finish without damaging gingival tissue was used to remove excess resin composite in the area of the gingival sulcus. The composite resin was then reduced to proper contours along the gingiva and middle thirds using a No. 7 10-blade Safe-End series carbide finishing bur (SS White Burs, Inc.). Final carbide polishing was completed using a No. 7 20-blade SafeEnd series carbide finishing bur (SS White Burs, Inc.) (Fig. 4).

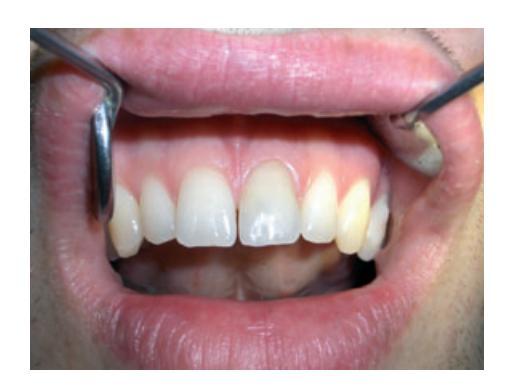
Clinical examination after 12 months revealed a stable reattachment of the fragment, acceptable esthetics, satisfying function, and periodontal health with no bleeding on probing (Fig. 5).

Fig. 5. Intraoral view of the patient one year after treatment.
