Evaluation of failure characteristics and bond strength after ceramic and polycarbonate bracket debonding: effect of bracket base silanization

SUMMARY The objectives of this study were to evaluate the effect of silanization on the failure type and shear–peel bond strength (SBS) of ceramic and polycarbonate brackets, and to determine the type of failure when debonded with either a universal testing machine or orthodontic pliers.

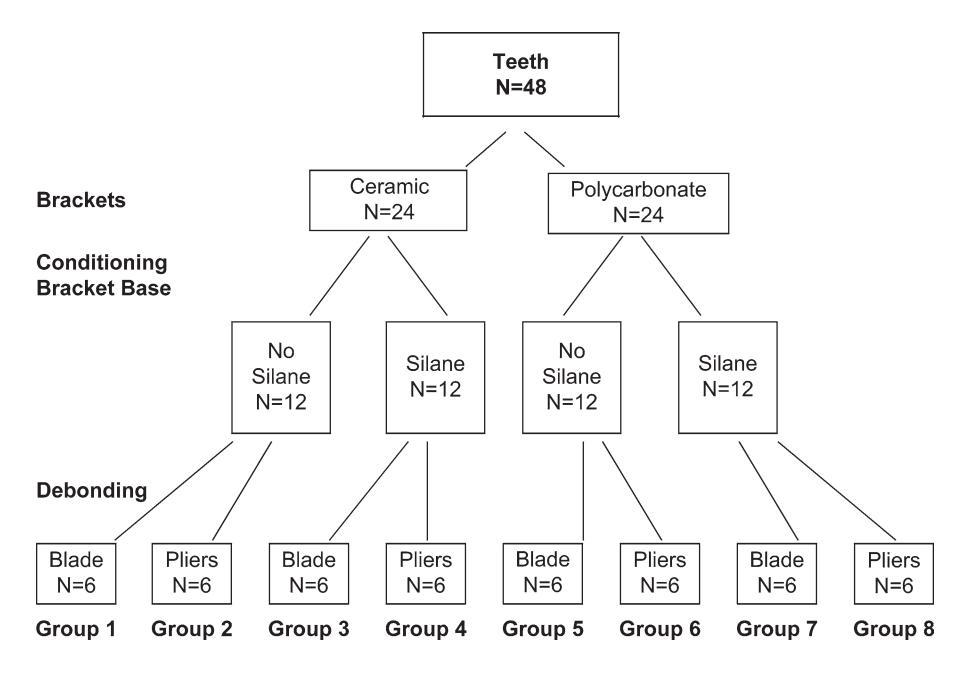
Figure 1 Schematic representation of the experimental groups depending on bracket type, silanization, and debonding technique.

The specimens were randomly divided into eight groups (N = 48, n = 6 per group). Classification of the experimental groups is shown in Figure 1.

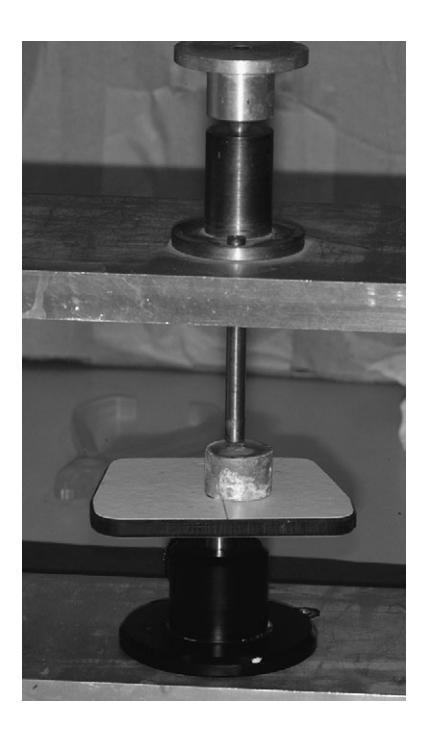
Figure 2 Bonding of the brackets using an alignment apparatus under a constant force of 750 g in order to achieve an even film thickness of the adhesive at the bracket–enamel interface.

In this study, mandibular incisor brackets were used due to their flat bases in order to ensure optimal adaptation to the tooth surface. It should also be noted that when brackets are more curved, there is a possible mismatch between the curvature of the bracket base and tooth surface. This mismatch will affect the stress distribution between the adhesive cement-tooth complex. Water uptake during thermocycling could also be affected depending on the thickness of the adhesive between the bracket base and the enamel surface. For this reason, in order to keep the film thickness standard, adhesion of the brackets was performed under a load of 750 g.

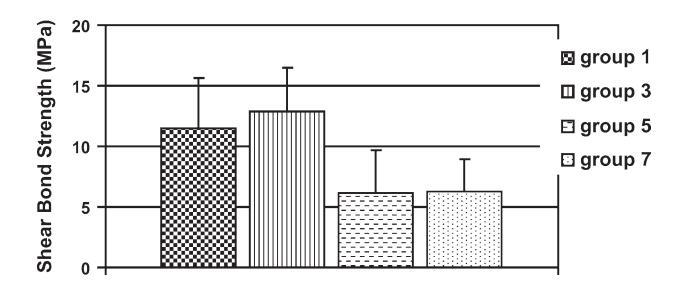
Figure 3 Mean shear bond strengths after thermocycling for the ceramic (groups 1 and 3) and polycarbonate (groups 5 and 7) brackets with and without silanization. Vertical lines represent the standard deviations.

As-received ceramic brackets showed significantly higher SBS values (11.5 ± 4.1 MPa) than polycarbonate brackets (6.3 ± 2.7 MPa; P = 0.0077; ANOVA). Interaction between bracket types and silanization was not significant (P = 0.4408). Silanization did not significantly improve the mean SBS results either for the ceramic or polycarbonate brackets (12.9± 3.7 and 6.3 ± 2.7 MPa, respectively; P = 0.4044; two-way ANOVA, Tukey-Kramer adjustment; Figure 3).

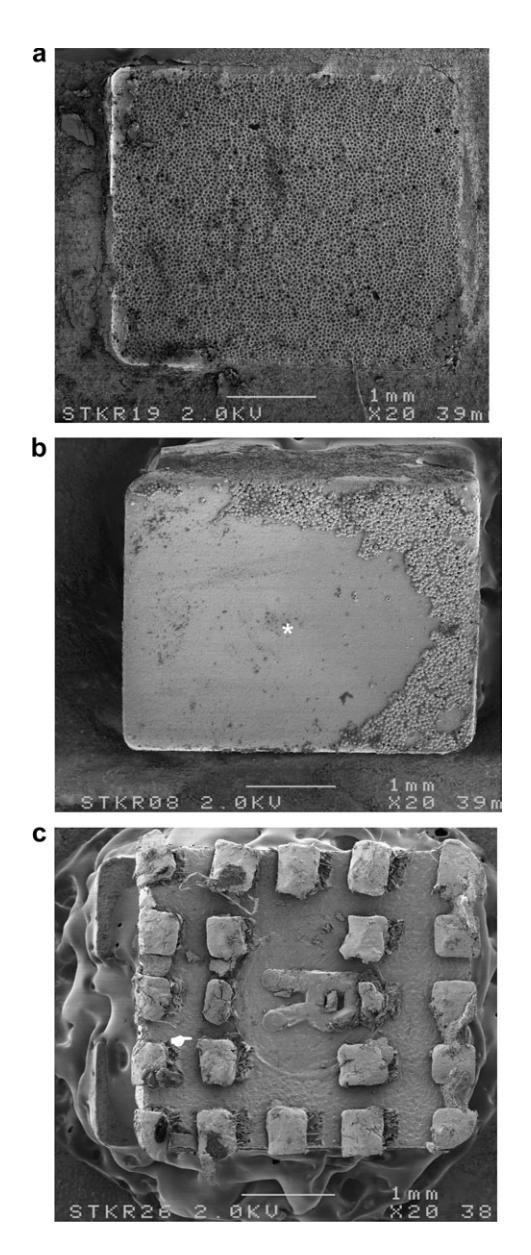
Figure 4 Representative scanning electrone photomicrographs ($\times 20$ original magnification) from (a) the enamel surface following debonding of a silanized ceramic bracket. Note that all adhesive resin is left adhering to the enamel with a distinct impression of the bracket base. (b) The base of the ceramic bracket after debonding. Note that the bracket base is devoid of adhesive resin and the coating is partially removed (*). (c) The base surface of a polycarbonate bracket following debonding with the universal testing machine. Note that the retentive features are distorted (\mathcal{P}).

from the enamel and bracket base surfaces are presented in Figures 4a-c.
