Three-dimensional, non-destructive visualization of vertical root fractures using flat panel volume detector computer tomography: an *ex vivo in vitro* case report

C. Hannig¹, C. Dullin², M. Hülsmann¹ & G. Heidrich²

¹Department of Operative Dentistry, Preventive Dentistry and Periodontology; and ²Department of Diagnostic Radiology, University of Göttingen, Germany

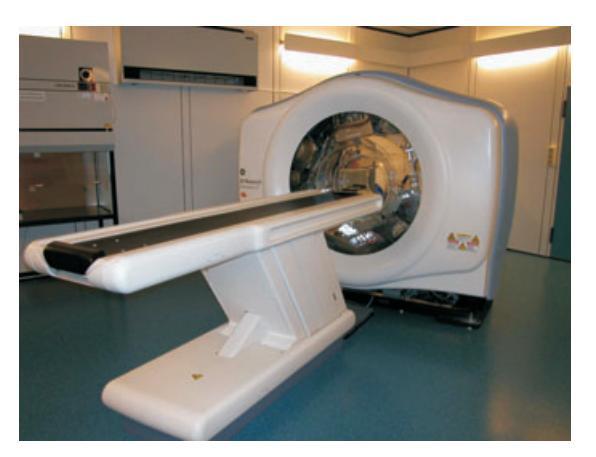
Figure 1 Prototype of the flat panel volume detector computer tomograph system, University of Göttingen, Germany.

Three-dimensional analysis of the extracted teeth was performed with a prototype of a flat panel volume detector CT (General Electric Global Research Centers, Niskayuna, NY, USA). The system allows three-dimensional, high resolution volumetry (Fig. 1). The gantry contains an X-ray tube (Performix 630; GE Medical Systems, New York, NY, USA) and two flat panel detectors. They perform a coupled rotation around a closed centre of rotation. The X-ray tube has a focus of 0.7 mm at a maximal voltage of 140 kV and a current of up to 400 mA. The power is limited to 20 kW. The CT dose index for a 16 cm standard phantom amounts to 0.172 mGy mA⁻¹, which is in the same level compared with commercially available MSCT-systems. Because of the lack of variable collimation of the X-ray in the prototype system, there is presently no permission for clinical use.

Both flat panel detectors are 20.5×20.5 cm. They are arranged at an angle of 120° parallel to the main axis of the system. Both detectors contain a diode-array made of amorphous silicon (a-Si) covered by a layer of thallium doped caesium-iodide for purpose of X-ray absorption. The sensor array is composed of 1024×1024 single elements. The FD-VCT is run as an axial system, all 1024 columns are read out parallel to the main axis of the system. The high density of detector elements allows evaluation of objects at a high isotropic spatial resolution. The pixel-size amounts to $200 \times 200 \ \mu$ m. Because of the

radiographic enlargement of 1.43, the spatial resolution amounts to 140 μ m; 3.6 line-pairs are read out per mm at a high cone-head speed. One scan is performed in about 7 s.

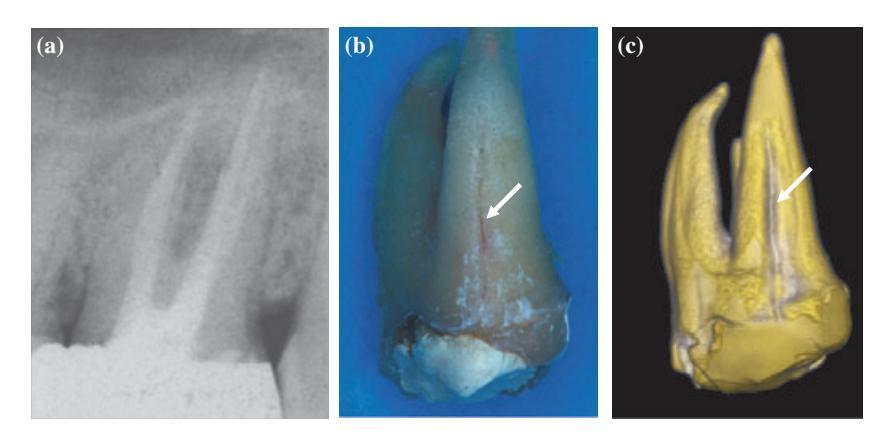
Figure 2 Tooth A: maxillary second molar with vertical hairline crack of the palatal root. The tooth had a fistula on the palatal aspect and a periodontal pocket at the site of the fracture. There was a crack on the palatal root (b) which was illustrated well with flat panel volume detector computer tomograph (c, arrows). No radiographic sign indicated the fracture line before extraction (a).

Five cases were included in this *ex vivo* study. Clinical inspection after extraction of the radiographically well filled teeth yielded root fractures or cracks in all cases (Figs 2b, 3b, 4b, 5b and 6b). Sometimes the cracks were of microscopic size (Figs 2b, 3b and 4b).

In none of the depicted cases was the fracture line detectable on conventional radiographs (Figs 2a, 3a, 4a, 5a and 6a). Separation of the fragments was not observed in any case radiographically. However, in all cases periapical and lateral lesions were detected radiographically, accompanied by clinical signs such as fistulous tracts and isolated periodontal pockets. In one example, the fistulous tract was marked with a guttapercha point (Fig 5a). These findings indicated the presence of a vertical root fracture or crack indirectly in all cases. Hence, surgery was not considered a viable treatment alternative.

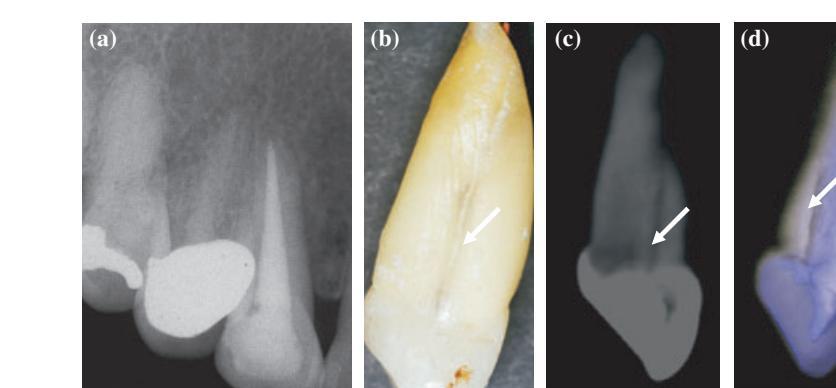
Figure 3 Tooth B: upper canine with vertical crack of the root. The hairline-crack, visible clinically after extraction (b) can be detected in longitudinal section (c) and external overview (d) using the flat panel volume detector computer tomograph (arrows). The crack was not visible in the conventional dental X-ray (a).

In horizontal and vertical cross-sections (Figs 3c, 5f,g and 6d,e), fracture lines were shown clearly despite the artefacts induced by the gutta-percha (Fig. 6e). Using the toothalgorithms developed especially for evaluation of dental hard tissues, the fracture lines were also detectable in a three-dimensional overview of the whole tooth (Figs 2c, 3d, 4c, 5c–e and 6c). Cracks may appear a little bit wider on FD-VCT images because of the semitransparency of the FD-VCT images.

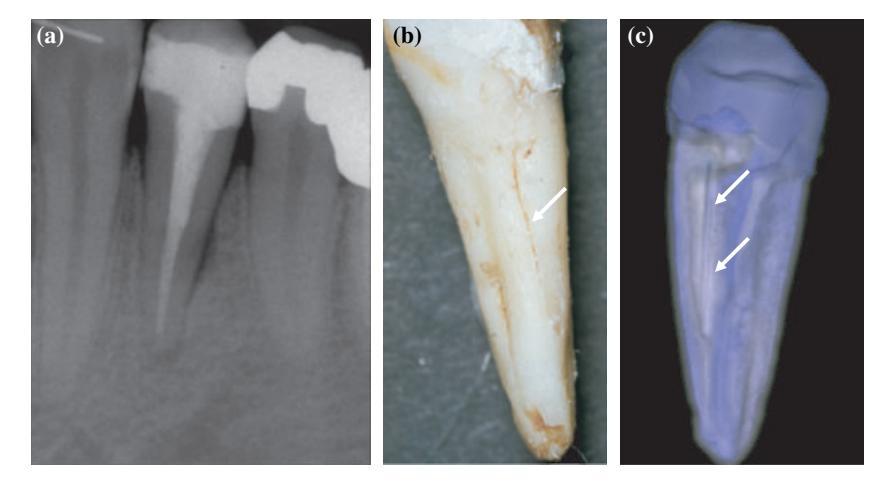
Figure 4 Tooth C: first mandibular premolar. The hairline-crack, visible clinically after extraction (b) can be detected with the flat panel volume detector computer tomograph (c, arrows). Periapical and lateral radiolucent area of bone loss give a clear hint on a vertical root fracture despite the fact that the fracture-line itself is not visible radiographically (a).

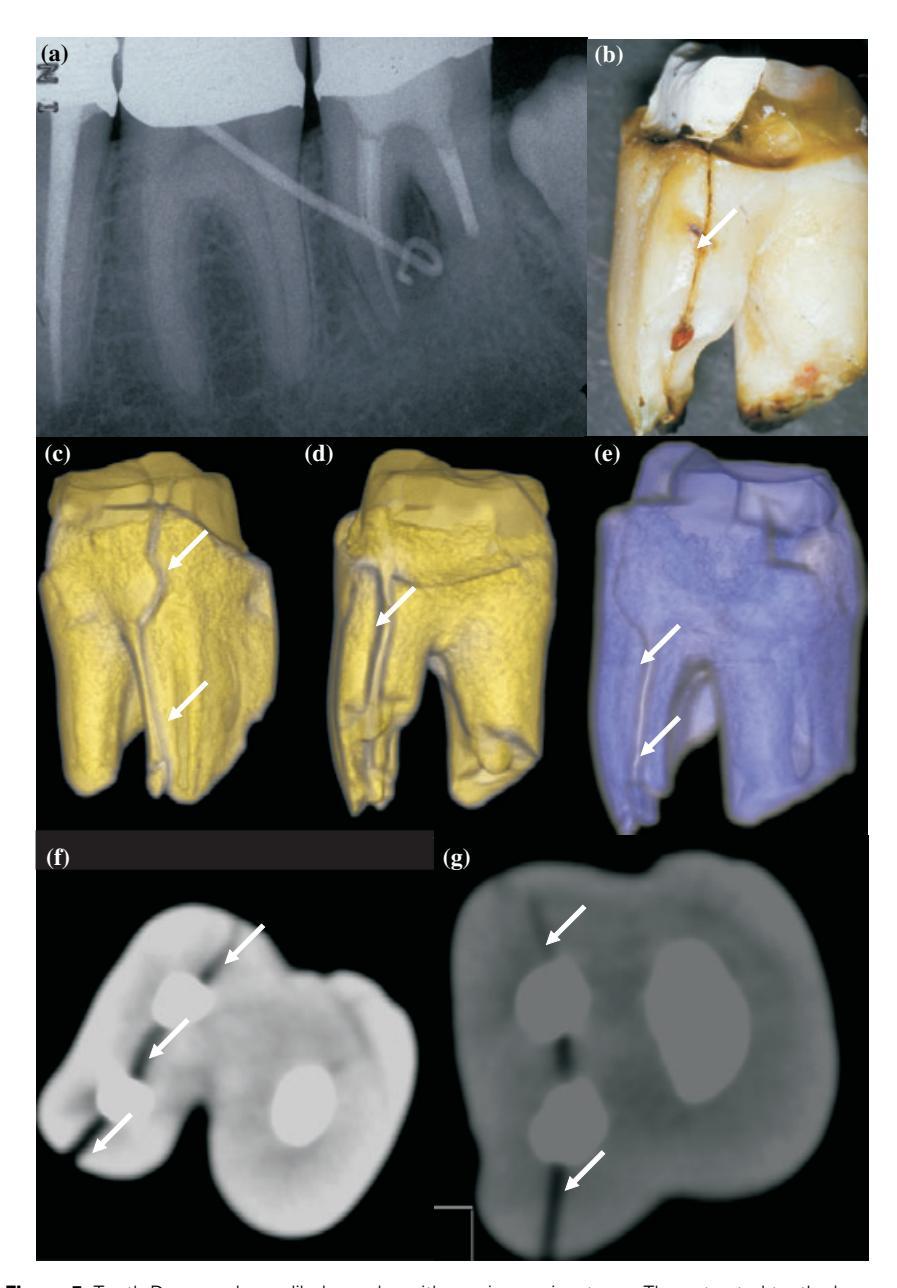
Figure 5 Tooth D: second mandibular molar with previous apicectomy. The extracted tooth shows a fracture of the mesial root (b). Vertical fracture lines are demonstrated clearly by different cross sections (f, g), views and modes (c, d, e) in flat panel volume detector computer tomograph (arrows). Different colours were used (c, d, e) in the special tooth-algorithm for visualization of the fracture line. Dental X-ray (a): furcational radiolucency and a gutta-percha point inside the sinus tract, the fracture line on the mesial root is not evident.

Conventional CT systems in medicine have a resolution of 500 μ m. Their value in the detection of more pronounced vertical root fractures characterized by separation of the adjacent root segments has already been proven (Youssefzadeh *et al.* 1999). Nevertheless, detection of microscopically small hairline cracks was impossible. In that study, there were about one third false negative results, which may be attributed to the low resolution (Youssefzadeh *et al.* 1999). The fracture lines of tooth D evaluated in the present study

would be visible using conventional CT (Youssefzadeh *et al.* 1999), but hairline cracks of the other teeth will not because of the lack of resolution.

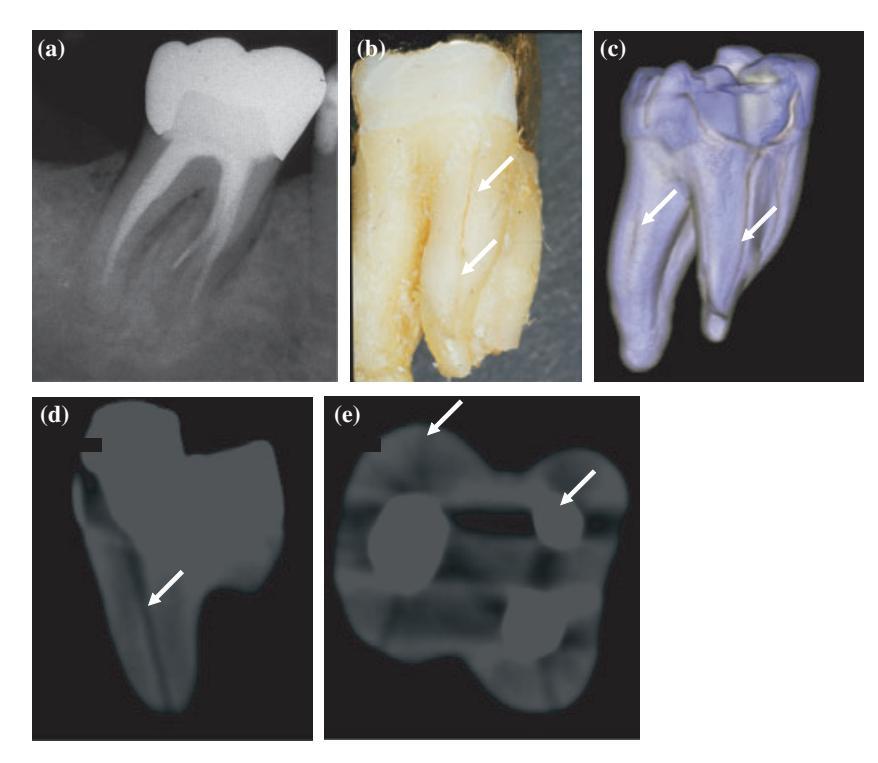
Figure 6 Tooth E: First mandibular molar. (b) Vertical cracks in mesial and distal root. Fracture lines are evident in different cross-sections (d, e), modes (c, d, e) and projections performed with flat panel volume detector computer tomograph (arrows), but not in dental X-ray (a).
