The corrosion of nickel-titanium rotary endodontic instruments in sodium hypochlorite

Nóvoa XR, Martin-Biedma B, Varela-Patiño P, Collazo A, Macías-Luaces A, Cantatore G, Pérez MC, Magán-Muñoz F. The corrosion of nickel-titanium rotary endodontic instruments in sodium hypochlorite. *International Endodontic Journal*, **40**, 36–44, 2007.

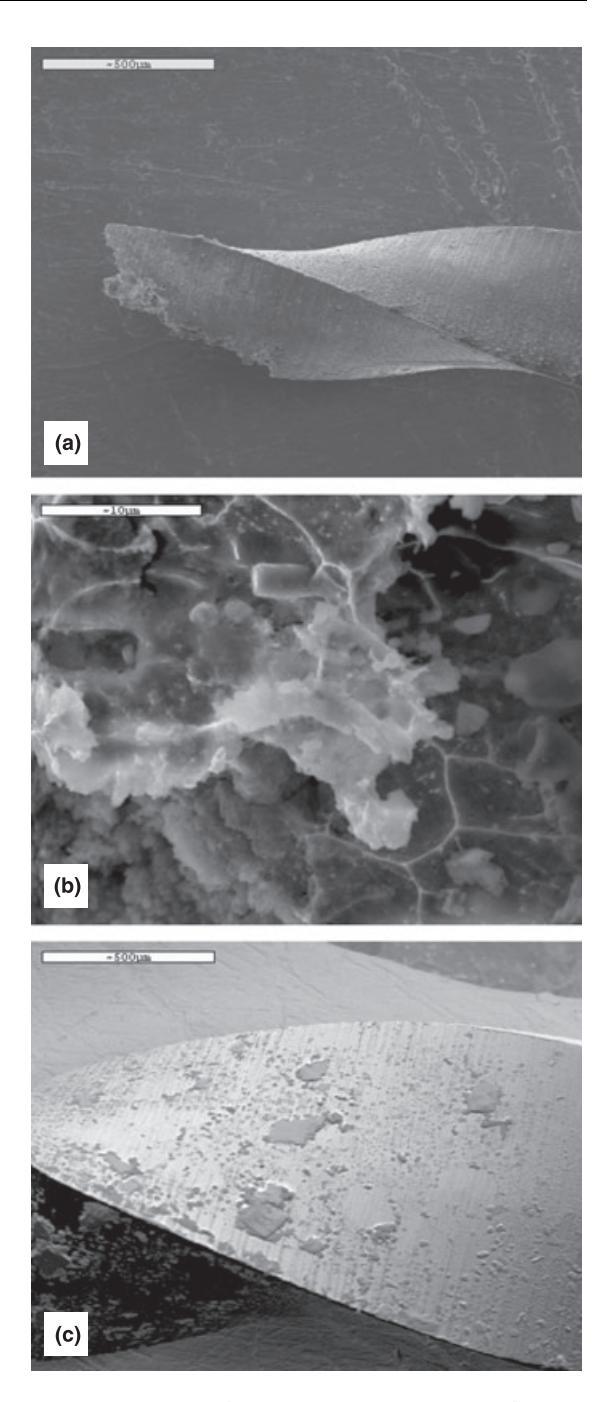
Figure 1 Scanning electron microscope images showing: (a) corroded end of the instrument, (b) detail of the corrosion attack: grain boundaries are visible below NaCl deposits, (c) detail of NaCl deposits outside the corroded area. Instrument immersed in NaOCl 5.25% overnight (about 15 h).

Sodium chloride deposits were identified over the surface of the instruments (see Fig. 1c); hence the cathodic process shall involve Cl⁻ formation. Moreover,

The transients in potential and current observed in Fig. 6a,b should correspond to events of oxide formation (thus surface passivation) and dissolution (activation). Figure 1b is the image of that instability. In summary, the system's instability described in Fig. 3 is because of the poor corrosion behaviour of the NiTi alloy in this solution. The passivating properties of the nickel and titanium oxides in this hypochlorite medium seem to be insufficient to maintain the chemical stability of the alloy.

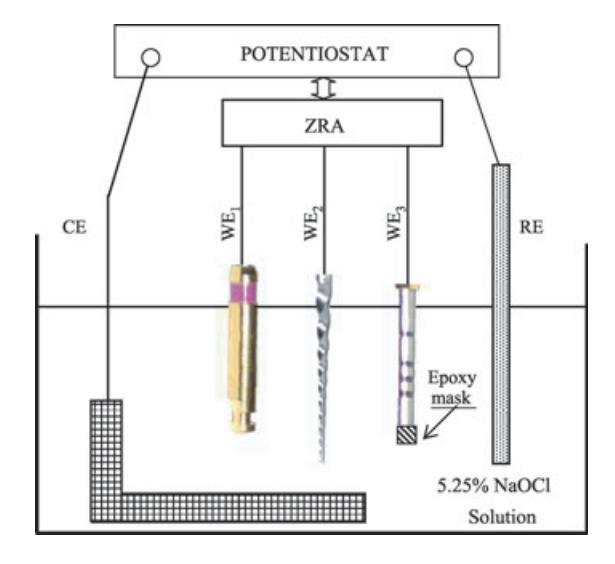
Figure 2 Experimental set-up devised for measuring galvanic currents. The three sections of the tested instrument (working electrodes WE_1 , WE_2 and WE_3) are short-circuited externally through the zero resistance ammeter (ZRA). The potentiostat drives the current through platinum gauze acting as counter electrode (CE), and measures the potential of the galvanic system with respect to the reference electrode (RE). The bottom end of the noncutting section is masked by an epoxy resin in order to avoid contact of the solution with the cross section of the instrument.

to the galvanic currents that circulate between the three parts (Fig. 2).

The measurement of galvanic currents between multiple elements is a well-documented procedure (Nóvoa *et al.* 1987, Alonso *et al.* 1993, 1995, 1998a,b, Collazo *et al.* 1999, Abreu *et al.* 2002) and involves the use of multiple ZRA which are wired to the elements being tested. Figure 2 provides a description of the experimental set-up devised for those measurements.

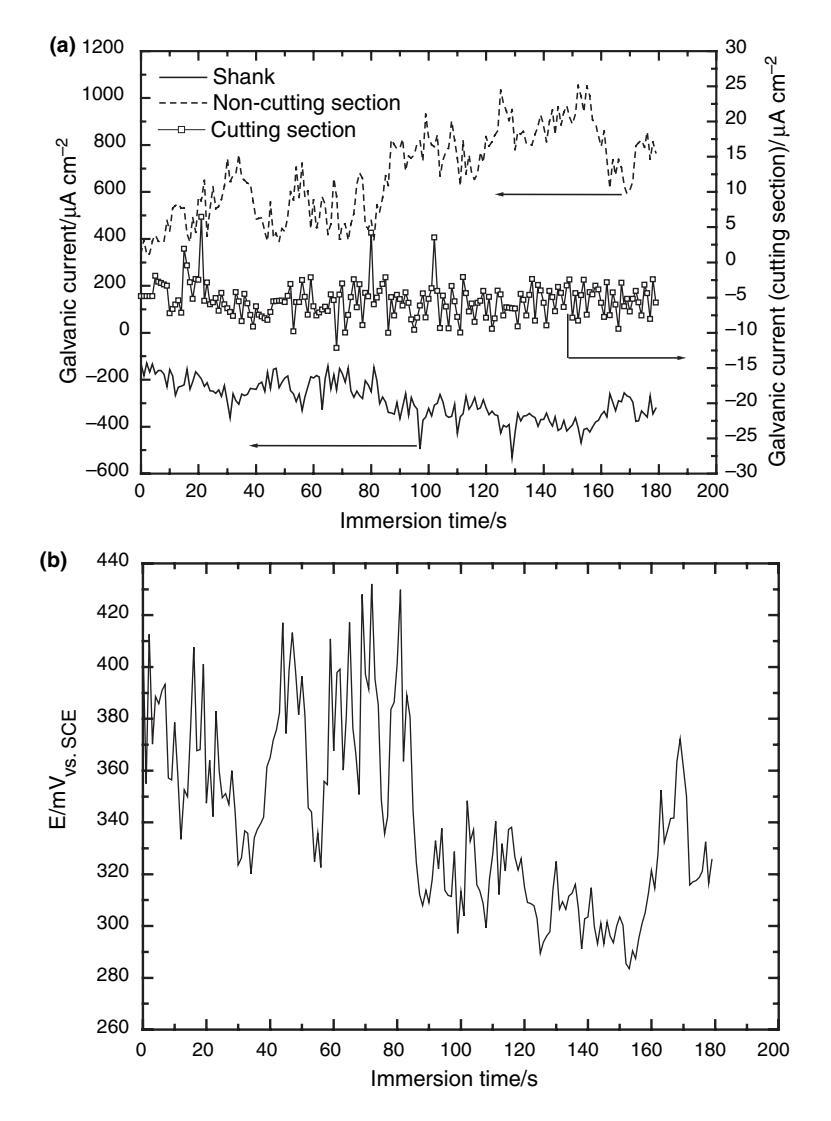
Figure 3 summarizes the initial behaviour of the unused electrodes. The corrosion potential fluctuates between +300 and +400 mV (Fig. 3b), the galvanic current between the instrument body and the shank was high, and the polarity was as expected: the shank (Au) is the cathode (negative current) and the body demonstrated anodic behaviour (positive current) as Fig. 3a shows. The cutting section of the instrument presented unexpected cathodic behaviour, although some discrete anodic periods were observed (at about 20, 80 and 100 s).

Figure 3 Evolution with immersion time of galvanic current densities (a), and corrosion potential (b).

Figure 3 corresponds to a highly unstable galvanic system where the shank behaves in a cathodic manner and the noncutting section in an anodic manner, whilst the cutting section supports a small cathodic current.

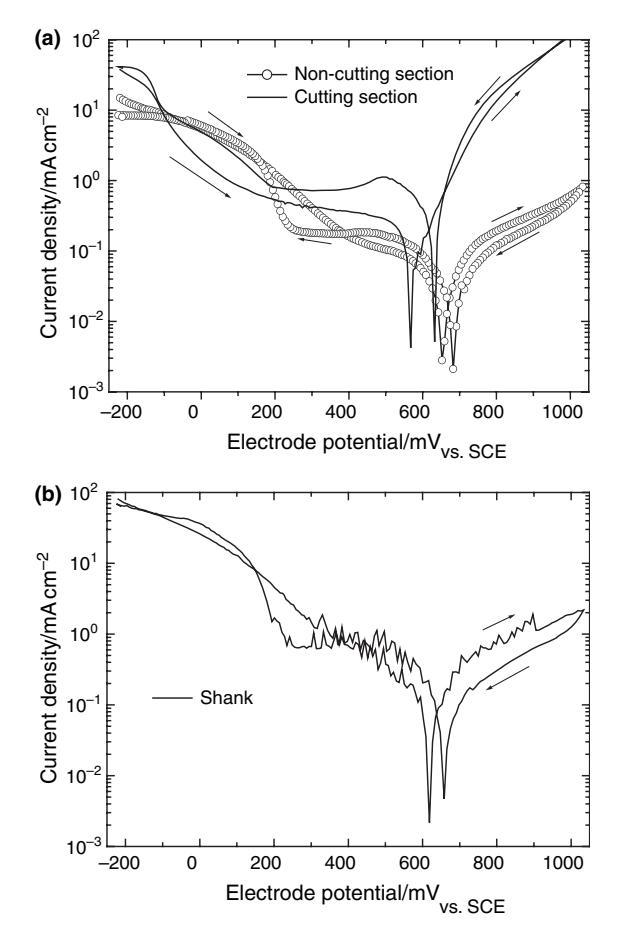
Figure 4a,b correspond to the cyclic voltammograms (from +200 to 1000 mV) performed on the threeelement galvanic system (cutting section, noncutting and shank).

Figure 4 Cyclic voltammetry for the galvanic couple elements. Scan rate was 1 mV s⁻¹. Potential range: from -200 mV to +1000 V (vs. saturated calomel electrode) in 5.25% NaOCl solution.

The processes developing on the three sections of the tested galvanic coupling is given in Fig. 4. The electrochemical potential of the system was scanned from -200 to +1000 mV and back again to -200 mV (cyclic voltammetry). It can be seen in Fig. 4 that whilst the cathodic branch (between -200 and about +600 mV) is similar for the three elements, the anodic current for the cutting section is about two orders of magnitude higher, which indicates higher activity, probably due to accumulated mechanical stress.

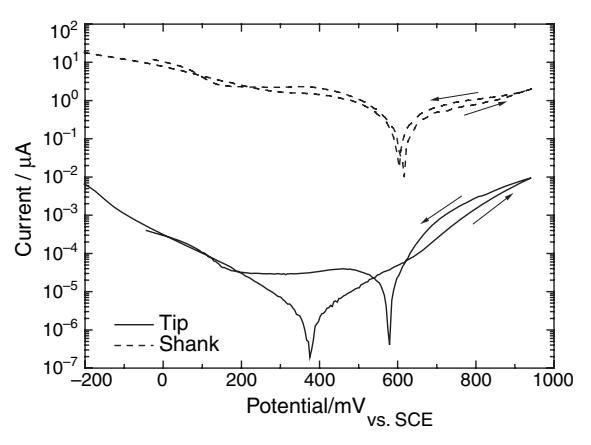
The behaviour of the most active (tip of cutting section) and most noble (shank) parts of the instrument is presented in Fig. 5, where substantial current values were recorded. At the end of this polarization, galvanic

Figure 5 Cyclic voltammetry for the galvanic couple rotary instrument tip + shank. Scan rate 1 mV s⁻¹. Potential range: from -200 mV to +1000 V in 5.25% NaOCl solution. The estimated active surface of the rotary instrument tip is (S = 0.005 cm^2).

The limiting behaviour of the galvanic system is analysed in Fig. 5. The good reversibility of the redox process developing on the gold surface can be seen in Fig. 5 because of the lack of hystereses between the forward and reverse curves. Nevertheless, the accumulation of corrosion products at the arrow makes the zero current potential to shift anodically by about 200 mV in the reverse curve (about +600 mV abscissa) with respect to the forward one (about +400 mV abscissa). The situation is typical for the formation of higher valence oxides, as occurs for iron oxides (Andrade *et al.* 1995, 2001, Alonso *et al.* 1998b).

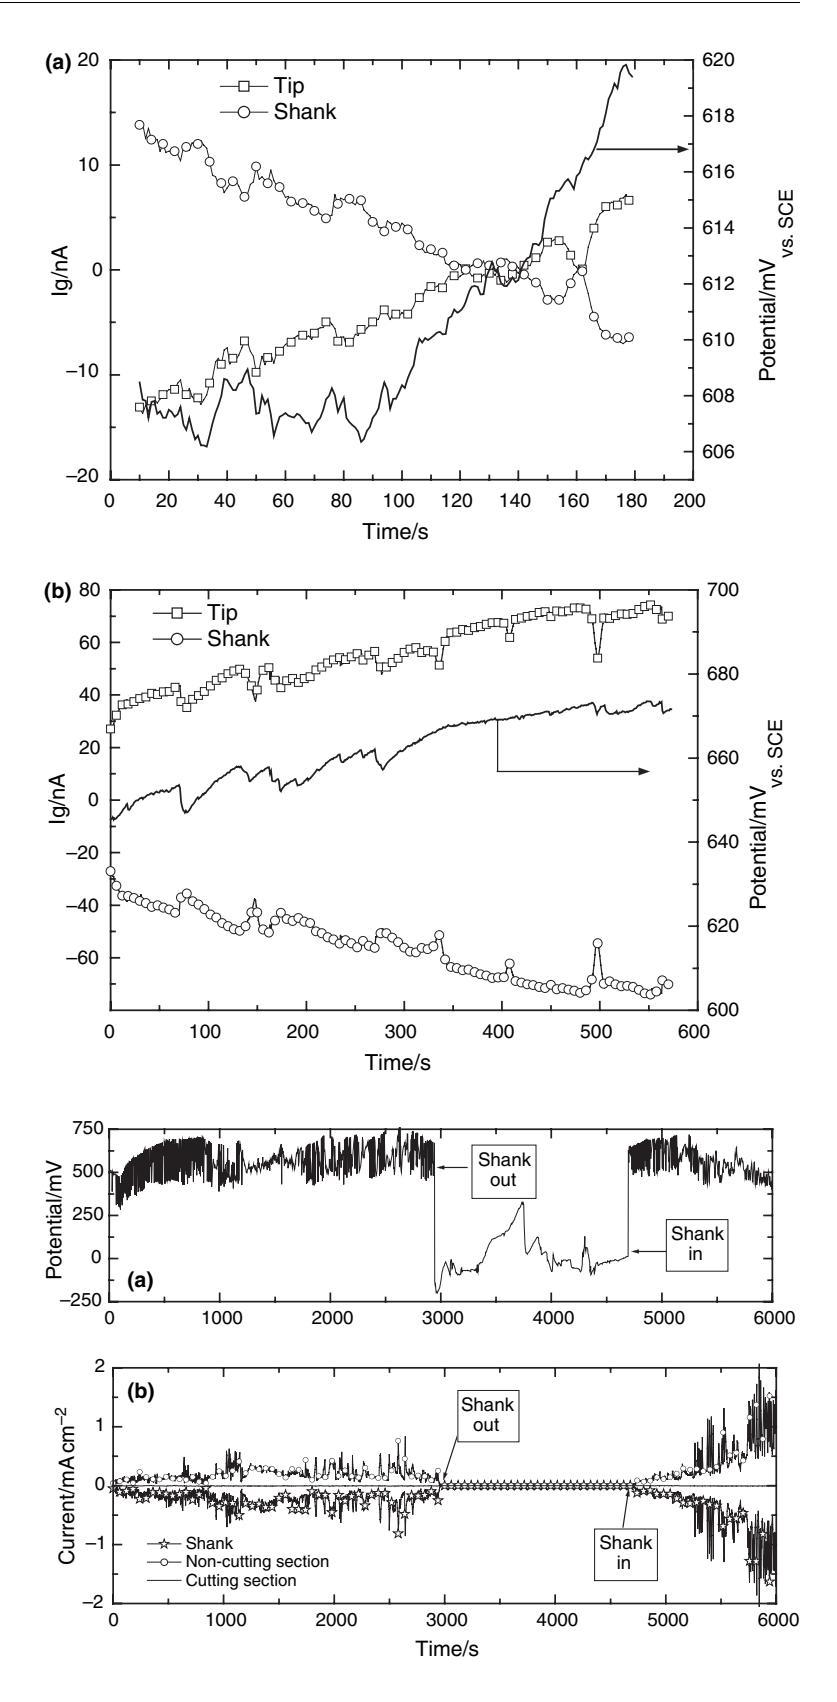
measurements were performed again in order to analyse the reactivity of the newly formed surfaces. The results are given in Fig. 6 where it can be seen that, initially, the tip behaved as a cathode with respect to the shank. Nevertheless, after 140 s the shank became more noble and the situation persisted over time, as shown in Fig. 6b.

Figure 6 Galvanic currents and corrosion potential for the galvanic couple rotary instrument tip + shank. (a) Immediately after cyclic voltammetry. (b) 10 min later.

Figure 7 Corrosion potential, E_{corr} (b) and galvanic current (a) for the studied system in pH 10.1 solution.

The behaviour of the samples was also investigated when immersed in a solution of lower pH. Figure 7 corresponds to the galvanic test performed in the pH 10.1 solution with and without the shank galvanically coupled to the system. In Fig. 8 the evolution of the corrosion potential, E_{corr} , with immersion time for the galvanic system (cutting section, noncutting and shank) in pH 10.1 and pH 12.3 solutions, are compared.

surface passivation, i.e. the surface becomes less reactive. In order to verify this hypothesis, galvanic measurements were performed after polarization. The results are given in Fig. 6 where it can be seen that, initially, the tip exhibited cathodic behaviour with respect to the shank. Thus, the electrochemically formed oxide ennobles the tip. Nevertheless, these oxides were not stable and dissolved, so that after 140 s the shank became more noble again. The corrosion potential increases as the shank becomes more cathodic, probably due to its higher active surface available for Cl_2 and ClO^- reduction.

The corrosion potential depicted in Fig. 7 (galvanic test performed at pH 10.1) is more anodic than that depicted in Fig. 3 (galvanic test performed at pH 12.3), which confirms the previous hypothesis concerning to oxidizing power of the solution. Moreover, potential fluctuations occur at higher frequency levels and no visible damage is observed neither on the shank, nor on the cutting section, although the measured current was high. Thus, probably most current from the anodic areas (noncutting section) is because of water oxidation (Equation 4) and current at cathodic areas from Cl_2 (Equation 3) and ClO^- (Equation 2) reduction, the latter one being highly favoured on gold (Xia & Kelly 2001).

When the gold shank is electrically isolated ('shank out' in Fig. 7), the galvanic current falls to the small value existing between the cutting and noncutting sections whilst the potential decreases by 0.5 V. The

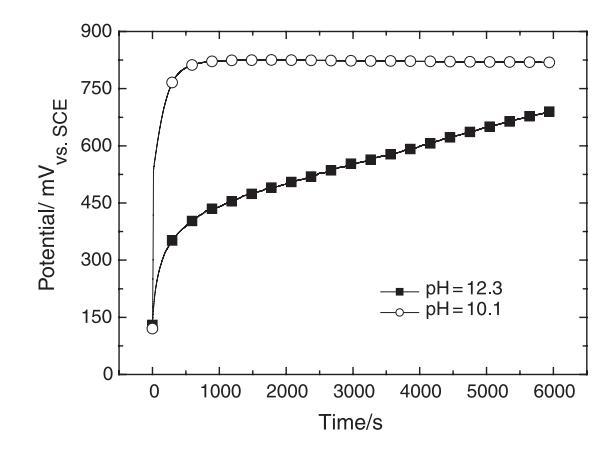
Figure 8 Corrosion potential evolution with immersion time (6000 s) of the rotary instrument (shank not immersed) in both test solutions: pH = 12.3 (5.25% NaOCl solution) and pH = 10.1 (NaOCl solution neutralized with H₂SO₄).

The passivation rate of the NiTi alloy in both solutions (pH 12.3 and 10.1) is compared in Fig. 8, which shows the evolution of E_{corr} with immersion time. It can be seen that at pH 10.1 the alloy reaches its passive state in about 20 s, and after that the potential remains steady indicating stable passivation. Nevertheless, at pH 12.3, a steady state is not reached even after 6000 s, which proves that the alloy is not stable in this medium.

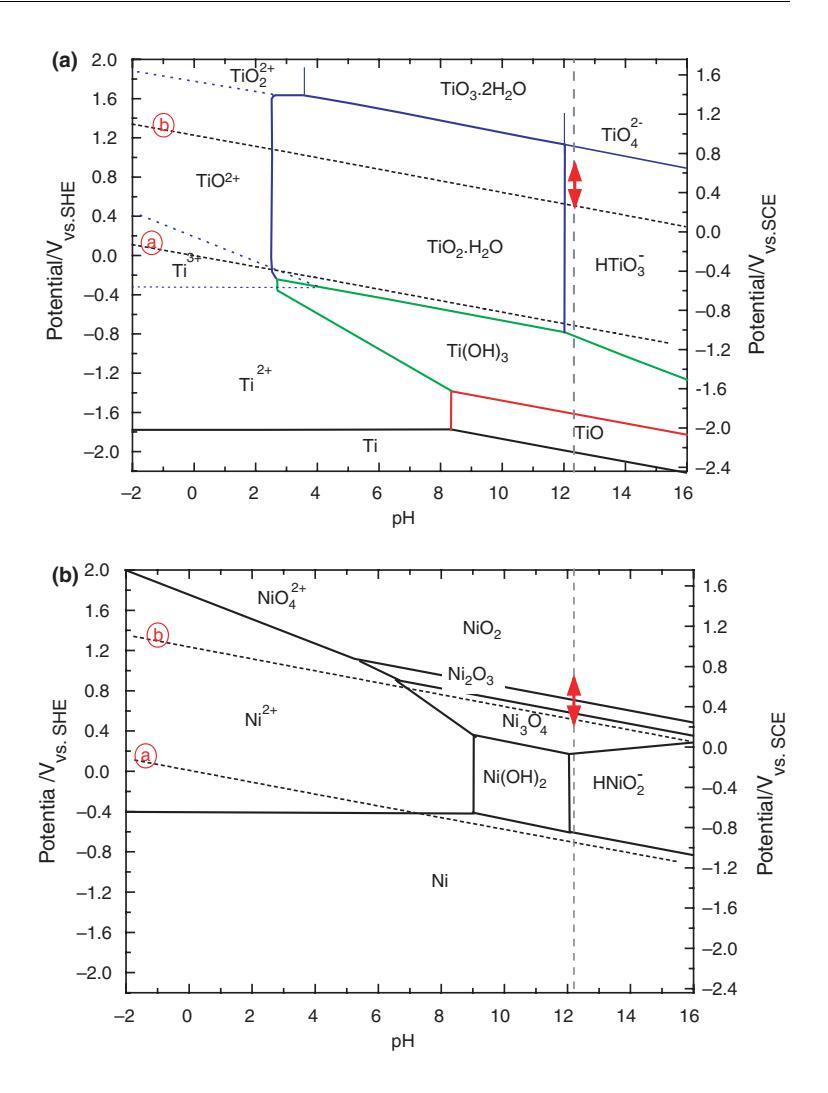
Figure 9 Pourbaix diagrams for titanium (a) and nickel (b), showing the domain of existence (pH and potential) of the studied system. The thick double arrows represent the range of corrosion potentials, E_{corr} , measured.

Figure 9 illustrates the situation from the thermodynamic perspective. The oxidizing power of the environment (due to the oxidants present, ClO^- and Cl_2) shifts the corrosion potential in the anodic direction to values depicted in Figs 3 and 6. That potential range is depicted in Fig. 9a,b as a double arrow located on the pH 12.3 vertical dotted line. The E_{corr} potential range is located above line (b) in the diagram. This line is the equilibrium line for water oxidation (Equation 4). Thus, oxygen evolution will take place along with alloy corrosion. Figure 9b demonstrates also that the measured potential range comprises several nickel oxide phases: from the reduced form Ni_3O_4 , to the highest oxidation state NiO_2 and, in between, the Ni_2O_3 form. All those valence changes involve:

Moreover, Fig. 9a shows that at pH 12.3 the possible TiO_2 passive film is not stable and tends to dissolve chemically as HTiO_3^- for pH > 12. These results show that the alloy does not reach a stable passive state because of chemical (pH) or electrochemical (redox potential) factors. One possible mechanism to overcome these effects is lowering the solution's pH in order to:

2. Give chemical stability to Ni oxides in the passive film. Lowering pH will shift the equilibrium in Equation 2 towards Cl_2 production, which, according to Equation 3 will increase the electrolyte's oxidizing power and thus E_{corr} will be shifted towards the NiO₂ stability domain, as depicted in Fig. 9b.
