Short Communication

Fatigue Resistance of Restored Endodontically Treated Teeth: A Multiparametric Analysis

Paolo Baldissara, DDS^a/Valerio Di Grazia, DDS^b/Anna Palano, DDS^b/Leonardo Ciocca, DDS^c

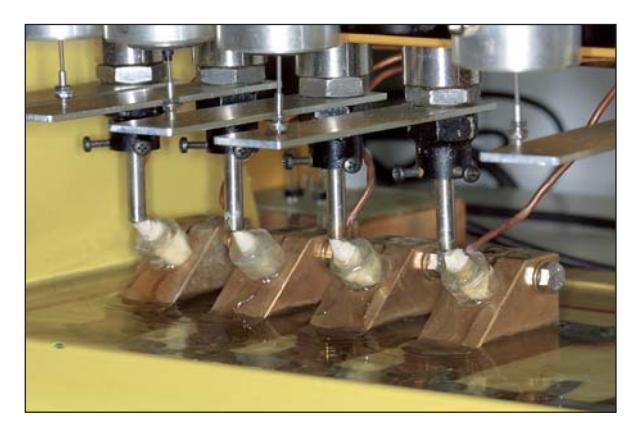
Fig 1 Specimens under cycling loading in wet conditions.

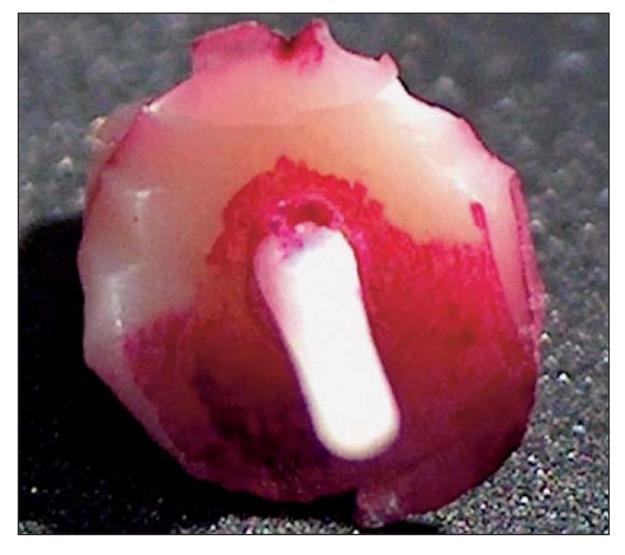
Fig 2 Microleakage pattern at the composite core/dentin interface (DT Light-Post). The highest dye penetration was most commonly observed on the tensile-stressed interface (left side).

Thirty-five single-rooted human teeth were severed at the cementoenamel junction. Their dimensional variations of root length and buccolingual and mesiodistal diameters were within \pm 15% of mean values. Following endodontic treatment, the teeth were subdivided into 5 groups (Table 1). Each post was inserted 10 mm into the canal. The composite core was made using standardized transparent shells. The cast metal post space was shaped with Largo burs and finished using a Batt bur (maximum diameter of 1.8 mm [Dentsply-Maillefer]). The metal posts were air-abraded and passively luted with Fuji Plus cement (GC). Three parameters were evaluated: number of fatigue cycles to failure, ultimate fracture strength, and dye penetration. Two million 100-N fatigue cycles were applied at a 45degree angulation in 37°C water (Fig 1). After the cycling, the specimens were soaked in 0.5% fuchsin for 24 hours. Subsequently, they were loaded with the Instron machine (Instron, Model 6021) until complete fracture occurred. The fractured surfaces were observed under a stereomicroscope to evaluate the dye penetration (Figs 2 and 3). The data obtained were analyzed using the Kruskal-Wallis test.

All the specimens showed high values of microleakage (Figs 2 and 3), mainly on the tensile areas of the dentin/core interface (P > .1).

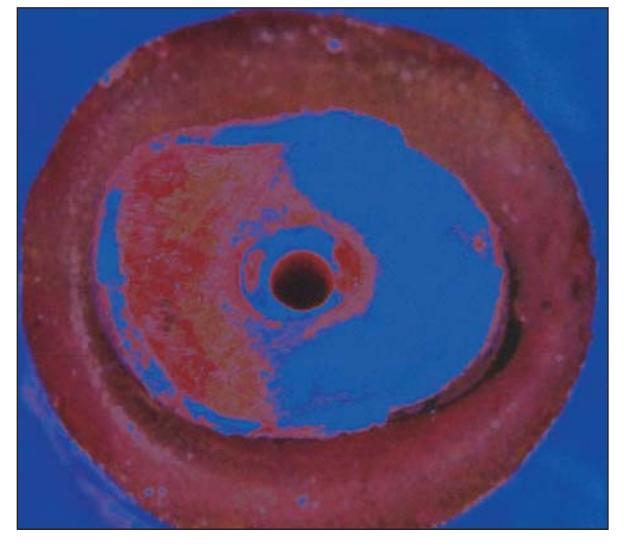
Fig 3 Dentin view of the same specimen shown in Fig 2. Note that on the compression-stressed surface, no leakage occurred. Dye penetration was evaluated in its circumferential and centripetal extension on an ordinal scale.
