# Short Communication

# **Prospective Clinical Trial of Polyethylene Fiber Ribbon–Reinforced, Resin Composite Post-Core Buildup Restorations**

The aim of this prospective clinical trial was to determine the outcome of polyethylene fiber ribbon–reinforced, resin composite post-and-core restorations used as endodontic buildups to support all-ceramic crowns. A total of 42 teeth (31 anterior, 11 posterior) with a mean follow-up time of 35.85 months (range, 10 to 73 months) were treated with 3-mm-wide polyethylene fiber ribbon–reinforced resin composite as post-and-core material. The posts and cores were assessed by clinical and radiographic examination. During the evaluation period, only 1 dentin-cement failure was observed as a post dislodgement after 11 months of clinical service. Performance of polyethylene fiber ribbon post and resin composite core foundation restorations provided clinically satisfactory support for all-ceramic crowns. *Int J Prosthodont 2007;20:55–56.*

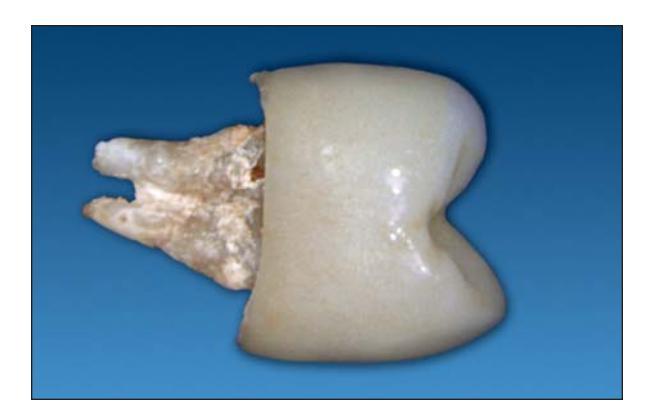
Fig 1 Restoration that debonded after 11 months in service.

<sup>†</sup>One patient experienced dentin-cement failure as a result of debonding of the post after 11 months in service.

The distribution of the types of teeth treated is shown in Table 1. The duration of service of the polyethylene fiber ribbon-reinforced resin composite post-and-core restorations varied from 10 to 73 months (Table 2). During the follow-up period, only 1 dentin-cement failure was observed as a post dislodgement after 11 months of clinical use (Fig 1). No caries and no pathologic changes were seen in the other treated teeth.
