# Repairing a Preveneered Stainless Steel Crown with Two Different Materials

**Purpose:** The objective of this study was to determine the in vitro shear bond strength of 2 different repair materials for anterior preveneered stainless steel crowns (SSCs) after bond failure in the prefabricated veneers.

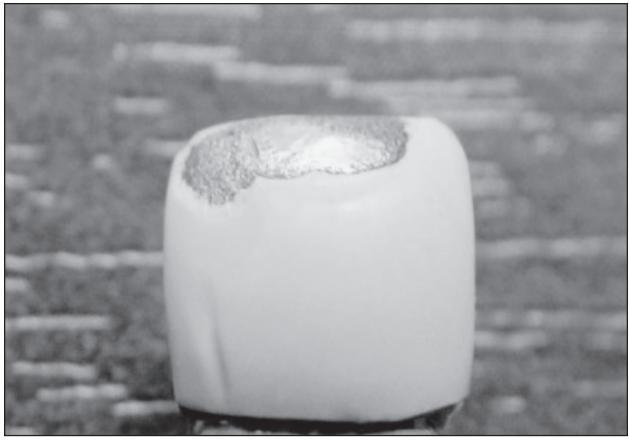
Figure 1. Original crown's facing's failure.

When the failure point of the veneer was reached, the data were recorded in newtons (N). The fractured test specimens were photographed under ×10 magnification with a stereo microscope (Nicon SMZ-U multi-point-sensor system, Japan; Figure 1). Characterizations of the bond failure of the veneer material were scored (adhesive failure at the steel/resin interface), cohesive failure (within the facing material), or adhesive/ cohesive failure (mixed).

In this study, failures of the NuSmile veneer material all displayed mixed, adhesive/cohesive failure. The veneer material separated from alumina blasted stainless steel base was characterized by a spalling. The observed failure modes were in agreement with previous studies.<sup>9,10</sup>

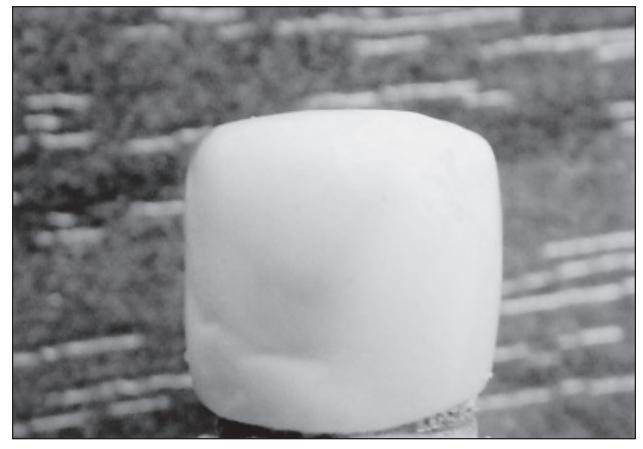
Figure 2. Crown repaired using Tetric Flow.

Major Resin was more successful than Tetric Flow in masking the base metal color (Figures 2 and 3).

Major Resin had self-hardening liquid opaquers with a high sealing power. An Opaquer-Major Resin combination may be presented as an excellent esthetic (Figure 3). Tetric Flow does not have an opaquer system. The assortment of Tetric Flow contains Dentin Shade A3.5, however, which, approximately 4 years ago used to be referred to by the manufacturer as opaque. In spite of its outstanding high bonding strength, the masking capability of the opaque resin's metal color is questionable (Figure 2).

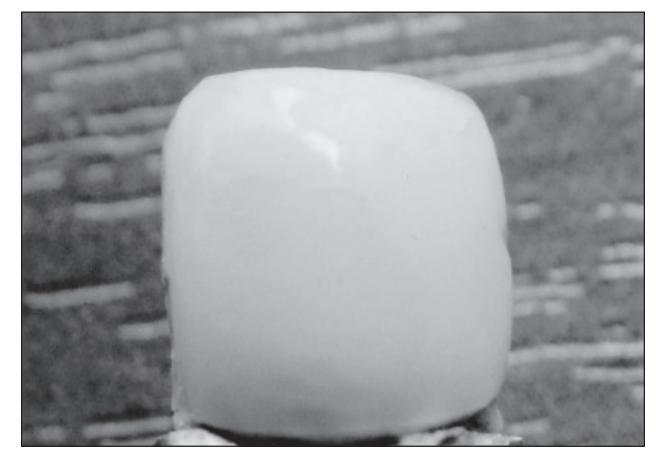
Figure 3. Crown repaired with Major Resin.
