Mechanical Failure of an Implant-Retained Bar: A Clinical Report

This clinical report describes the mechanical failure of an implant-retained bar where the bar fractured midway between two implants. The location of the fracture is not typical for implant-retained bars. Possible causes of the fracture are discussed. The prosthodontic treatment provided to manage the mechanical failure and prevent it from recurring is also discussed.

J Prosthodont 2004;13:184-186. Copyright © 2004 by The American College of Prosthodontists.

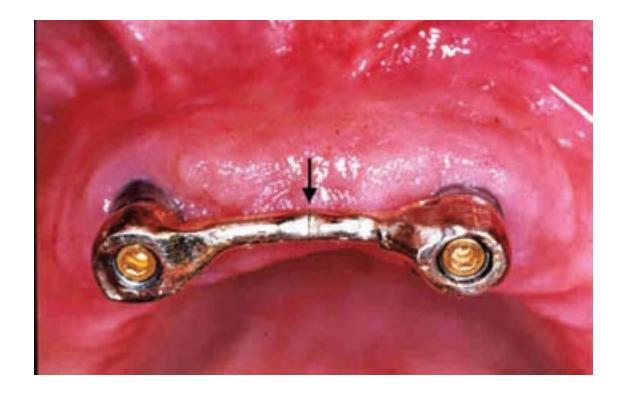
A 56-year-old Caucasian female presented with the following chief complaint: "My denture is becoming loose; it has been a year, and I want the clip changed." Upon examination, the patient presented with a maxillary overdenture supported by a two-implant-retained bar, opposing a mandibular fixed detachable prosthesis. The maxillary overdenture was retained on the bar using a nylon clip (Sterngold, Attleboro, MA). Further examination of the implant-retained bar revealed a midline fracture (Fig 1).

Figure 1. Implant bar fractured midway between the implants (arrow showing the fracture line and wear facets).

Type III gold has a high yield strength (40,000 psi). With this patient, one would expect the fracture to occur at the solder joint,⁸ not in the middle of the bar. Further examination of the fracture site using magnification and radiographs showed no presence of voids that could weaken the bar and explain the fracture. The presence of a wear facet on the bar supports the notion that the fracture was caused by an occlusal overload

To prevent recurrence, a ceramo-metal (Classic 4, Jensen Industries Incorporated, CT) with higher yield strength ($\approx 50,000$ psi) was used to fabricate the new implant-retained bar (Fig 3). This is significantly higher than the yield strength $(\approx 40,000 \text{ psi})$ provided by Type III gold. The occlusal overload caused by nocturnal parafunctional habits can also be minimized with the use of an occlusal device.9 The occlusal device covered the implant-retained bar and extended to fully cover the edentulous maxillary arch. The occlusion was adjusted to provide the patient with simultaneous contact in centric occlusion and protrusive and laterotrusive movements. The patient was instructed to wear the occlusal device over the bar at night after removing her maxillary implantretained overdenture, to prevent occlusal trauma from nocturnal parafunctional habits, and to avoid direct contact between the mandibular-fixed detachable prosthesis and the implant-retained bar.

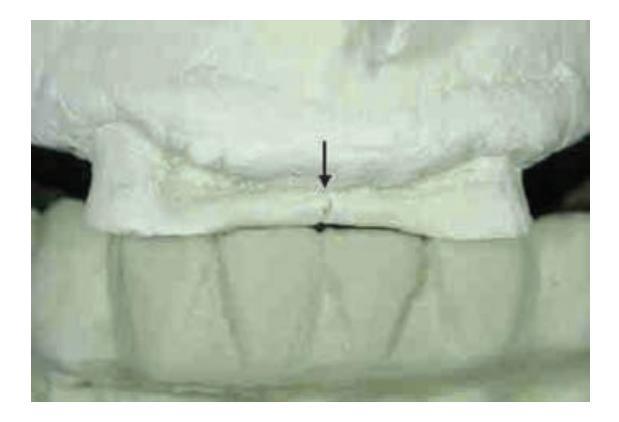
A review of the patient's record showed that the bar was fabricated from Type III Gold (Firmilay, Jelenko, Heraeus Kulzer, Inc., Armonk, NY) and was soldered at the junction of the bar and the abutment away from the fracture line. A wear facet directly related to the area of the fracture was observed. The patient reported removing her maxillary over-denture when she sleeps at night. When the patient was asked to occlude against the bar, the mandibular fixed detachable prosthesis occluded on the bar (Fig 2). The patient revealed a history of parafunctional habits.

Figure 2. Articulated casts of the fractured implant bar in occlusion with the opposing mandibular prosthesis (arrow indicating the fracture line).

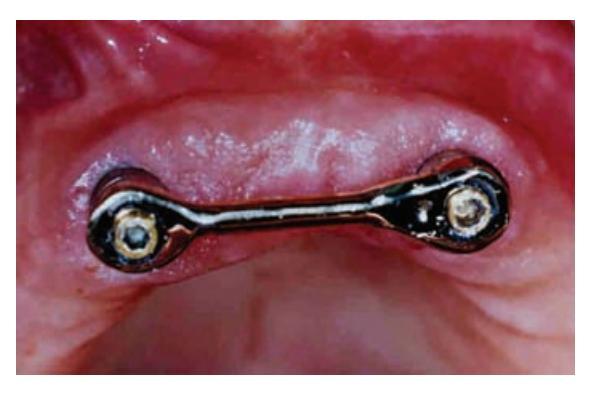
Figure 3. New implant-retained bar.
