The comparison of the effects of three types of piezoelectric ultrasonic tips and air polishing system on the filling materials: an *in vitro* study

Int J Dent Hygiene 5, 2007; 205–210
Arabaci T, Çiçek Y, Özgöz M, Çanakçı V, Çanakçı CF, Eltas A. The comparison of the effects of three types of piezoelectric ultrasonic tips and air polishing system on the filling materials: an *in vitro* study.

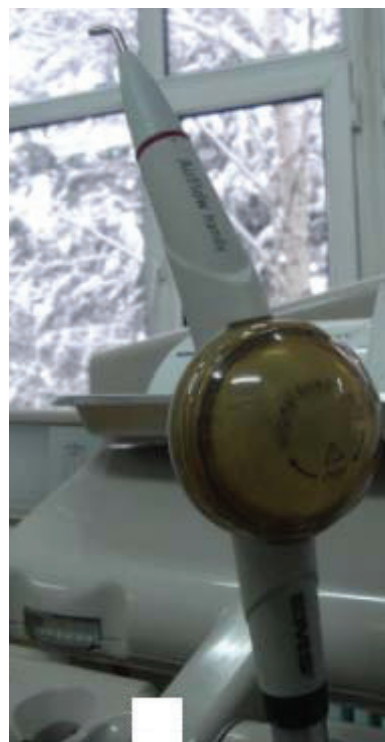
Fig. 2. Air-abrasive device (Air flow handy).

This study was performed on amalgam, composite and porcelain restoration samples. The restorations were prepared at standard conditions and were instrumented with three types of piezoelectric ultrasonic tips (Instrument A, PS and PI) (Fig. 1) and an air polishing unit (Fig. 2). Then the instrumented surfaces were examined under stereomicroscope and the roughness values were measured with a profilometer (Mitutoyo SJ: 301, Kanagawa, Japan).

This study was performed by using an EMS mini piezon piezoelectric ultrasonic scaling unit (EMS CORP. USA, Greenville Ave.) and an air-abrasive unit (Air Flow handy; EMS, Nyon, Switzerland). Three types of piezoelectric ultrasonic tips were used. The piezoelectric instruments were Instrument Tip A, PS and PI (Electro Medical Systems, Nyon, Switzerland).

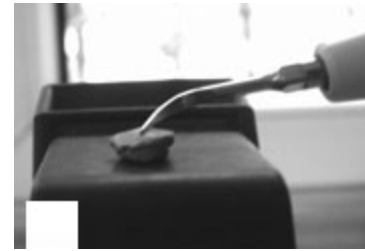
Fig. 3. Application of the ultrasonic tip on the samples.

Each filling material samples was instrumented with each tip (Instrument A, PS and PI) under standard conditions (medium power setting, 0° angulation and standard lateral force) (Fig. 3) and air abrasion was applied at 20 psi with prophylaxis powder for 2 s (size <100 µm; Ch-1260, Nyon, Switzerland).
