Hugh Devlin

Operative Dentistry

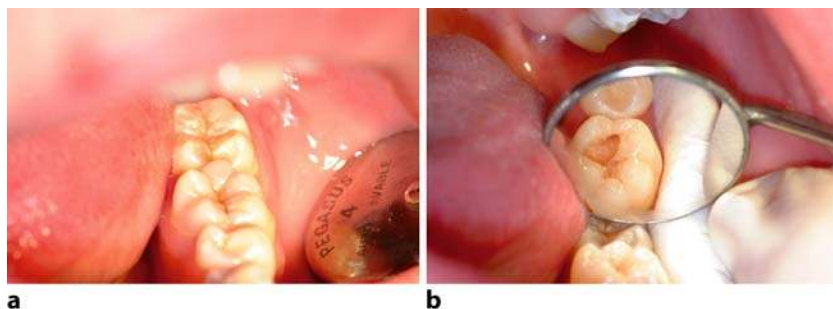
Fig. 1.1 (a) Caries is one of the most difficult diseases to diagnose. (b) Deep dental caries beneath an intact enamel surface can often be invisible to the examining dentist

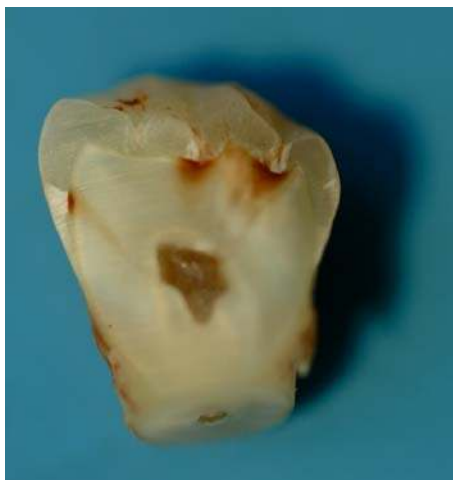
Fig. 1.2 Caries undermines enamel by spreading laterally along the dentinoenamel junction, resulting in a cone-shape dentinal lesion

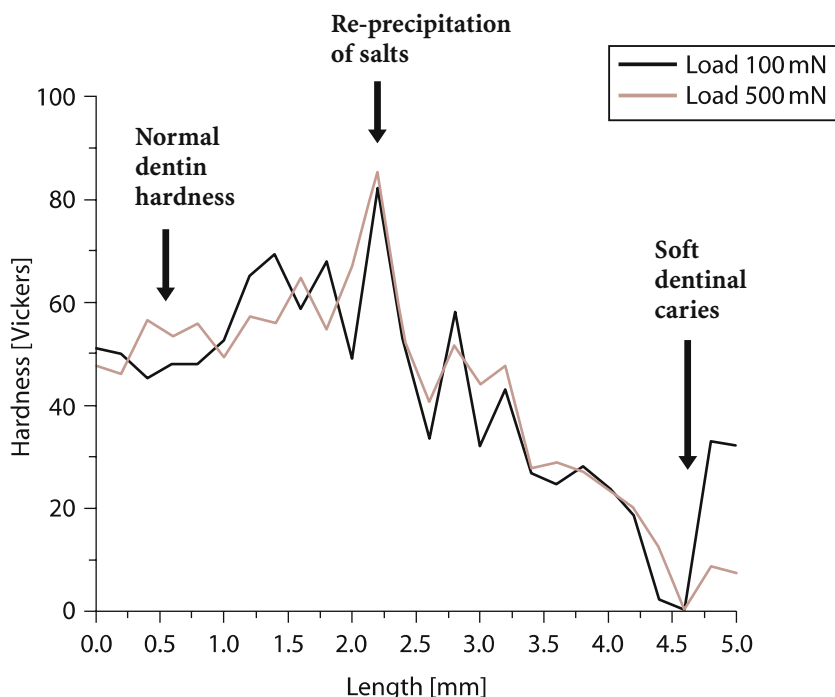
Fig. 1.3 Hardness measurements recorded at intervals from the carious surface to the normal unaffected dentin. Moving away from the softened carious dentin, there is a gradual increase in hardness, so that at 2 mm hardness has returned to that of normal dentin

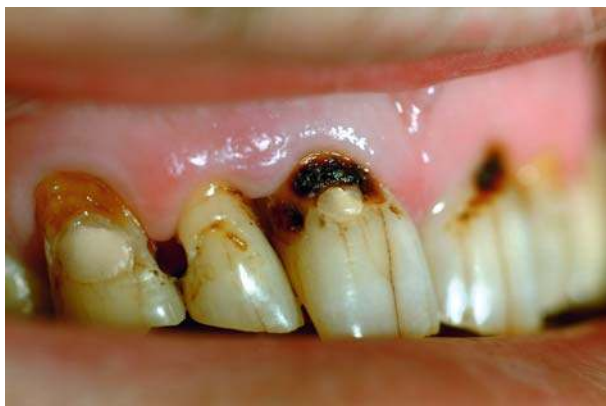
Fig. 1.4 In the elderly, there is an increased incidence of carious lesions affecting the cervical margins. This may result from multifactorial causes such as a change in diet, sugary medicines, declining health, xerostomia, and gingival recession

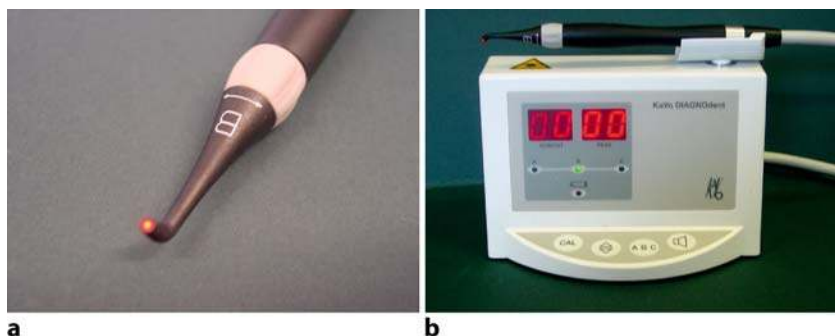
Fig. 1.5 (a) The DIAGNOdent probe emits a red light, which is shone onto the tooth. (b) DIAGNOdent: The emitted fluorescence from the tooth surface changes with tooth demineralization

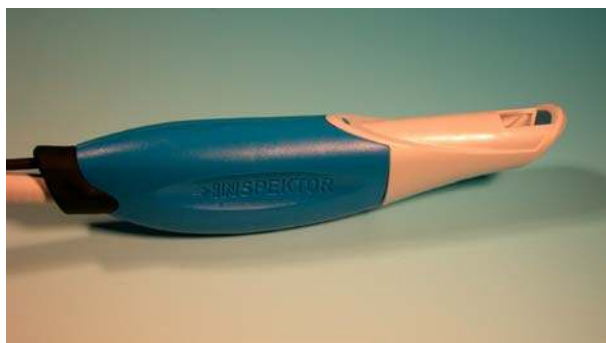
Fig. 1.6 The quantitative light-induced fluorescence system (QLF system, Inspektor Research Systems, Amsterdam, The Netherlands)

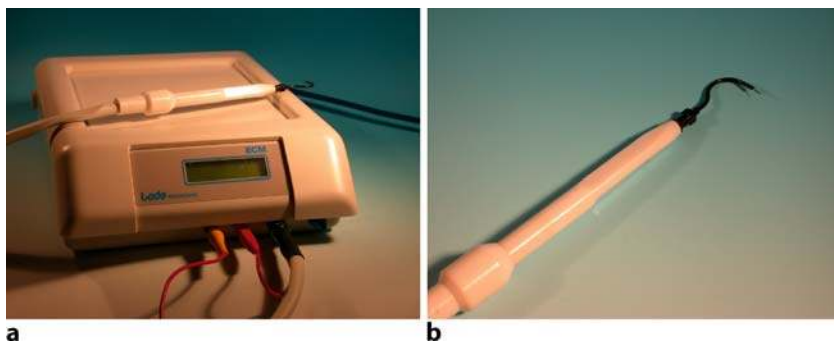
Fig. 1.7 (a) Electronic Caries Monitor (ECM, Lode Diagnostic, Groningen, The Netherlands). (b) The ECM has an excellent sensitivity in detecting occlusal caries, but its specificity is lower. It may have less reproducibility than other caries-detecting systems such as DIAGNOdent

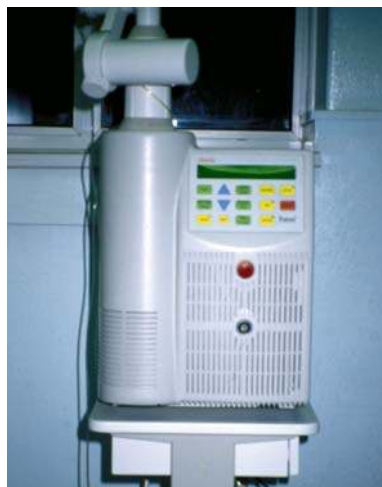
This might be expected to improve the adaptation and retention of adhesively retained resin composites to the tooth. However, experimental results with the erbium:YAG laser have been disappointing (Eguro et al. 2002), probably because laser irradiation weakens the surrounding dentin. Erbium:YAG preparation of enamel must be followed by conventional etching with phosphoric acid if adequate adhesion of resin composites to enamel is to be achieved (Otsuki et al. 2002).

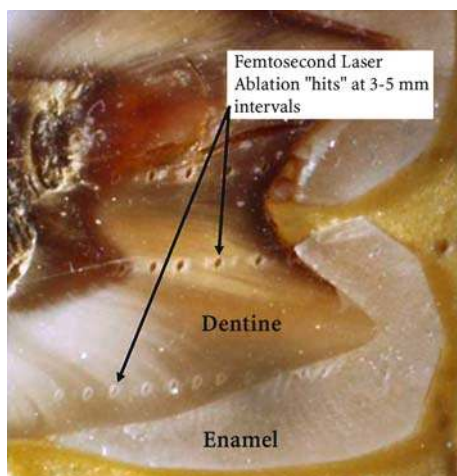
Fig. 2.3 These holes were created by a femtosecond laser (laser pulse duration = 10^{-15} s). The femtosecond laser can photoablate bone, enamel, and dentine with the minimum of collateral thermal damage. This laser is still in the experimental stage of development for dental use

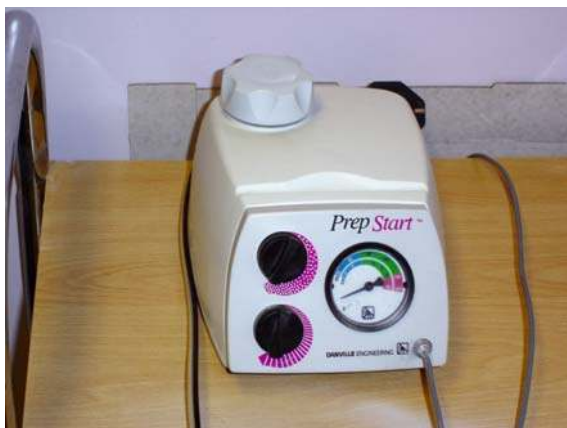
Fig. 2.5 The air abrasion handpiece is light and the flow of powder has a controlled variable outflow

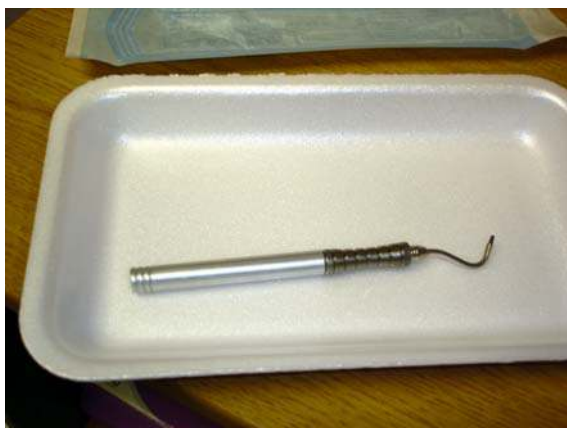
but they have the disadvantage that they can easily cause iatrogenic damage by removing exposed cementum and root dentin in teeth affected by gingival recession and periodontal disease. Atkinson et al. (1984) found that their air-powder abrasive system removed a mean depth of $637\mu\text{m}$ of root structure in 30s of exposure time. Further research aimed at identifying less abrasive powders is ongoing (Petersilka et al. 2003), because softer particles might be more effective in removing carious dentin more selectively. Laurrell et al. (1995) showed in dogs that higher pressures and smaller particles yielded significantly fewer pulpal effects than treatment with high-speed rotary burs.

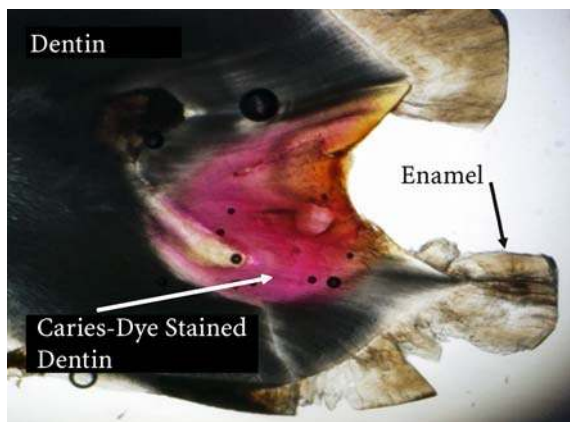
because these dyes will stain food debris and other organic material in the fissure. The consequences of a false-negative diagnosis (i.e., the dentist concluding that fissure caries is absent when it is truly present) are less significant than providing an unnecessary restoration.

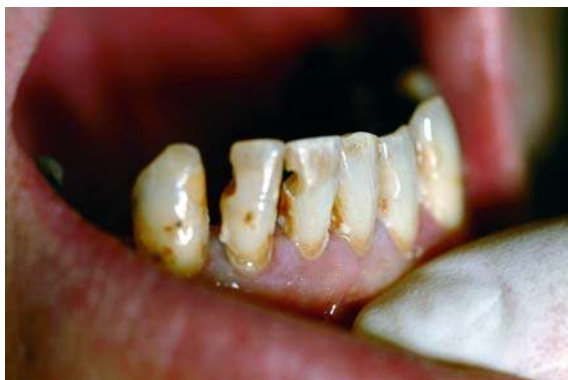
Fig. 2.7 Oral hygiene instruction and diet advice are essential to prevent further deterioration of this dentition

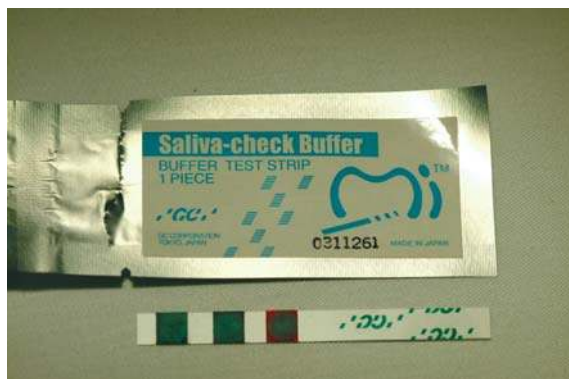
Fig. 2.9 Universal indicator paper can provide a visual indication to the patient of their salivary pH. The lime green color illustrated indicates a normal salivary pH

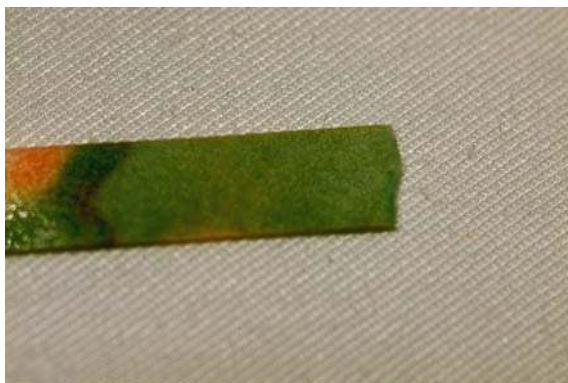
2.2.3 Preventing Dental Caries

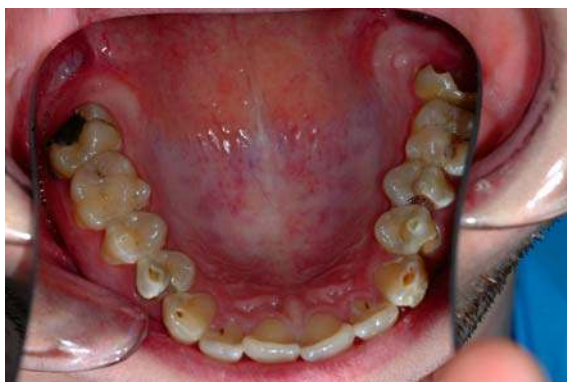
fluoride mouthwash. In-office fluoride gel applications are also helpful. They consist of applying 2% neutral sodium fluoride gel for 4 min every week for 4 weeks. This regime can be repeated every 6 months. The dentist can apply small quantities of fluoride varnish (fluoride at a concentration of 22,600 ppm in a resin base) directly to an early noncavitated lesion. Fluoride varnish (Duraphat, Colgate; Fluor Protector, Vivadent), when applied to the decalcified enamel lesion, will encourage remineralization. The teeth are dried and isolated from saliva with cotton wool rolls and when the varnish is applied it adheres to the enamel. Chlorhexidine causes unsightly brown staining of the teeth if used persistently (Fig. 2.11). The stain may require professional removal with prophylaxis paste.

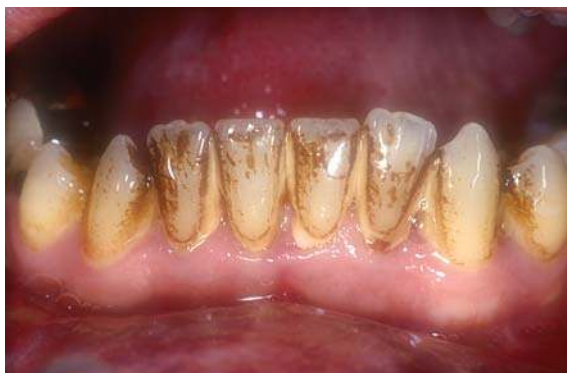
Fig. 2.11 Chlorhexidine causes an unsightly brown staining of the teeth if used persistently

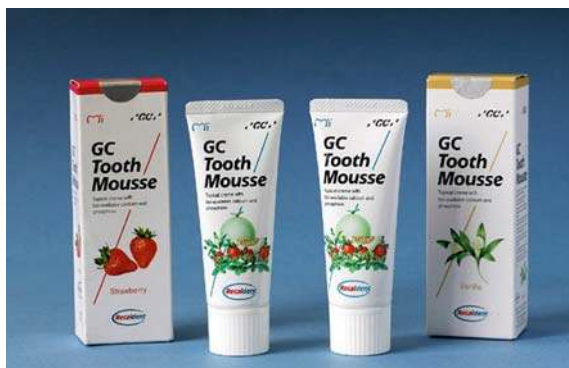
confirm that the chlorhexidine has been effective in bacterial suppression. Xylitol chewing gum has also been shown to be effective and its use is recommended three times a day after meals; it stimulates salivary flow, which will tend to buffer acid in plaque and assist in enamel remineralization. GC Tooth Mousse is a new, water-based, topical cream containing Recaldent casein phosphopeptide–amorphous calcium phosphate. When applied to the tooth surface, calcium phosphate is made available for remineralization of the tooth surface. The mineral-rich paste has a pleasant taste, which should stimulate salivary flow (Fig. 2.12).

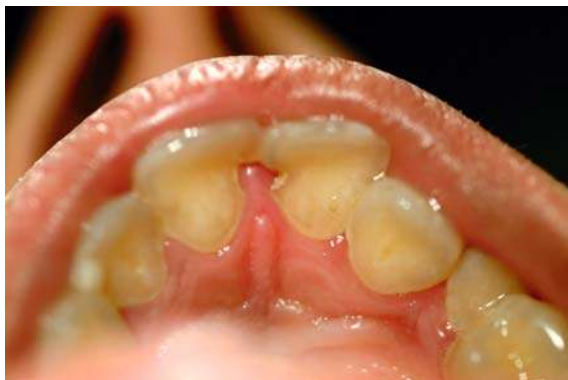
dentin and reported that even amongst well-motivated dental students, 20% of the lesions cavitated within an 18-month period.

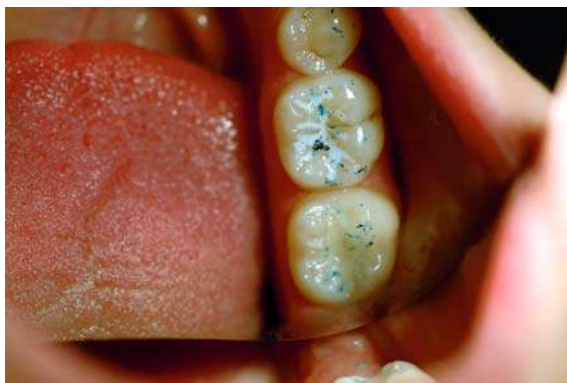
Fig. 2.14 Fissure sealants should be used in recently erupted teeth, when the tooth is most vulnerable to caries

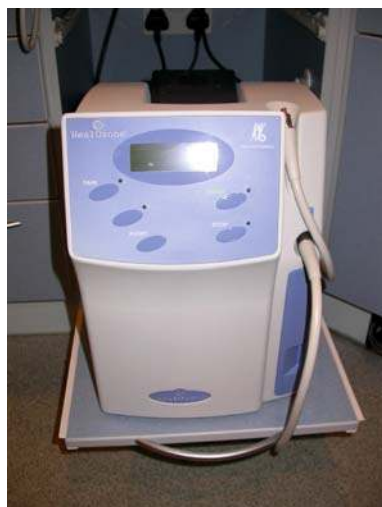
Fig. 2.15 HealOzone (KaVo Dental, Biberach, Germany) delivers ozone gas, which disinfects the tooth. The minimally carious lesion is encouraged to remineralize over a period of 4 weeks using fluoride and mineral mouthwashes, toothpaste, and sprays

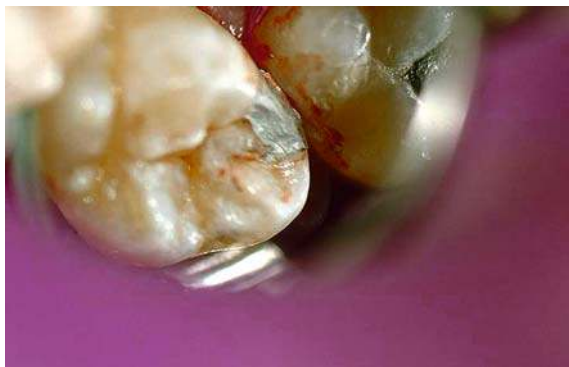
Fig. 2.16 The slot preparation preserves occlusal tooth substance. Grooves increase the retention of the restoration

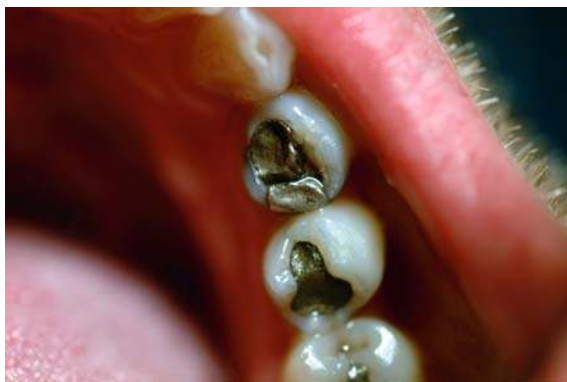
Fig. 2.17 Bulk fracture of the amalgam at the occlusal isthmus region is a common reason for failure of these restorations

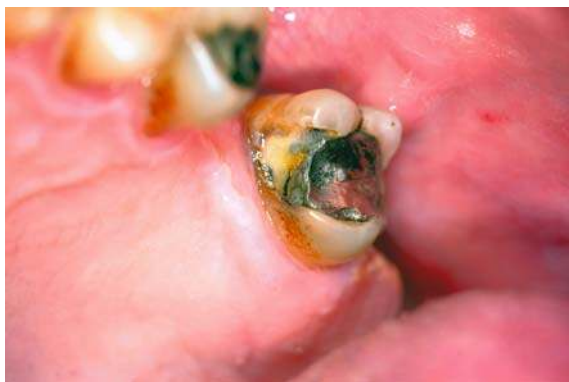
1984). Whether recurrent caries is associated with marginal amalgam defects often depends upon the overall caries risk of the patient (Goldberg et al. 1981). So in considering whether to replace the deficient restoration shown in Fig. 2.19, the overall caries risk of the patient must be assessed. Whereas features such as a gingival overhang of the restoration margin certainly reduce the quality of the resulting restoration, opinion is divided as to whether even such a restoration should be replaced (Paterson et al. 1995). Similarly, there is disagreement among experts about the need for operative intervention where white spots or dentinal staining exist adjacent to restoration margins (Paterson et al. 1995). However, most would agree that the loss of an amalgam restoration or its fracture should require replacement or repair to prevent secondary caries.

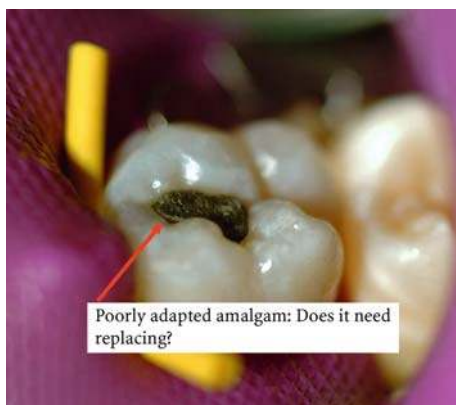
Fig. 2.19 Better clinical guidance about when to replace restorations is required, but an important factor for the dentist to consider is the overall caries risk of the patient

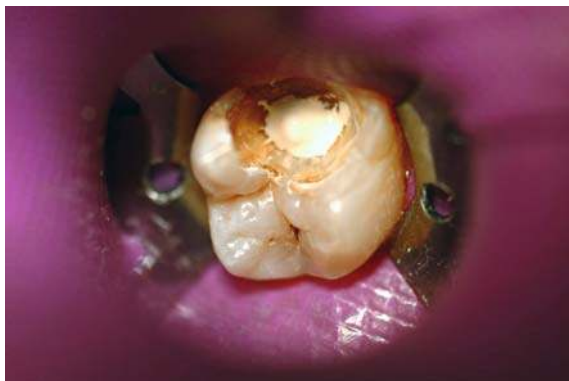
The success of direct pulp capping, measured in terms of an absence of symptoms, and maintenance of pulpal vitality and blood supply (Ricketts 2001) is increased where: (1) the pulp is pink and any hemorrhage is easily controlled by washing with sterile saline, (2) there is a normal vital response, (3) there is no radiographic pathology, (4) there is no previous spontaneous pain, (5) the tooth has no tenderness to percussion, and (6) the patient is young and where the pulp would be expected to be more vascular than in an

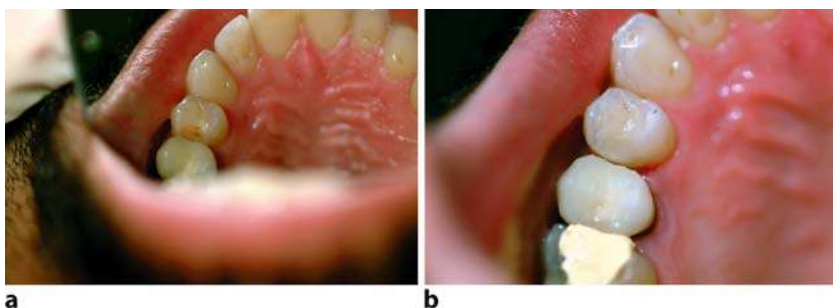
Fig. 2.21 (a) This was a small pulpal exposure in the upper premolar tooth, but little bleeding was evident. The tooth was isolated from salivary contamination, and calcium hydroxide applied to the exposure. (b) With the calcium hydroxide placed over the pulpal exposure, a coronal seal was established with a glass ionomer base and adhesively retained composite resin restoration. The tooth remained vital and symptomless

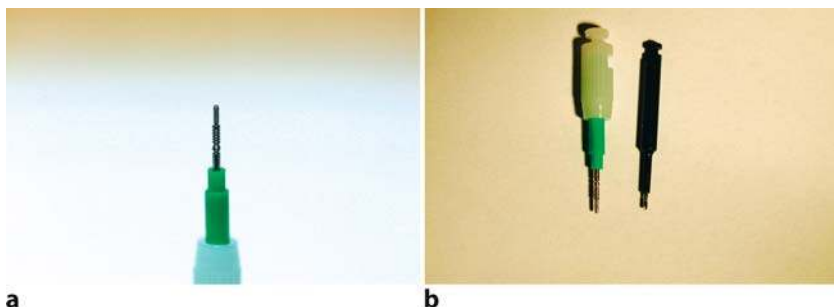
Fig. 2.22 (a) Self-threading pins should be placed in dentin in a direction parallel to the external surface of the tooth and about 0.5–1 mm from the enamel-dentin junction. (b) Self-threading pins are used with matching drills

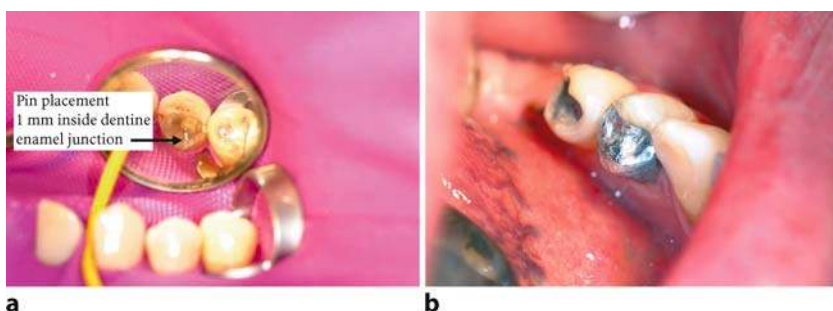
Fig. 2.23 (a) The minimum number of pins should be used (usually one per replacement cusp) with a minimum distance of 3–5 mm between pins. (b) The finished pin-retained amalgam. A 1-mm width of amalgam must cover the pin for the restoration to have good strength

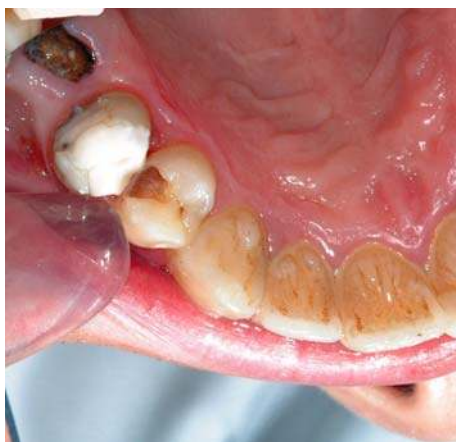
flow of the composite resin is reduced. Large contraction stresses are then applied directly to the adhesive bond. The most unfavorable situation is found where there is a large bonded surface:free unbonded surface ratio, such as with class I and II cavities.

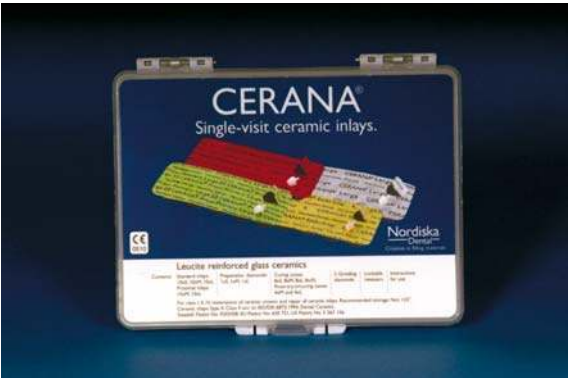
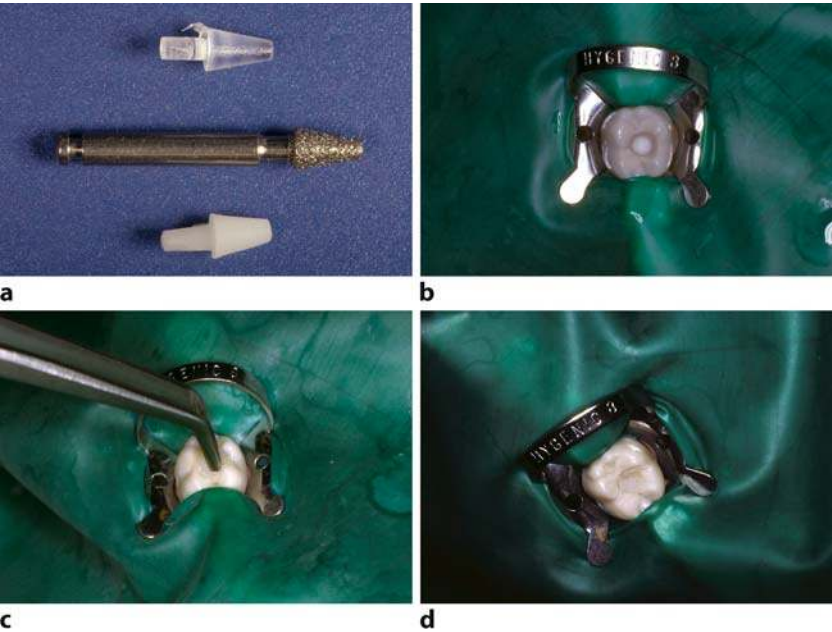
Fig. 3.3 (a) The cavity is prepared using a size-matched bur and etched. Primer/bond and resin composite are applied and cured. The clear curing cone is used in large cavities to assist with light-curing of the deepest areas of resin composite. The white ceramic insert is matched for the size of the bur. (b) The ceramic insert technique is best used where the cavity is large and requires a considerable amount of resin composite, or where the cavity has a large “C” factor. (c) Bonding resin is applied to the ceramic inlay and is pressed into the cavity. Excess resin composite is removed and the restoration is light-cured for 40 s. (d) The occlusal contour of the ceramic/resin composite restoration is adjusted

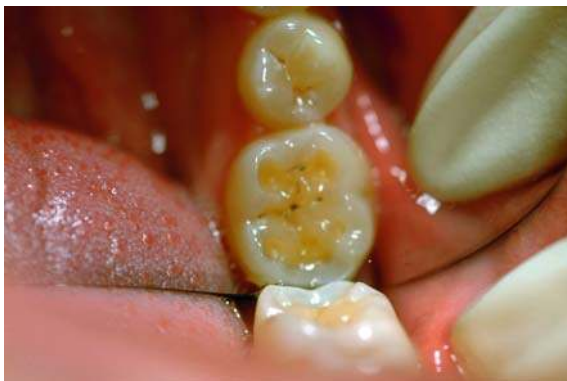
3.6 Preventive Resin Restorations

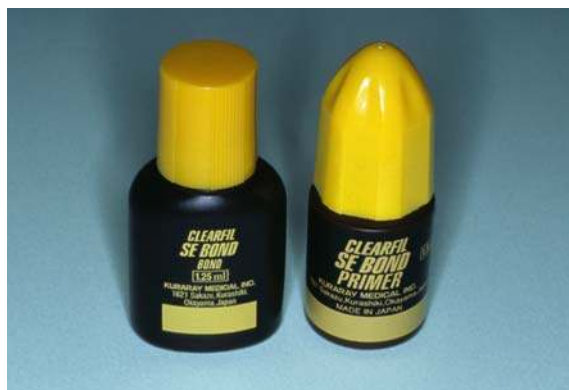
Fig. 3.5 This self-etching primer simultaneously etches and primes dentin. If the restoration involves enamel, then the enamel requires separate etching with phosphoric acid

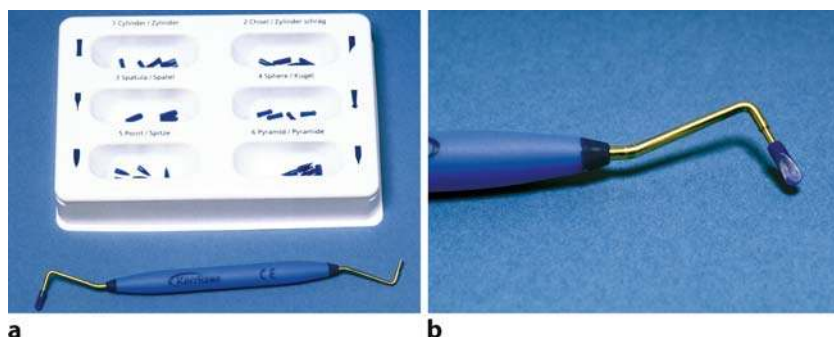
Fig. 3.6 (a) Some disposable tips that can be used to carve posterior composite resin prior to curing (Optra Sculpt from Ivoclar Vivadent). (b) After carving of the resin composite is complete, the disposable tips are removed. The metal handle is sterilized for reuse

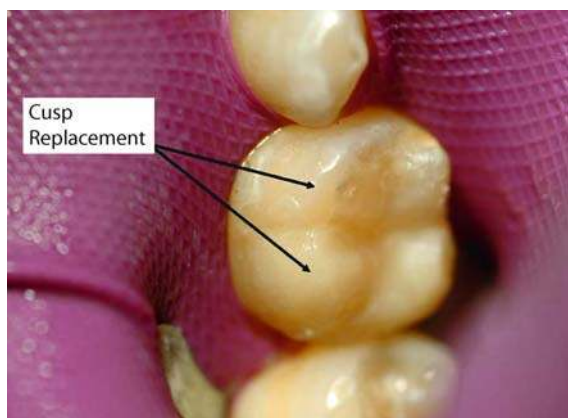
Fig. 3.8 With extensive direct composite restorations, contact of weak remaining cusps during working side contacts should be avoided to prevent tooth fracture. If the isolated distobuccal cusp of the first molar is left, further tooth fracture is likely

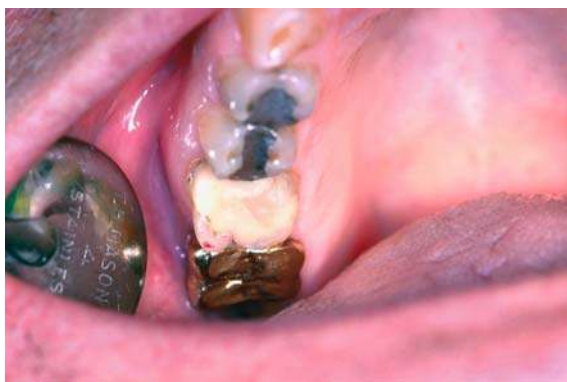
In smaller posterior restorations, discoloration of the margin and secondary caries are significant causes of failure, perhaps due to poor adaptation and gap formation at insertion and polymerization of the composite resin. But the success rate of these smaller restorations rival those of amalgam, especially where the composite resins have been placed under ideal conditions in university settings (Wilson et al. 1991). The success of posterior composite restorations is maximized where the external surface is surrounded by enamel and direct occlusal forces are avoided (Ferracane, 1992).

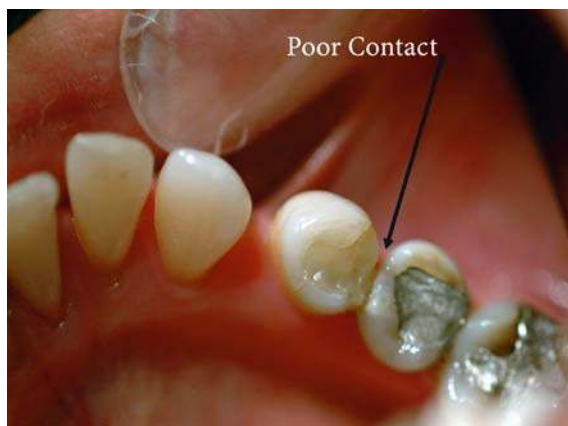
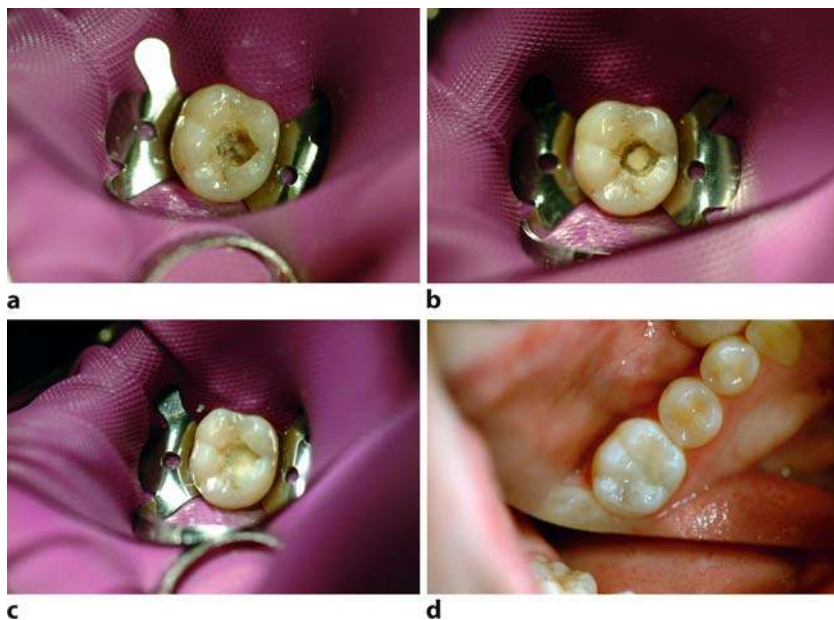
Fig. 3.10 (a) The caries is removed with minimal extension into the adjacent fissures. The pulpal floor is rounded. (b) A calcium hydroxide base was applied to the pulpal floor of the restoration, where it approached the pulp. (c) Calcium hydroxide is a weak, soluble material, therefore glass ionomer (or resin modified glass ionomer) base is placed over it. (d) The cavity was restored, polished, and the occlusion perfected

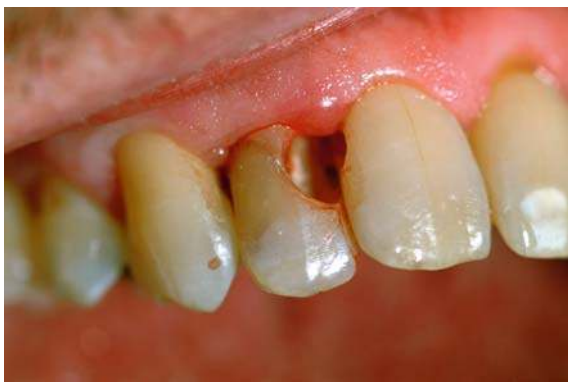
Fig. 4.2 Interproximal caries lesion may be associated with gingivitis, and a well-contoured temporary restoration can allow healing. This facilitates impression taking for crowns and allows careful planning of the crown margin

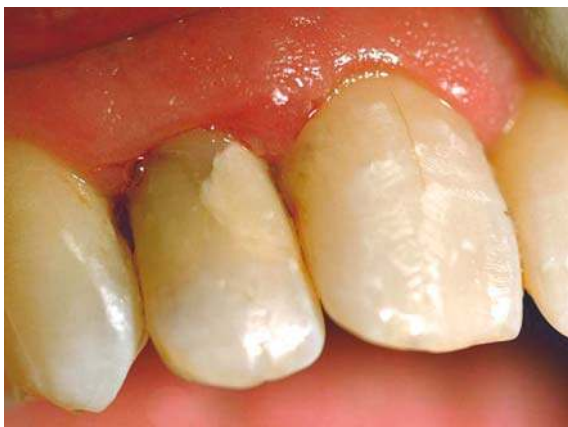
Fig. 4.3 A periapical radiograph is essential prior to crown preparation to assess the periodontal bone support, root length, and the extent of caries, if present. However, radiography underestimates the extent of caries

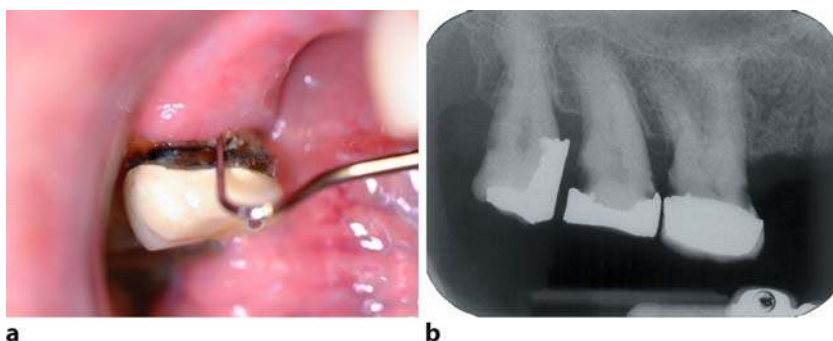
Fig. 4.4 (a) Could this carious cavity on the upper right first molar be repaired with a simple restoration, or would the metal-ceramic crown require replacement? (b) A radiograph revealed that extensive caries was present on the distal interproximal surface, and the metal-ceramic crown therefore required replacement

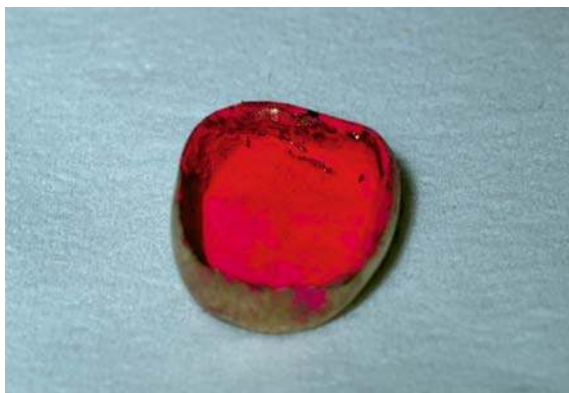
Fig. 4.5 Small discrepant areas of tight contact of the crown with the tooth can be localized using a disclosing dye that is applied to the fitting surface of the crown. The crown is pressed into place and discrepant areas are visible where the metal shines through the dye layer

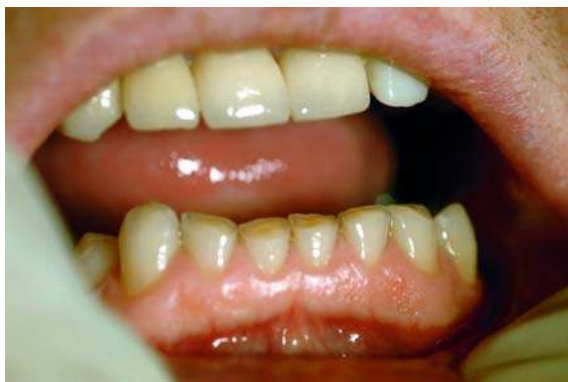
ing horizontal loading on the teeth; the restoration can become uncemented, the tooth may become painful, or temporomandibular joint disorders can result.

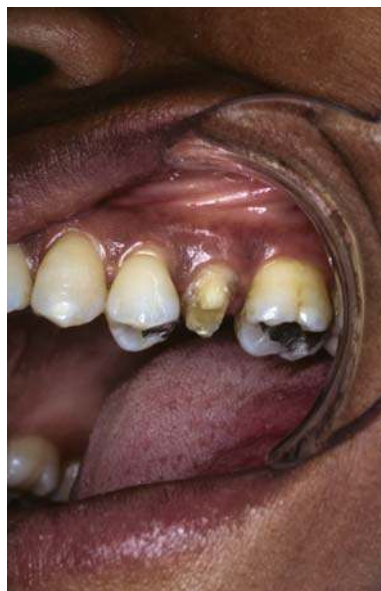
Fig. 4.8 Overpreparation in the axial plane with a torpedo-shaped bur results in an unsatisfactory marginal “lip”

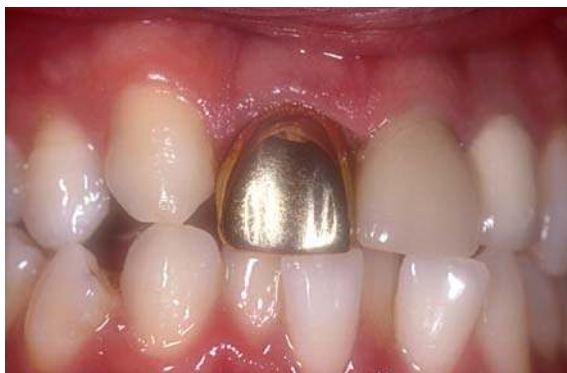
Fig. 4.11 A gold-veneer crown placed on the upper central incisor tooth

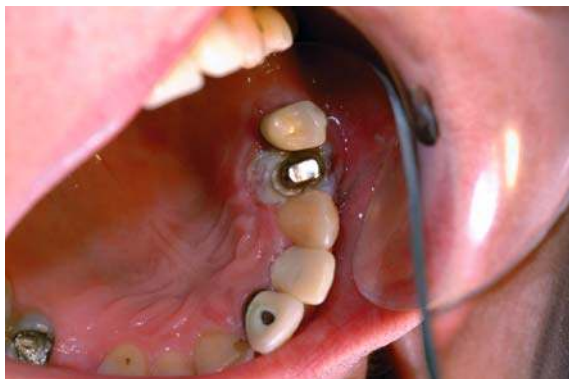
Fig. 4.12 Traumatic tooth preparation, excessive cauterization or prolonged application of hemostatic cord and astringent solutions can cause extensive gingival necrosis

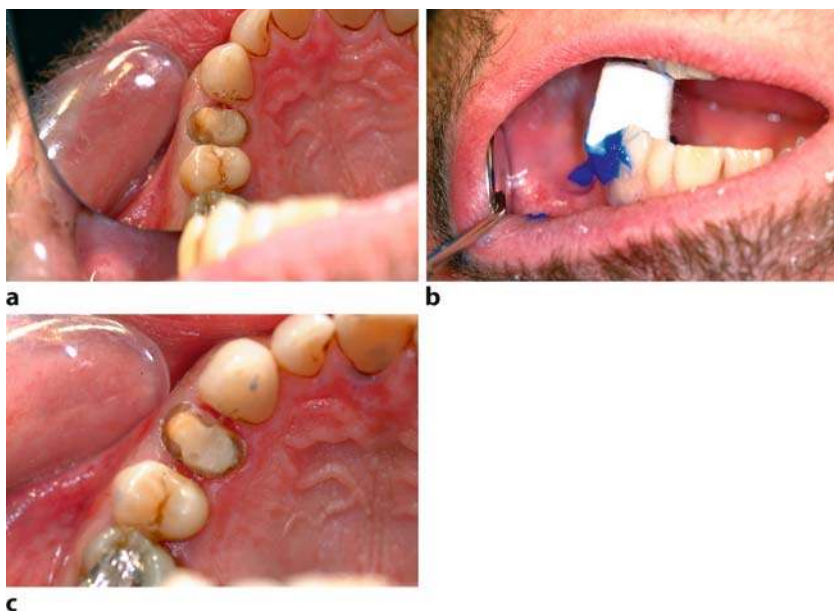
Fig. 4.13 (a) Where bleeding, debris, or gingival exudate is present, subgingival margins are difficult to record accurately using hydrophobic impression materials (such as addition silicones). (b) A blue, expanding polyvinylsiloxane material is injected around the gingival sulcus and held in place with a shaped cotton pad (Comprecap Anatomic) placed over the tooth. The material expands and gently retracts the gingiva. (c) When the cotton pad is removed, a fully retracted gingival sulcus can be seen

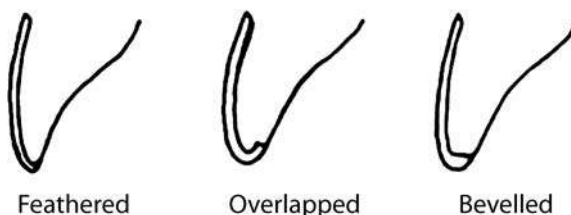
Fig. 4.15 With the more extensive beveled or overlapped preparation designs, an esthetic, translucent incisal edge in porcelain can be produced

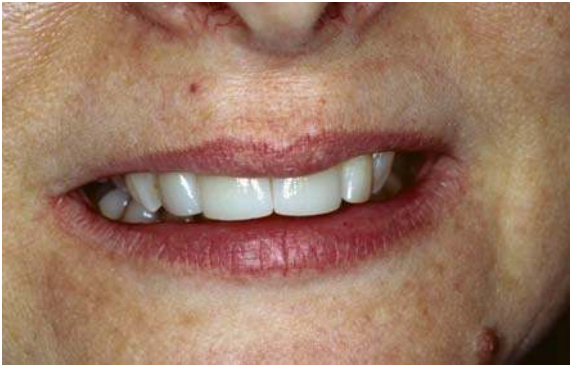
of current dentin bonding agents to hermetically seal the veneer margin can lead to microleakage in the long term.

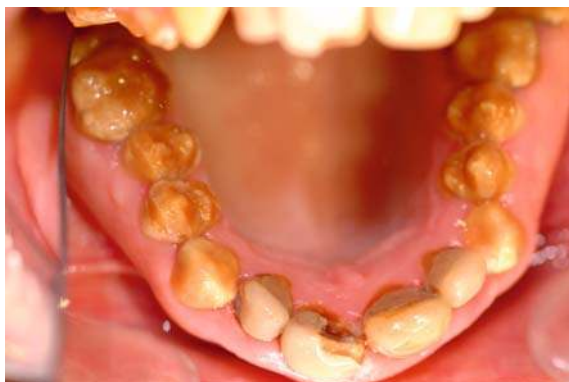
Fig. 4.17 This patient has the genetic condition amelogenesis imperfecta, which has resulted in the absence of formation of enamel on her teeth

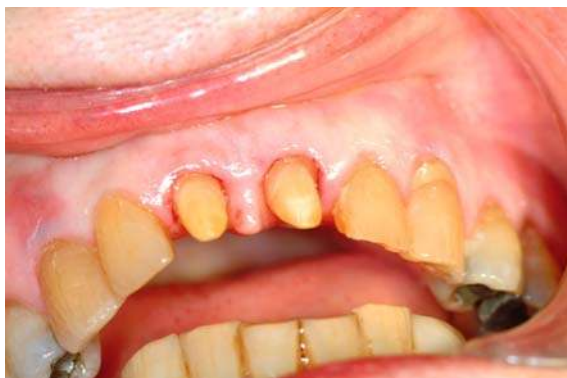
Fig. 4.18 Preparations for resin-bonded ceramic crowns should be rounded, with a chamfer margin placed supragingivally where possible

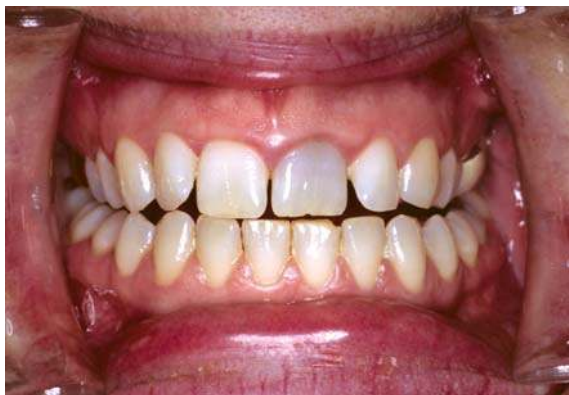
Fig. 4.19 In the “walking bleach method,” sodium perborate is placed into the pulp chamber of a discolored nonvital tooth

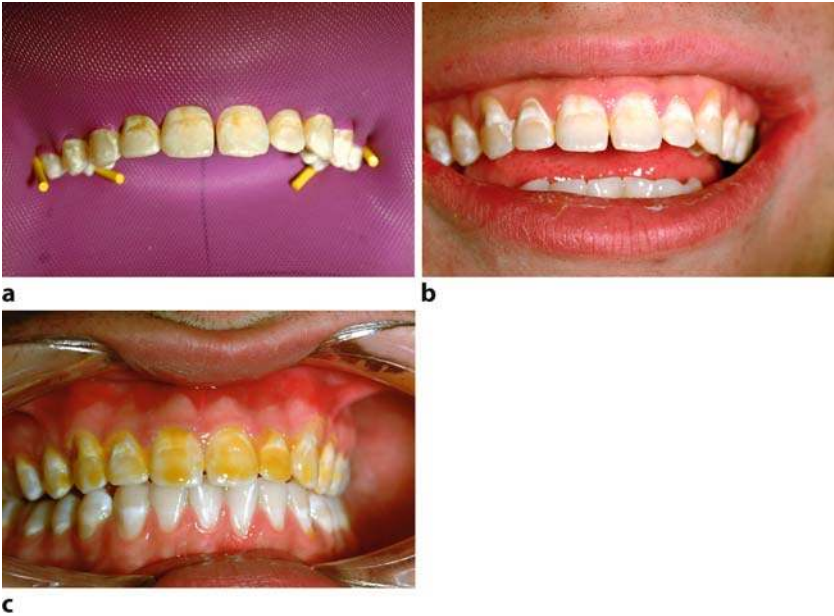
Fig. 4.20 (a) This patient presented with discolored, hypoplastic anterior teeth. (b) Using a rubber dam, a slurry of hydrochloric acid mixed with particles of silicon carbide was brushed onto the teeth and the brown staining was removed. (c) The patient complained of mild tooth sensitivity following microabrasion. This was reduced by applying a thin layer of fluoride varnish to the microabraded teeth

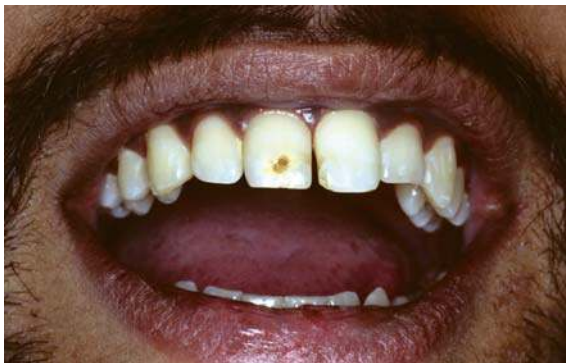
Fig. 4.21 Microabrasion can be used to treat hypoplastic incisors with small localized defects

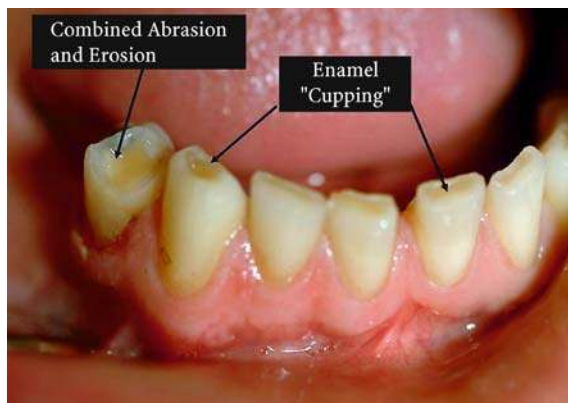
Fig. 5.1 Erosion is a common cause of noncarious tooth tissue loss, often acting in combination with abrasion and attrition

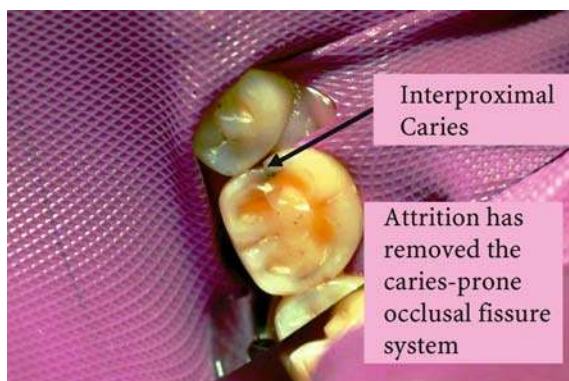
The incidence of occlusal caries in teeth undergoing rapid attrition is low because there is no caries-prone fissure system and early caries is abraded away (Fig. 5.2). In interproximal areas of teeth, caries can initiate and spread unhindered by the occlusal attrition.

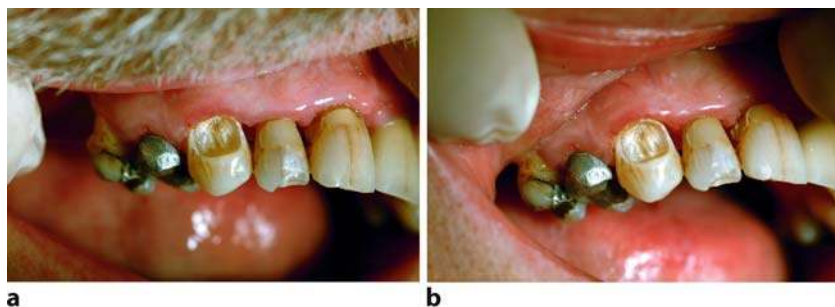
Fig. 5.4 (a) During placement of the resin composite for this deep subgingival restoration, contamination by gingival exudates is possible. (b) Placement of retraction cord and astringent solution for 2 min allowed the gingival tissues to retract

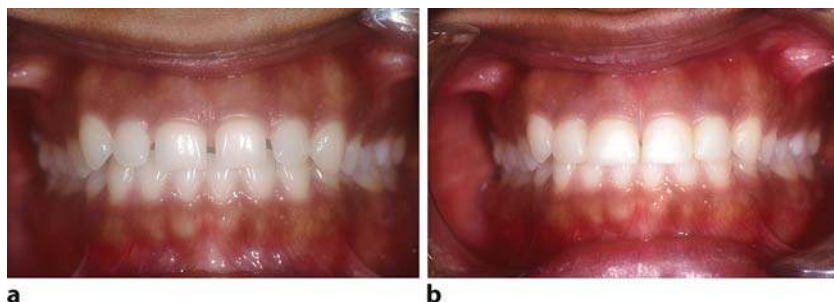
Fig. 5.6 (a) Long-term consumption of carbonated beverages had caused mild erosive wear of the upper teeth with spacing and thinning of the enamel. (b) Closure of the spaces between the upper incisor teeth was made with resin composite additions

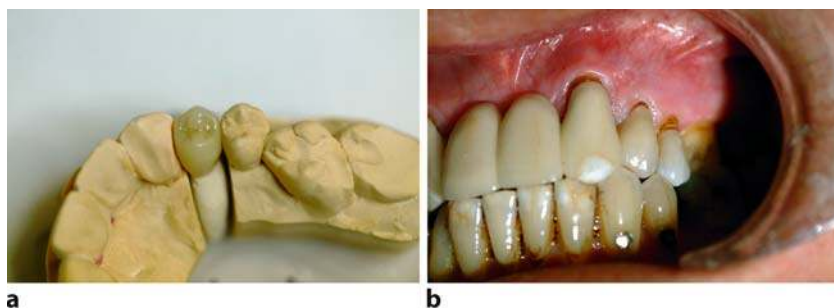
Fig. 5.8 (a) Feldspathic porcelain inlays and onlays are fired on phosphate-bonded working models and then refitted to the master model. (b) Feldspathic porcelain onlay restoring the upper premolar. These restorations have excellent esthetics, but fracture easily

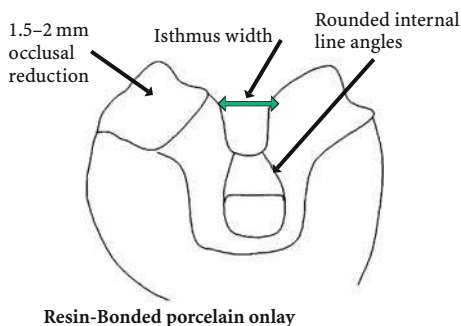
Fig. 5.9 Resin-bonded porcelain onlay

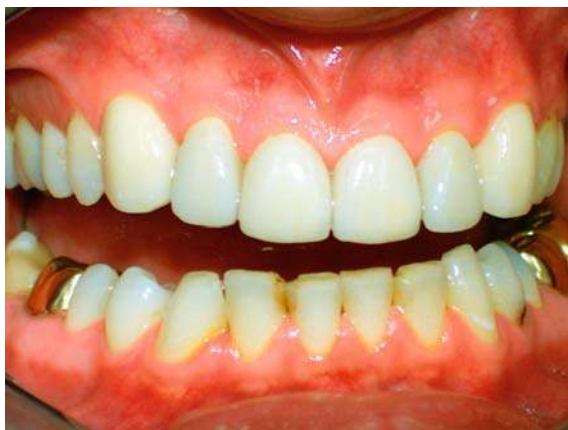
5.8 Cementation of the Restoration

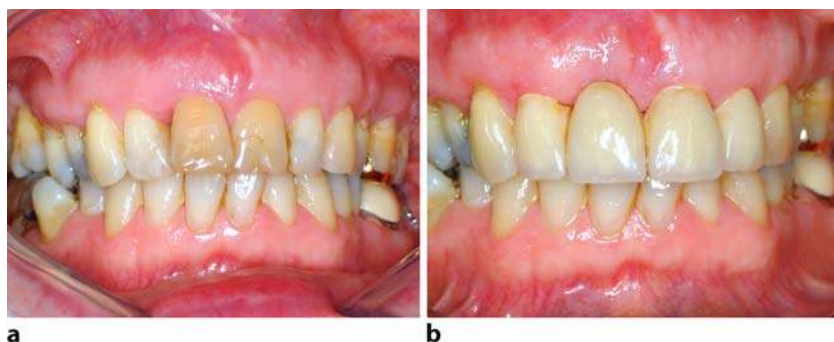
Fig. 5.13 (a) This patient requested an esthetic improvement to their dark yellowish-brown upper incisors. (b) The upper right central was extracted and replaced with a fixed partial denture using Lava technology. In addition, the upper left lateral incisor received a Lavacrown. There was an excellent esthetic improvement

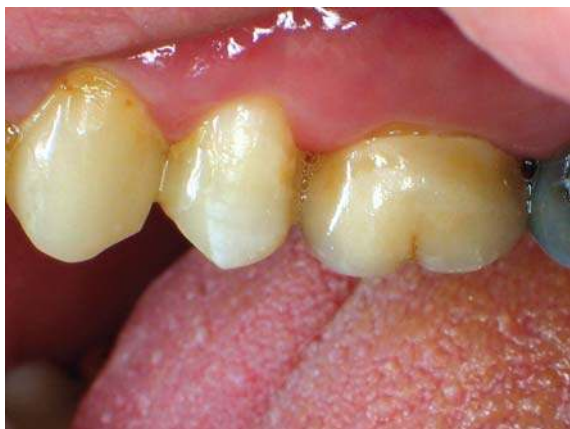
(Fig. 5.13b). In addition, the upper left lateral incisor received a Lava crown. Figure 5.14 illustrates the use of Lava technology in replacing an upper first molar, producing a restoration with excellent esthetics and strength.
